GROUP	MODEL
ELE	2025MY K4 (CL4)
NUMBER	DATE
363	December 2024

## TECHNICAL SERVICE BULLETIN

### SERVICE ACTION: SUNROOF OPERATION SOFTWARE LOGIC IMPROVEMENT (SA595)

This issue number is SA595.

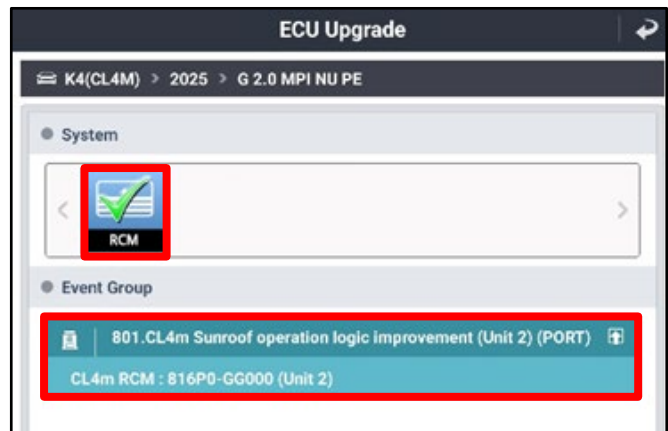
1. **UPGRADE EVENT:**

- 801.CL4m Sunroof Operation Logic Improvement (Unit 2)

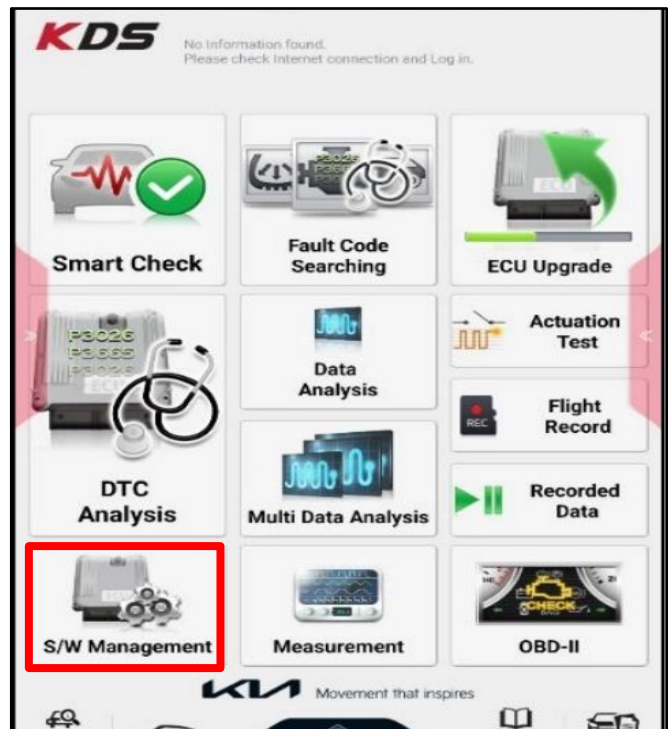
2. Navigate to the 'S/W Management' menu.

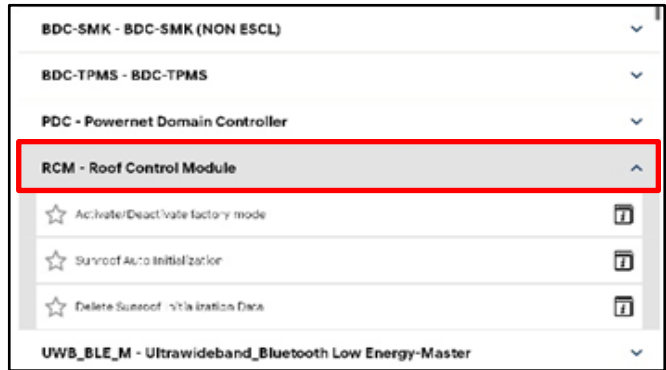
3. Select 'RCM - Roof Control Module'

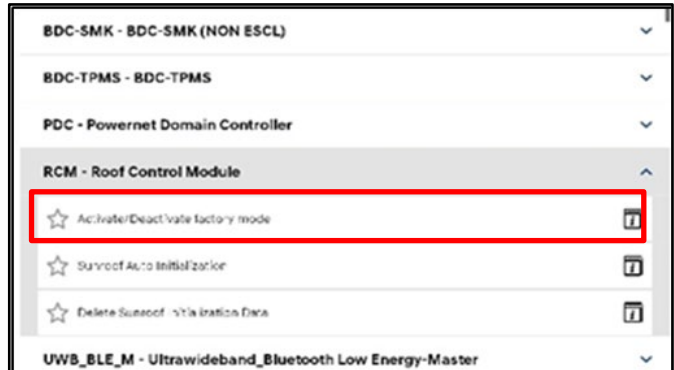
4. Select 'Activate/Deactivate Factory Mode'

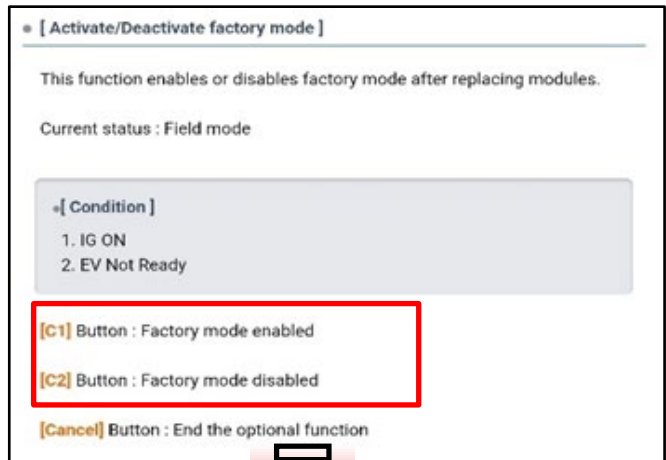
5. Select C1 or C2 to enable or disable factory reset mode:

- 5a. > Select 'C1' to enable factory reset mode and wait until calibration is complete.
- > Select 'OK'
- > Select 'C2' to disable factory reset mode and wait until calibration is complete.
- > Select 'OK'.
