# TECHNICAL SERVICE BULLETIN

## Rattle From The Right Loadspace Trim Panel At High Audio System Volumes

**24-2387**

<b>Ford</b> 2021-2024 Bronco	Equipped with a factory subwoofer
---------------------------------	-----------------------------------

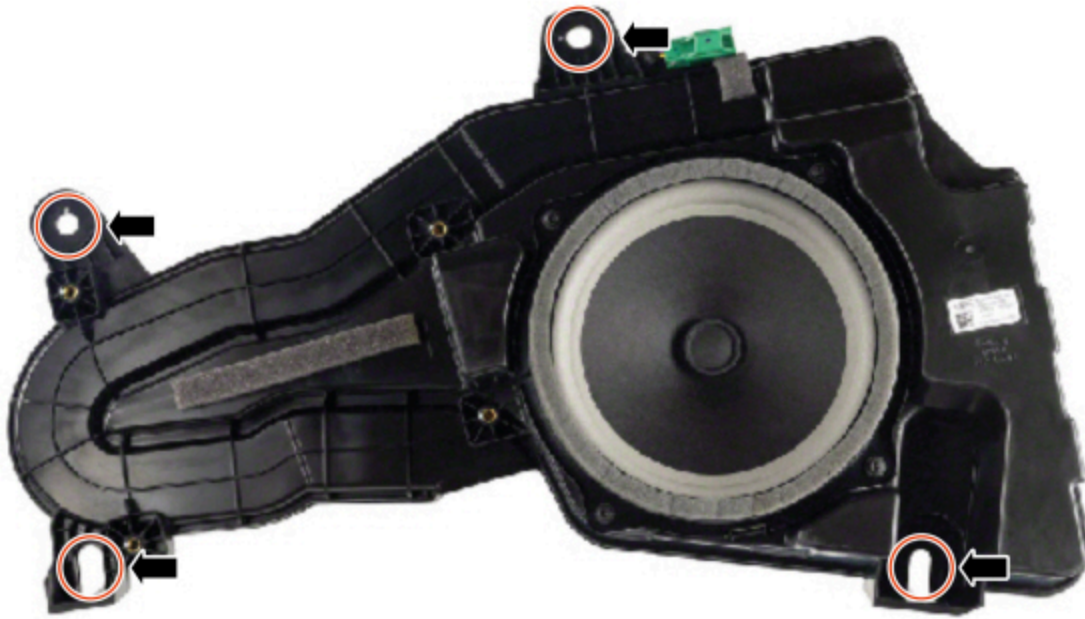
Figure 5

4. Remove the subwoofer and inspect the subwoofer for broken plastic mounting tabs. Refer to WSM, Section 415-00 Information and Entertainment System. (Figure 5)

- (1). Yes - replace subwoofer. Proceed to Step 6.
- (2). No - proceed to Step 6.

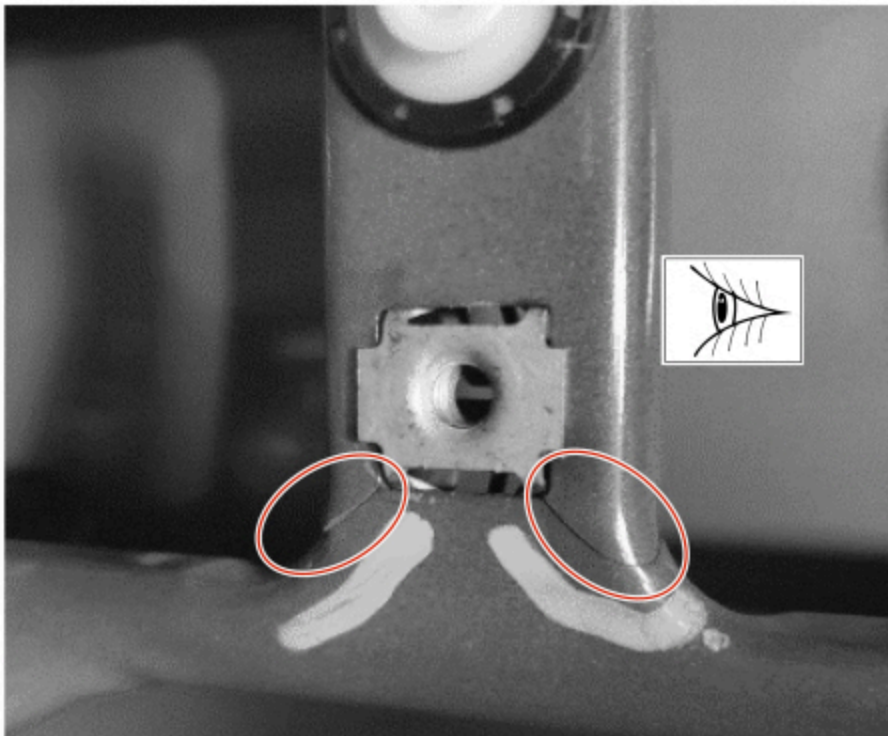
Figure 6

**6. Inspect the top mounting point of the subwoofer for a crack in the metal as seen in Figure 6. Is the metal mounting point cracked? (Figures 6-7)**

(1). Yes - proceed to Step 7 for the temporary repair and inform the customer that they will need to return at a later date when the permanent fix is available. Monitor PTS for updates.
