Service Bulletin

Bulletin No.: 24-NA-025

Subject: Check Engine Light or Malfunction Indicator Lamp Illuminated with DTCs U0401 and/or U1611 Set

Brand:	Model:	Model Year:		VIN:		Engine:	Transmission:
		from	to	from	to		
Chevrolet	Corvette Z06	2024	2025	—	—	5.5L (LT6)	M1M

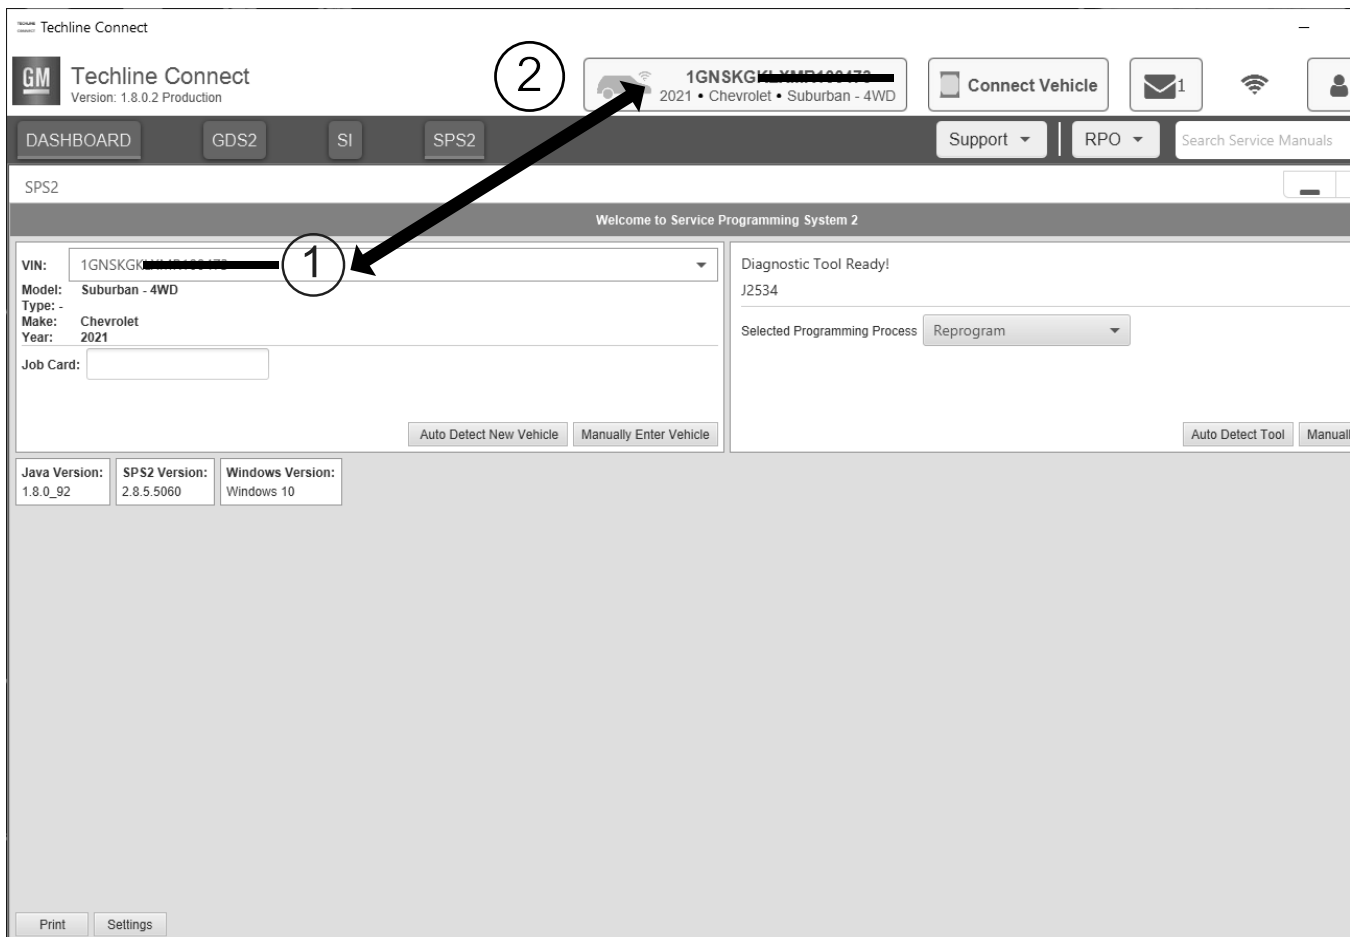
5743643

Caution: Be sure the VIN selected in the drop down menu (1) is the same as the vehicle connected (2) before beginning programming.

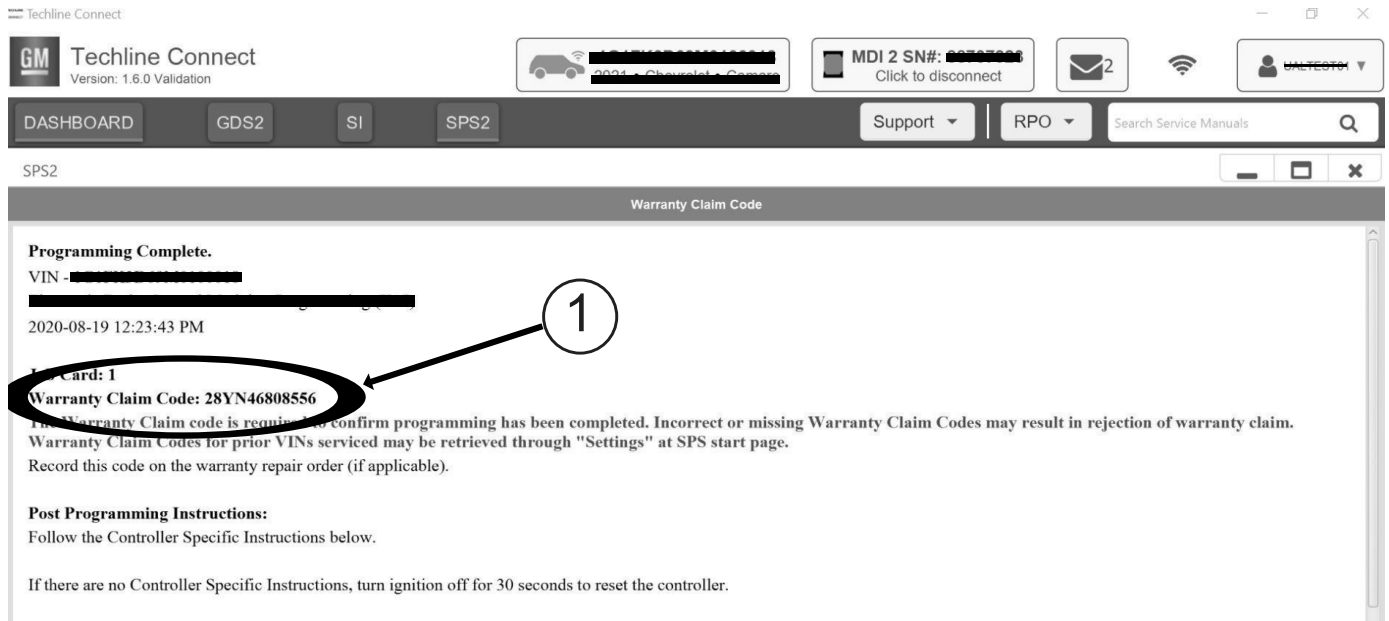
5644478

Important: To avoid warranty transaction rejections, you **MUST** record the warranty claim code provided on the Warranty Claim Code (WCC) screen shown above on the job card. Refer to callout 1 above for the location of the WCC on the screen.

2. Record the SPS Warranty Claim Code on the job card for warranty transaction submission.
