## Fuse Replacements WITHOUT Wiring Repairs

## Coolant Leak & Engine Overheating Issue - MY 2021 - 2025 - Jeep Wrangler (JL), Jeep Grand Cherokee (WL), Jeep Compass (MP), Dodge Hornet (GG)/ Alfa Romeo Tonale (GC)

## 2023 - 2025 MY (VF) - Brake Pedal Switch Stuck Condition

## Ram 1500 (DT) - Front Lower Control Arm to Knuckle Balljoint Removal Process

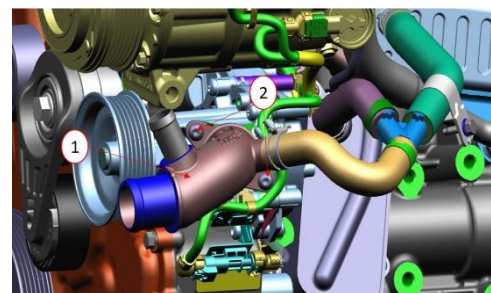
- A. Water pump inlet pipe (1) losing bolts/torque (2):

been returned, after testing they are determined to be no trouble found. Below are the possible parts which may be causing the coolant leak: water pump inlet pipe bolts losing torque (refer to CSN ZD8), thermostat's bolts losing torque, cylinder block casting porosity /cracks versus combustion chamber, oil coolant exchanger internal crack (evidence of coolant and oil mixing).

When diagnosing an engine overheated due to coolant leak, be aware that it's not necessary to replace full engine there are several components failing that may be the root cause and in most cases the replacement of the component rather than the long block\*.

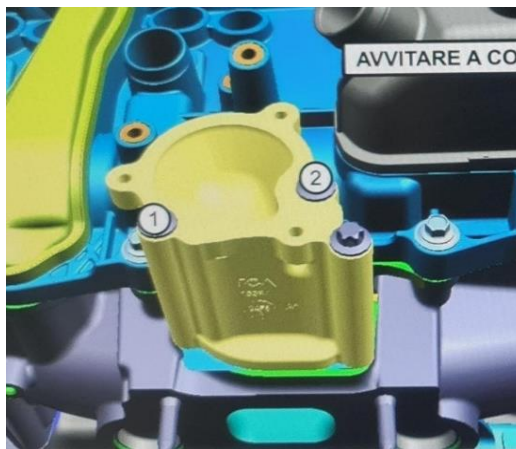
C. Thermostat column manifold losing torque/bolts

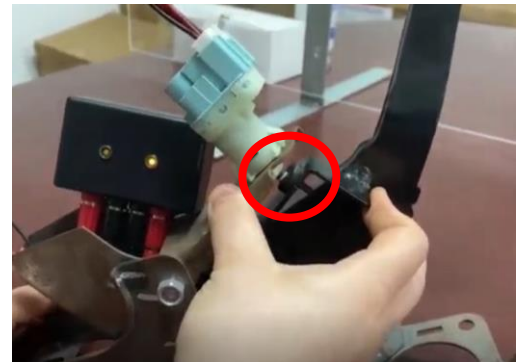
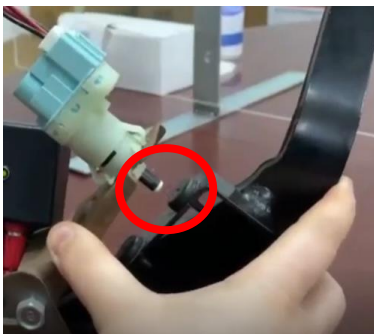
NOTE: Verify that the switch plunger is in contact with the brake pedal as shown in the image, before proceeding with the uninstallation process:

NOTE: If the plunger switch is not in contact with the brake pedal during switch uninstallation, potential additional damages to the component/stuck condition may occur.

- a) Take the brake pedal switch and apply a 45-degree clockwise twisting motion to uninstall it.
- b) Remove the switch from the mounting bracket.

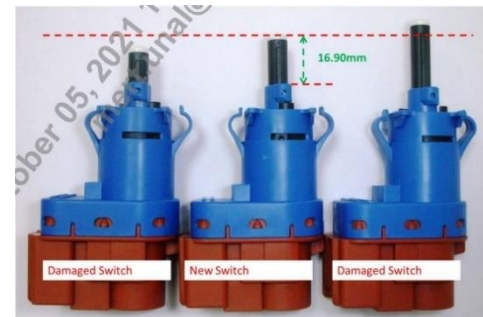
Figure 4 - Switch Damage – Plunger Length

- **Brake pedal switch manufacturing inspection:**
  - Visually verify if brake pedal switch housing is damaged.
  - Check if tabs (small plastic pieces positioned beside the plunger) are damaged or broken.
- **Brake pedal switch plunger verification:**
  - Measure the exposed plunger initial position length (16.90mm should be the initial measurement).

- A. Plunger from the switch is not positioned/set within the Service Library’s recommended distance (stuck condition):

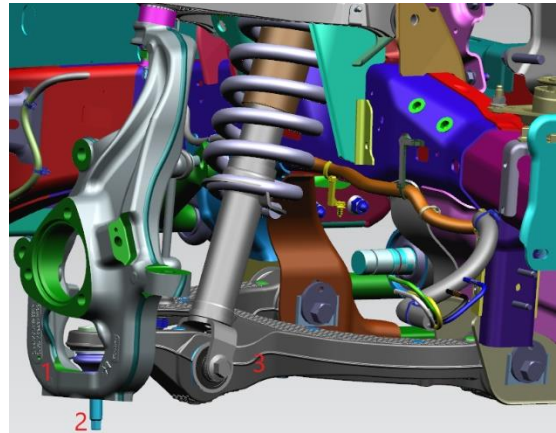
When removing the front lower control arm balljoint from the front steering knuckle, do not hammer any of the components. This includes the knuckle (1), the balljoint stud (2), or the lower control arm (3). This can damage the stud and crack the knuckle.

Instead, please use the proper tool to separate the balljoint from the knuckle, as described in the service procedure for knuckle removal. The tool pushes the balljoint out of the knuckle, no hammering is necessary.
