Fuse Replacements WITHOUT Wiring Repairs

Coolant Leak & Engine Overheating Issue - MY 2021 - 2025 - Jeep Wrangler (JL), Jeep Grand Cherokee (WL), Jeep Compass (MP), Dodge Hornet (GG)/ Alfa Romeo Tonale (GC)

Exterior Mirrors (Especially Ram Trucks 1500-5500 (DS, DT, DJ, D2, DD, DP))

MY 2023 - 2024 Compass (MP) - Technical Service Bulletin Guidelines (Expectations)

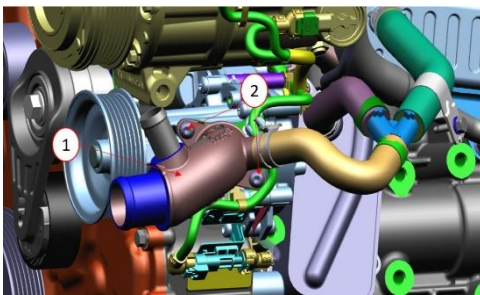
A. Water pump inlet pipe (1) losing bolts/torque (2):

When diagnosing an engine overheated due to coolant leak, be aware that it's not necessary to replace full engine there are several components failing that may be the root cause and in most cases the replacement of the component rather than the long block*.

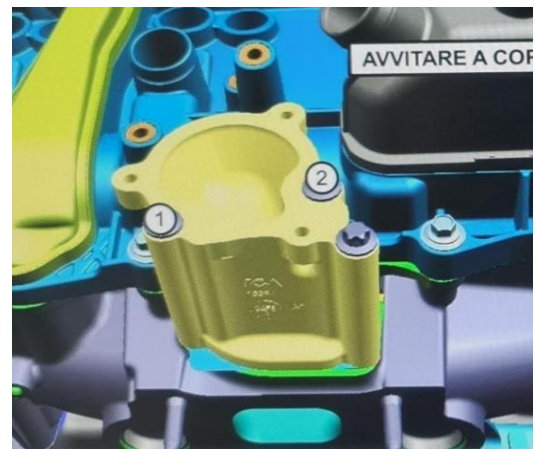
C. Thermostat column manifold losing torque/bolts

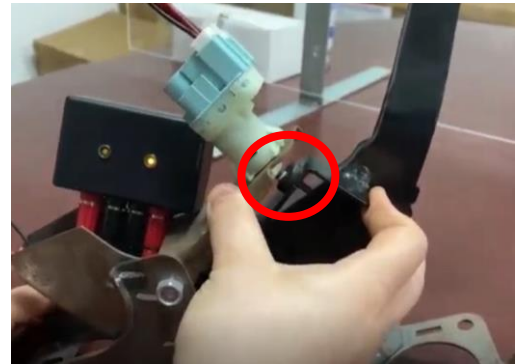
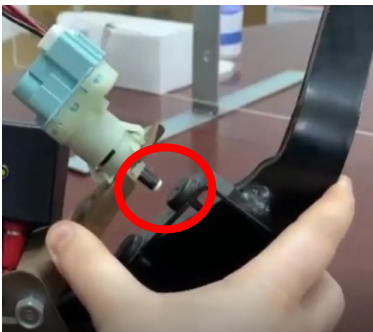
NOTE: Verify that the switch plunger is in contact with the brake pedal as shown in the image, before proceeding with the uninstallation process:

NOTE: If the plunger switch is not in contact with the brake pedal during switch uninstallation, potential additional damages to the component/stuck condition may occur.

- a) Take the brake pedal switch and apply a 45-degree clockwise twisting motion to uninstall it.
- b) Remove the switch from the mounting bracket.

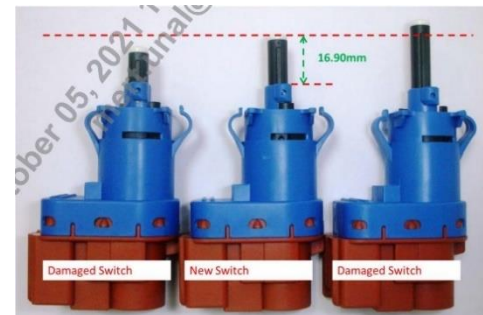
Figure 4 - Switch Damage – Plunger Length

- **Brake pedal switch manufacturing inspection:**
 - Visually verify if brake pedal switch housing is damaged.
 - Check if tabs (small plastic pieces positioned beside the plunger) are damaged or broken.
- **Brake pedal switch plunger verification:**
 - Measure the exposed plunger initial position length (16.90mm should be the initial measurement).

- A. Plunger from the switch is not positioned/set within the Service Library’s recommended distance (stuck condition):

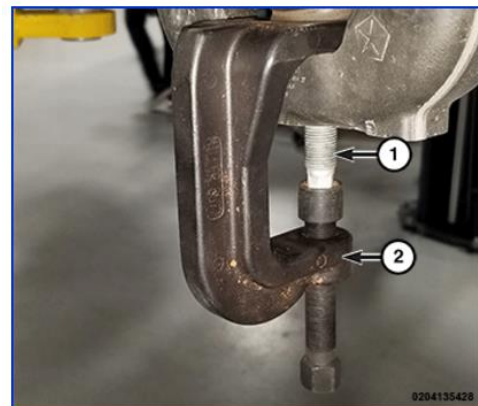
1 - Lower Ball Joint Stud
2 - Ball Joint Remover

Picture of tool properly installed and used to remove the balljoint from the knuckle

Instead, please use the proper tool to separate the balljoint from the knuckle, as described in the service procedure for knuckle removal. The tool pushes the balljoint out of the knuckle, no hammering is necessary.
