MAS004482 RU 24-44

Rapid Update 772 Ghibli, Levante - Water infiltration in the windshield area check

DATE: December 11, 2024

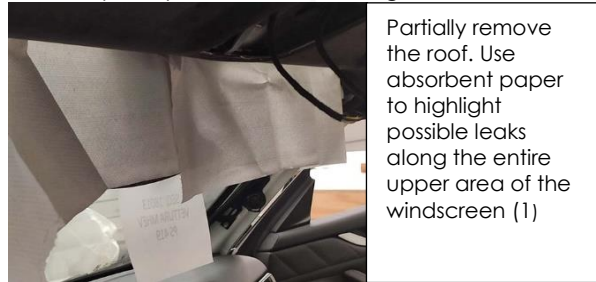
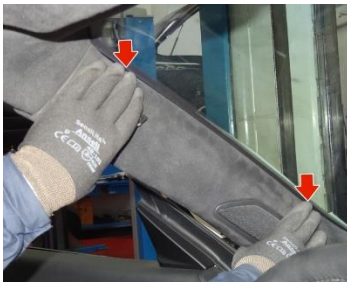
Remove the internal covers of the A-pillar to be able to inspect any leaks along the edges of the windshield (2).

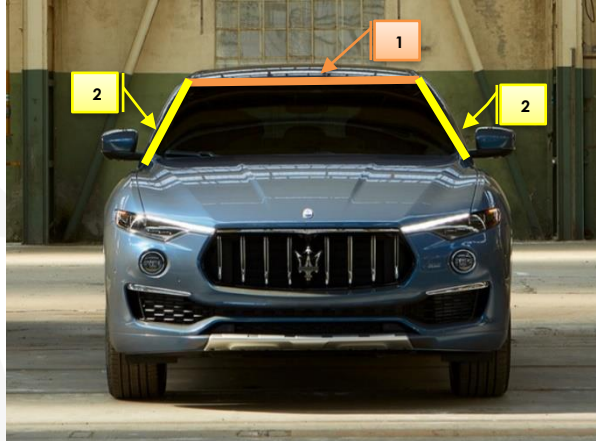
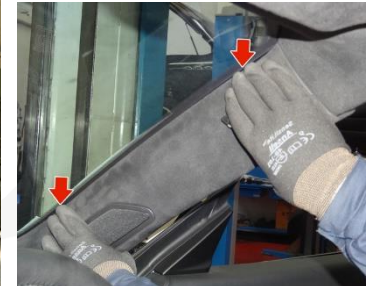
Remove the internal covers of the A-pillar to be able to inspect any leaks along the edges of the windshield (2).

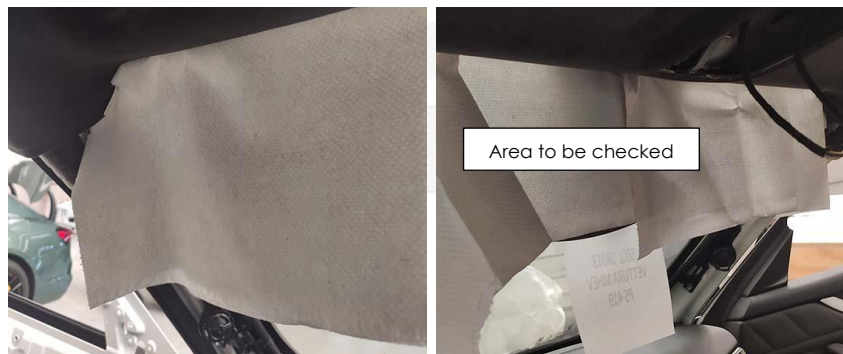
3. Follow the side strut removal procedure as per the instructions in the workshop manual:
 - **09.44.002 00** **LEFT WINDSHIELD PILLAR COVER.**
 - **09.44.001 00** **RH WINDSCREEN PILLAR COVER.**
4. Then proceed with the removal of the central ceiling light according to the instructions in the workshop manual:
 - **08.10.001 00** **FRONT CEILING LIGHT**
5. Continue by removing the sun visors and retainers, always following the procedure given in the workshop manual:
 - **09.45.003 00** **DRIVER SIDE SUN VISOR**
 - **09.45.002 00** **PASSENGER SIDE SUN VISOR**
 - **09.45.010 00** **SUN VISOR SUPPORT PASSENGER SIDE**
 - **09.45.011 00** **SUN VISOR SUPPORT DRIVER SIDE**
6. With the utmost care, lower the inner roof and place sheets of absorbent paper as shown in the following images:

7. Close the doors completely and perform a 10-minute water leak test on the windshield using a Showerhead or low-pressure spray pattern overhead to simulate a "real world scenario" rainstorm. DO NOT use a High-Pressure Washer or an open garden hose to douse the area.
