FROM: Maserati TSO

Tech Tips 74D - Engine Replacement BOL Requirements

DATE: December 12, 2024

MODELS: All MY.

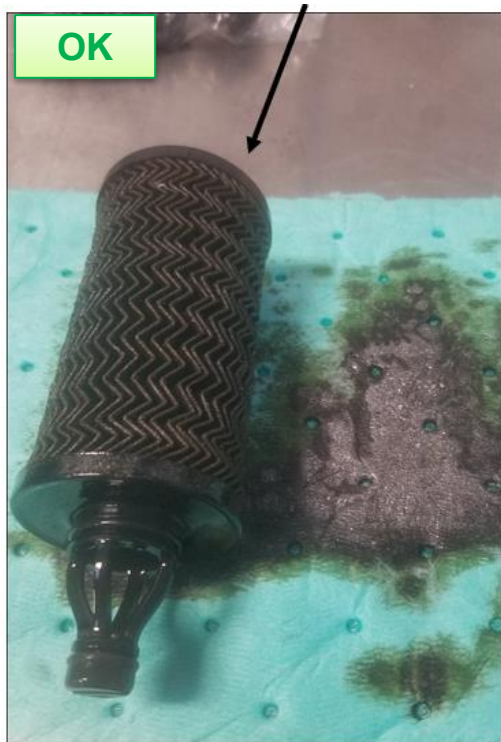
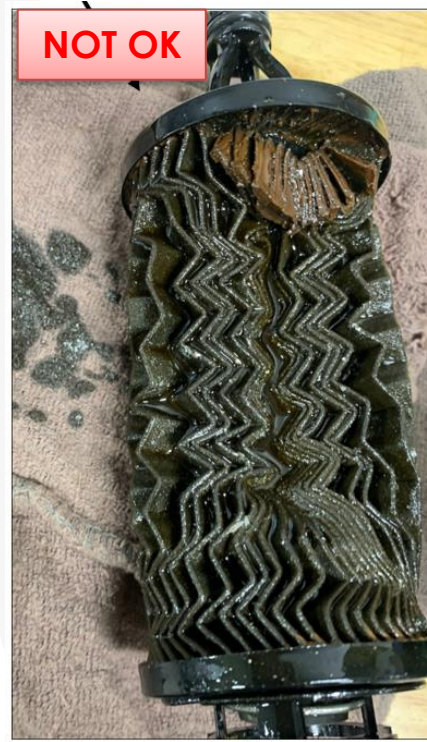
FILTER Conditions to determine if turbos need further inspection:

- **OK** ▶ Filter intact = Turbos OK - No additional inspections need to be performed on the turbo's.
- **NOT OK** ▶ Filter element damaged/collapsed = Inspect the integrity of both turbo's including the oil delivery pipe for signs of metal debris. Continue with turbo inspection on the next page.

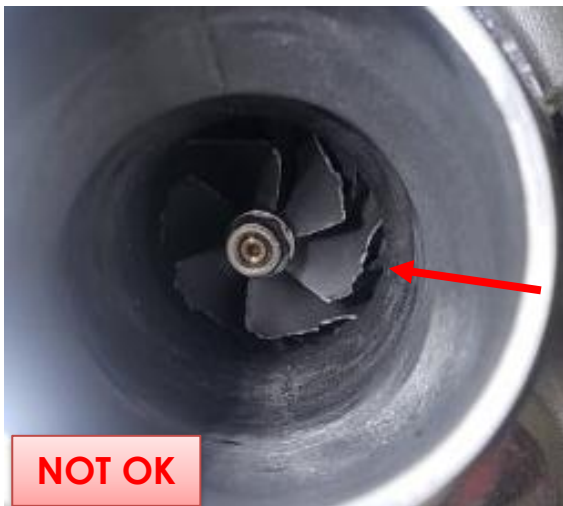
- 1) Check for possible compressor blade damage to both the compressor and turbo side.

Take pictures and attach to the BOL

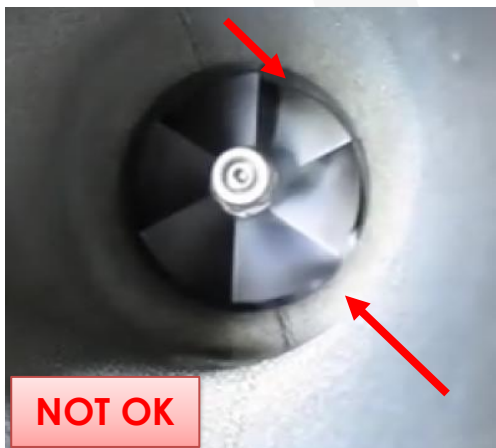
Compressor wheel excessive freeplay

Without reviewing the video demo included with bulletin. The above screencapture clearly demonstrates excessive shaft free play which is not perfectly centered in the bore.

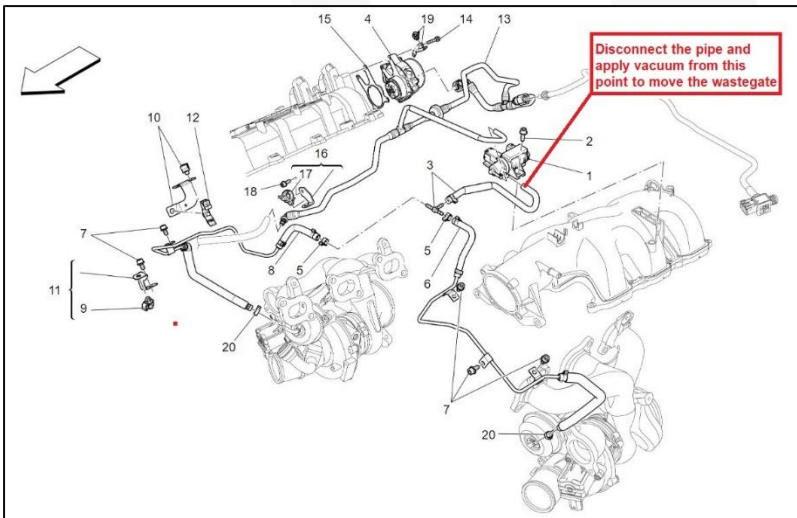
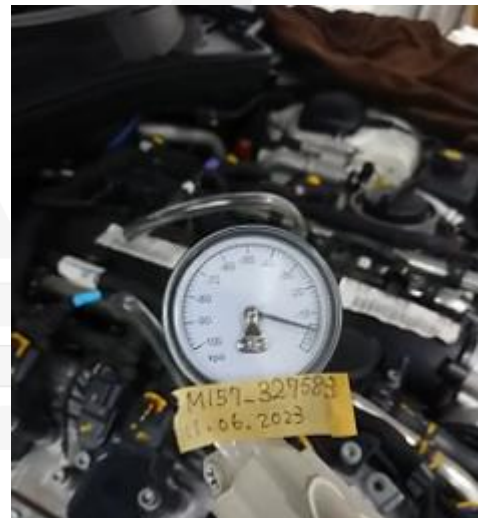
Correct wastegate movement Examples (See attached videos included with this bulletin)

- a. Remove the catalyst to have a correct view of turbine outlet and Waste-gate valve.
- b. Visually check the integrity of the wastegate.
- c. For F160 V6 and F154 V8: check the correct movement of the wastegate applying vacuum from the point suggested in the picture below using a vacuum pump.
- d. For T4 and V6 Nettuno: check the correct movement of the wastegate performing the active diagnosis through the MD EVO tool.
- e. Check if the wastegate valve plate on the turbine outlet side is completely closing

Capture a short video and attach to the BOL
