Service Bulletin

Bulletin No.: 24-NA-264

Subject: Diagnostic Tips for 10L60/80/90 Transmission Noise

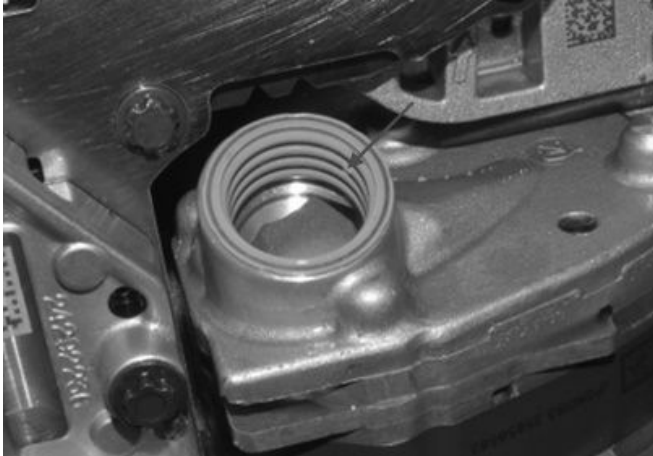
6769556

Park-Transmission Oil Pump Aeration/Cavitation

Aeration is the introduction of air into the transmission fluid (pump inlet).

Erratic whining sound due to uneven distribution of air.

Cavitation occurs when cavities are formed due to a drop in fluid pressure (outlet).

Rattling, whirling/roaring or grinding sounds are all possible.

- 75°C (167°F) Pump Aeration Cavitation 900 RPM Steady State
- 75°C (167°F) Pump Aeration Cavitation 650-1500 RPM Sweep

Common Causes:

- Low fluid level
- Plugged/mis installed filter

- Torn/damaged filter O-ring
- Transmission running max line pressure due to DTCs

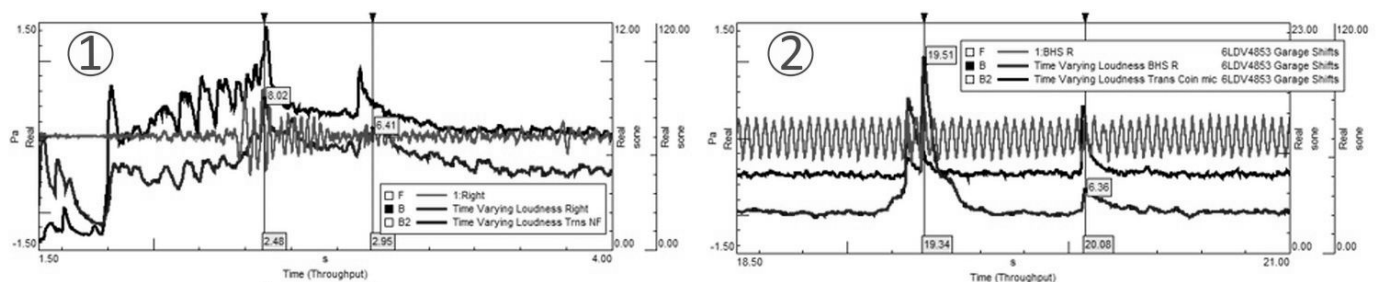
6769524

Start Up/Garage Shift Clunk

Described as an infrequent audible thud that delayed 400–700ms after either a key start or garage shift event.

Severity of thud depends on the load that's placed on the driveline.

Previous root cause work determined noise is related to the C2 clutch application at high line pressure causing the rotating components in park to stop too quickly.

- Key Start
- Garage Shift

C2 clutch calibration has been modified to assure the C2 knockdown area is pressurized in park and neutral when C2 is being applied.

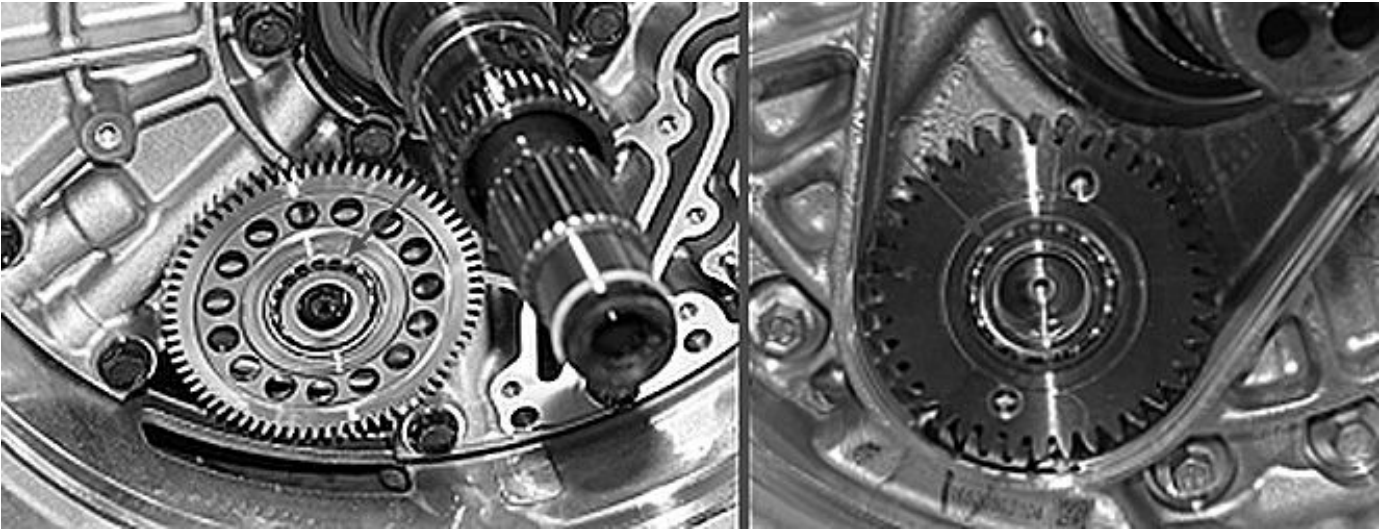
6769588

Underbody Gear Rattle (7th Gear Only)

While rare, rattle during light acceleration (10–15% throttle) in 7th gear only may be observed.

Size of the idler gear inner diameter can affect the interference fit of the pressed in bearing reducing the overall axial/radial clearance of the bearing balls.

The gear free lock will increase or decrease depending on that interference fit:

- High interference fit can create gear rattle
- Low interference fit does not produce rattle

Increasing line pressure can reduce rattle by overcoming the drag torque.
