GENERAL MOTORS
DCS7107
URGENT - DISTRIBUTE IMMEDIATELY

Subject: N242490440 - Service Update
Multiple Module Reprogramming

Models: 2025 Cadillac Escalade IQ

N242490440 Multiple Module Reprogramming

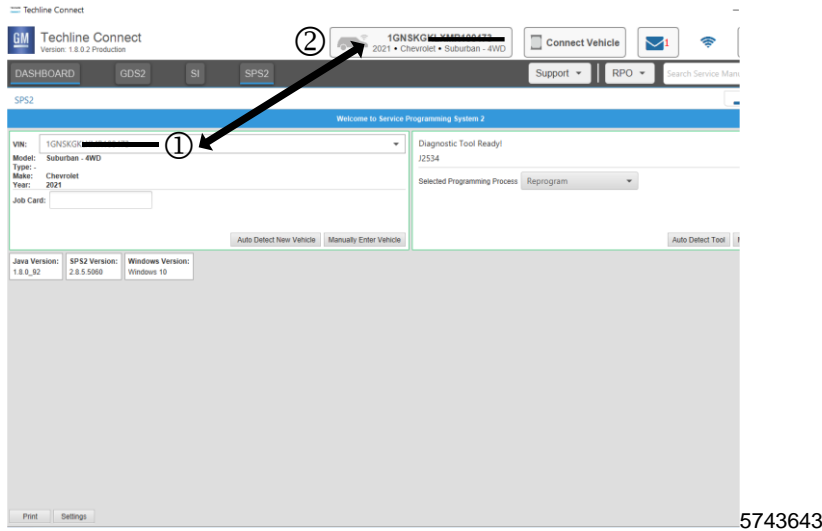
Caution: Be sure the VIN selected in the drop-down menu (1) is the same as the vehicle connected (2) before beginning programming.

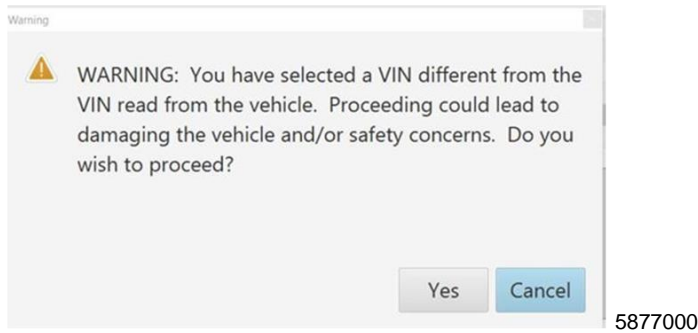
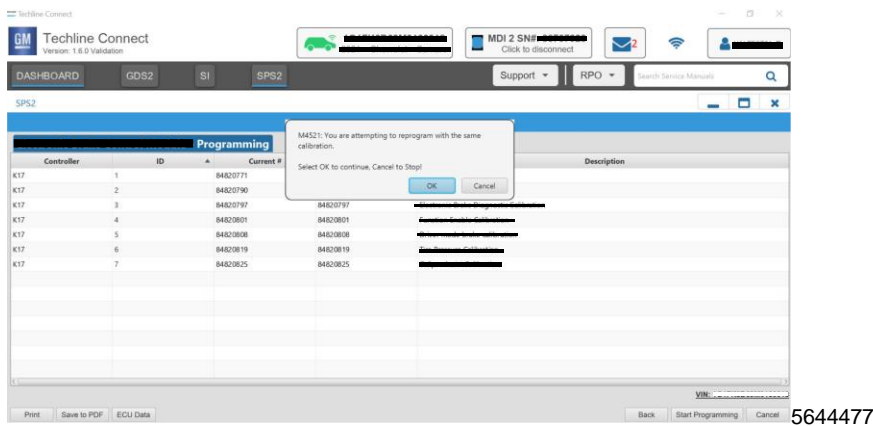
Important: If the vehicle VIN DOES NOT match, the message below will be shown.

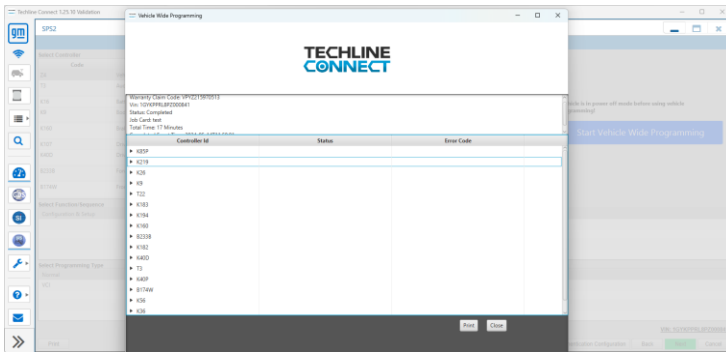
6693875

Note: The screenshot above is an example of Vehicle Wide Programming and may not be indicative of the specific modules that are being programmed. VIN information has been blacked out.

Important: To avoid warranty transaction rejections, you MUST record the Total Time provided on the Warranty Claim Code (WCC) screen shown above on the job card.

3. Print a copy of the Warranty Claim Code screen and attach to the repair order. "Status Completed" or "Status Blocked" must be achieved to close out the field action. It is also critical to record the total time in order to close out the Field Action.
