HYUNDAI

Technical Service Bulletin

GROUP ENGINE MECHANICAL	NUMBER 24-EM-010H
DATE DECEMBER 2024	MODEL(S) ELANTRA N (CN7 N) KONA N (OS N) VELOSTER N (JS N)

SUBJECT: DTC P1326 - KNOCK SENSOR AND CONNECTOR REPLACEMENT

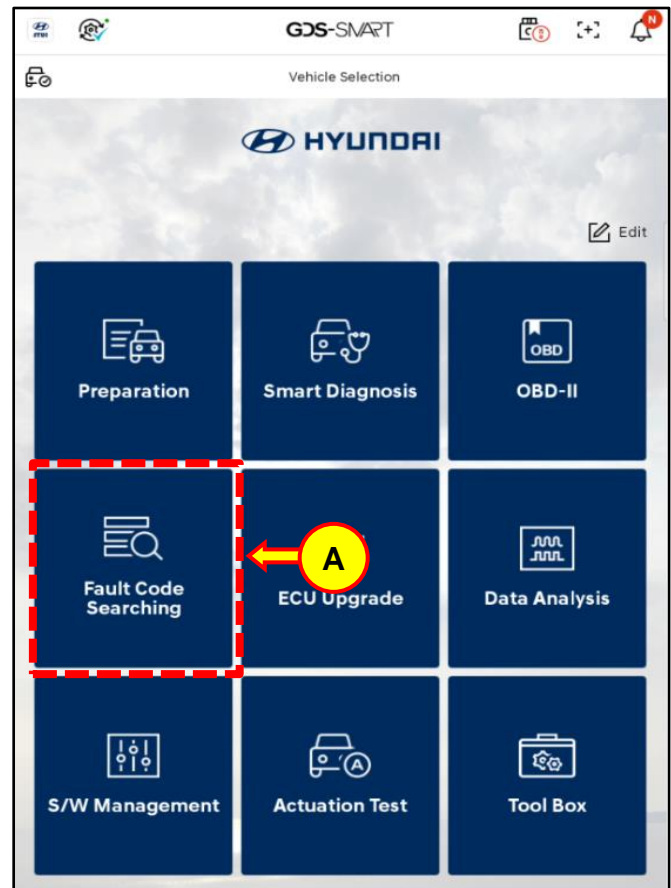
4. Verify if DTC P1326 is present.
 - **YES:** Proceed with the **Knock Sensor Replacement** and **Knock Sensor Wiring Repair** procedures.
 - **NO:** This TSB does **NOT** apply.

1. Connect the GDS and turn **ON** the IGN switch.
2. Select **Fault Code Searching (A)** on the home screen.
3. Select **ENGINE** and press **OK**.
