Technical Service Bulletin

GROUP	NUMBER
BODY ELECTRICAL	24-BE-020G
DATE	MODEL(S)
DECEMBER 2024	GV70 (JK1A)

SUBJECT: ACTIVE AIR FLAP ON-BOARD DIAGNOSTIC SENSORS REPLACEMENT

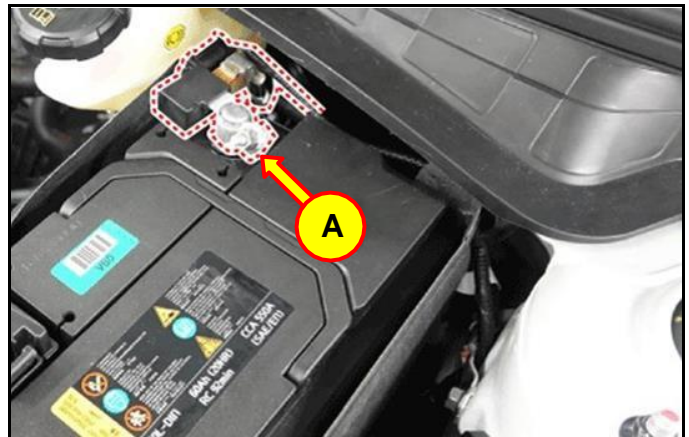
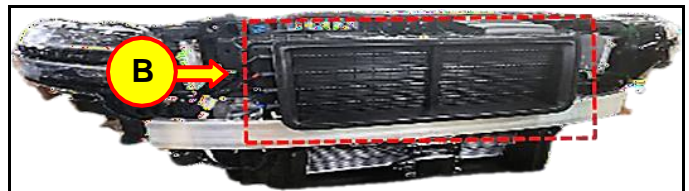
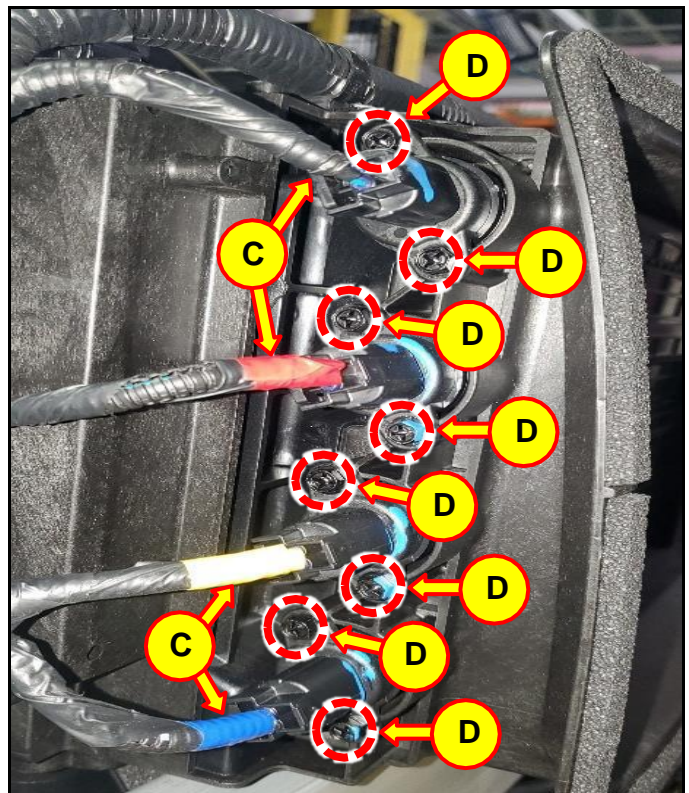
Description: Certain 2025MY GV70 (JK1A) vehicles may experience an illuminated check engine light for DTC P059A from a faulty connection due to improper soldering within the sensor components. This bulletin outlines the procedure to replace the active air flap (AAF) on-board diagnostic (OBD) sensors to resolve this issue.

1. Turn **OFF** the ignition.
2. Disconnect the negative (-) battery terminal (A) by referring to the shop manual:
 - **G 2.5 T-GDI THETA III >Body (Interior/Exterior) > Front Bumper > Front Bumper Assembly > Replacement**
3. Locate 4 AFF OBD sensors (B) on the FEM module.
4. Remove the wire connections (C) and 2 screws (D) from each AAF OBD sensor, shown in the red circles.
