SIB 01 10 24

G30 I01 PHEV HV BATTERY CELL MODULE TEMPERATURE SENSORS
EXT LTD WTY (ELW) 15/150

Service Information Bulletin

B01 10 24

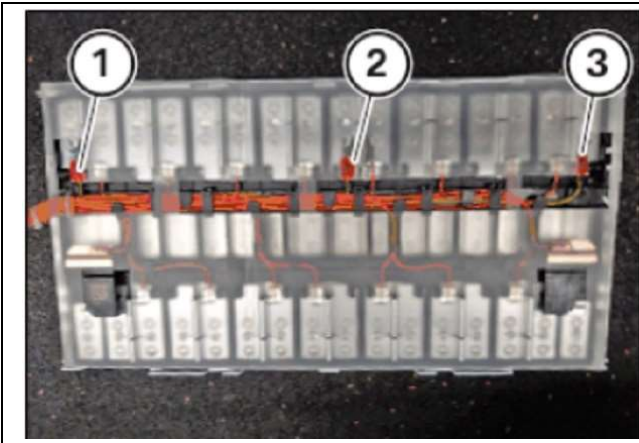
For the eligible vehicles, BMW of North America, LLC (BMW NA) is extending the limited warranty for the vehicle's **the High-Voltage (HV) Battery Assembly's Cell Module Temperature Sensors (Internal NTC repair kit) (G30 Shown)** to:

Over time, the temperature sensors may fail, this can cause the measured values of one or more of the temperature sensors to deviate from specification. The vehicle's monitoring system may interpret these deviating temperature sensor values as either implausible or impermissible.

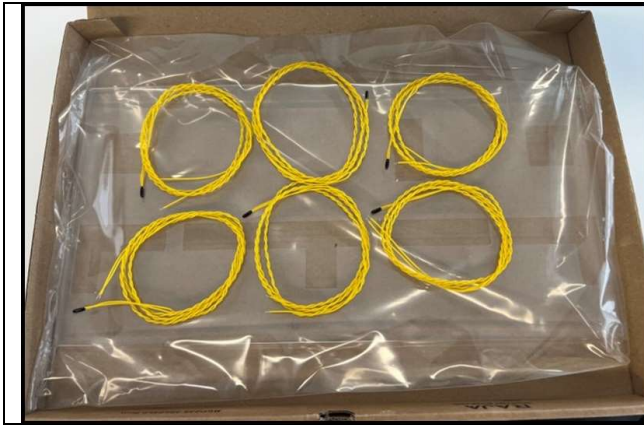
If a vehicle listed above arrives at your center with the issues described in this Service Information Bulletin, perform the corresponding diagnosis.

If there are failed cell module temperature sensors, the test plan will instruct you to replace the applicable HV cell module's internal temperature sensors (NTC repair kit), one repair kit per cell module.

The NTC repair kit repair / installation instructions are provided during the test plan, and they are available separately in the repair instruction section of ISTA.
