SIB 01 11 24

F30 G12 I12 PHEV I01 BEV HV BATT CELL MOD TEMP SENSORS EXT LTD WTY (ELW) 15/150

Service Information Bulletin

B01 11 24

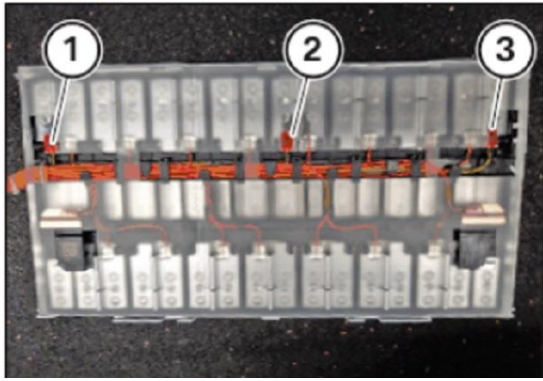
For the eligible vehicles, BMW of North America, LLC (BMW NA) is extending the limited warranty for the vehicle's **the High-Voltage (HV) Battery Assembly's Cell Module Temperature Sensors (Internal NTC repair kit) (F30 Shown)** to:

Over time, the temperature sensors may fail, this can cause the measured values of one or more of the temperature sensors to deviate from specification. The vehicle's monitoring system may interpret these deviating temperature sensor values as either implausible or impermissible.

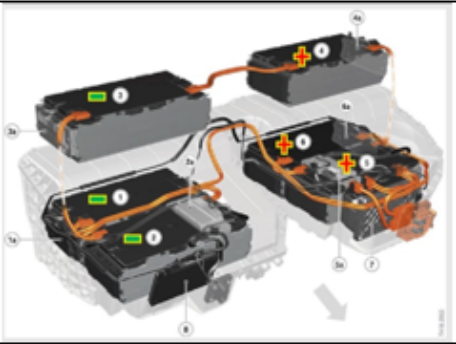
CM 4LRTop	<p>Six (6) Cell Module Configuration Stacked: 2 Rear Top/2 Rear Bottom, Single Front Bottoms, 1 Left /1 Right</p> <p>15 Years / 150,000 Miles ELW: Qualifying Repairs – Claim Submission</p> <p>Obtain the flat rate unit (FRU) allowances for the following that applies.</p>
☞ CM 1RRBottom		☞ CM 6LRBottom	
CM 2RFBottom		CM 5LFBottom

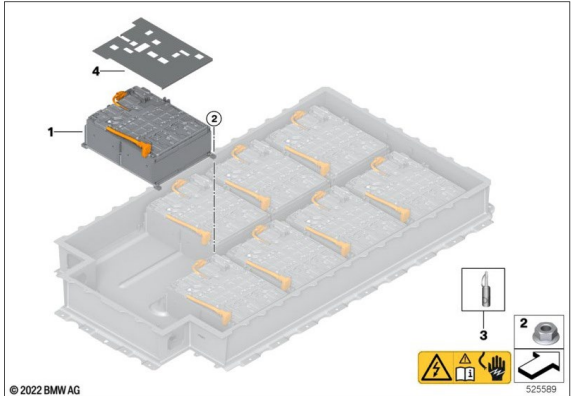
<p>Eight (8) Cell Module Configuration 4 x 4 Linear</p> <p>15 Years / 150,000 Miles ELW: Qualifying Repairs – Claim Submission</p> <p>Obtain the flat rate unit (FRU) allowances for the following that applies.</p>
---	--

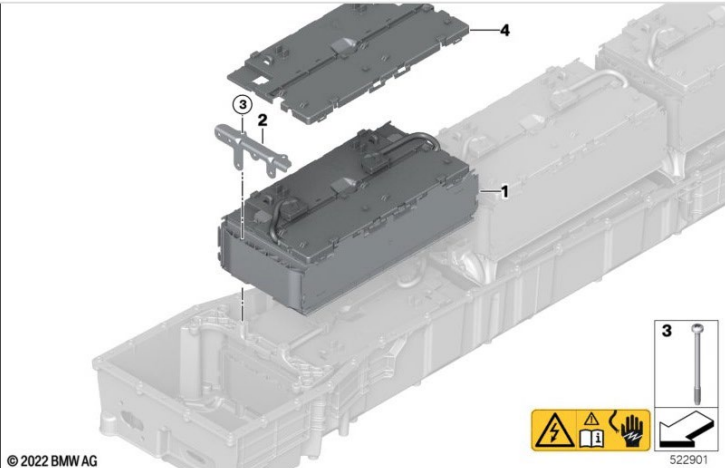
<p>Six (6) Cell Module (Stacked 3 Top/3 Bottom) Configuration</p> <p>15 Years / 150,000 Miles ELW: Qualifying Repairs – Claim Submission</p> <p>Obtain the flat rate unit (FRU) allowances for the following that applies.</p>
---	--
