SIB 28 02 24

SERVICE ACTION: DOUBLE CLUTCH TRANSMISSION REWORK AT TRANSFER CASE

2024-12-20

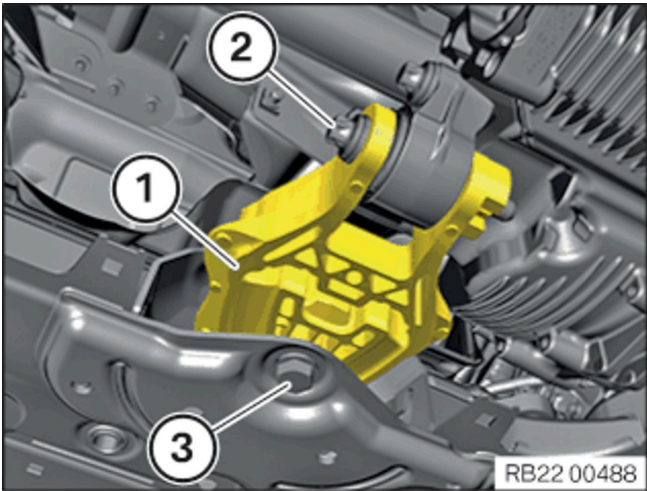
Remove the stabilizer link (1).

Reinstallation: Replace bolts 2 and 3

Tighten to 100 Nm and torque angle 90°

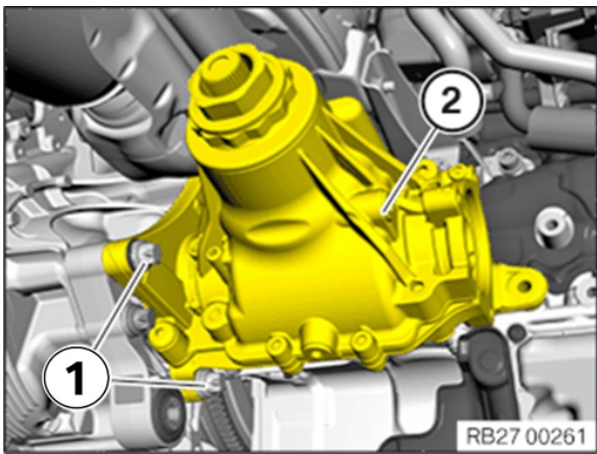
Remove the two bolts (1) on the transfer case.

Reinstallation: Replace both bolts

Tighten to 100 Nm and torque angle 90°

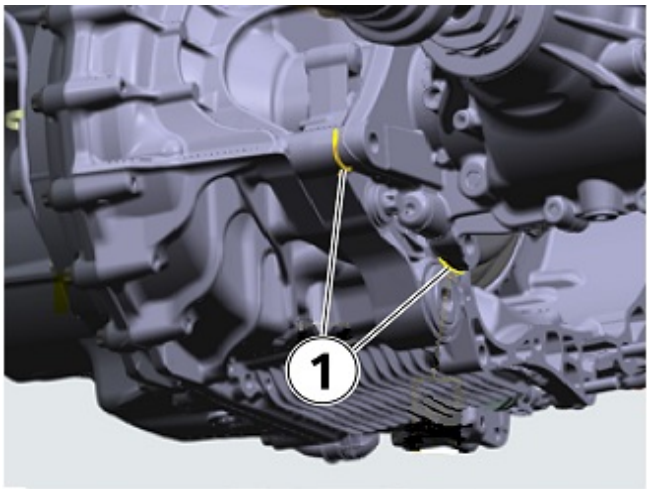
Micro-movements combined with frictional corrosion can increase wear on the longitudinal splined connection between the double clutch transmission (DCT) and the transfer box.

Add spacers at the connection between the DCT and transfer box to decrease micro-movements.

Install washers between the link and transfer case. It may be necessary to slightly push the transfer case to the side to install the washers.
