SIB 51 32 24

## DELIVERY STOP: REAR BUMPER BRACKET

E-Series	Model Description	Production Date	Affected Option Code
G07	X7 Sports Activity Vehicle	October 14, 2024	(05AS Active Driving Assistant) and/or (5AU Driving Assistance Pro)

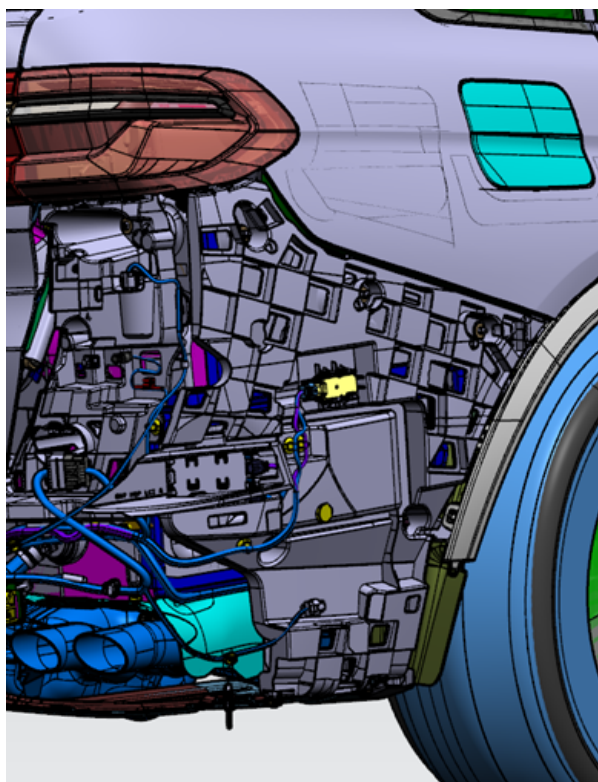
Vehicles produced on October 14, 2024, with option code(s) 05AS (Active Driving Assistant) and/or 5AU (Driving Assistance Pro); and have a short-range radar sensor (SRR sensor) clipped into the left and right rear of the vehicle. The short-range radar sensor (SRR sensor) on the right rear of the vehicle may come loose while driving.

A loose short-range sensor (SRR sensor) may cause a fault in the driver assistance system which is displayed to the customer via a check control message (CCM). In individual cases, the performance of this driver assistance function maybe reduced/not functioning if the vehicle is being approached from the right rear.

**Note:** The yellow highlighted component in the photo is the short-range radar sensor (SRR sensor).

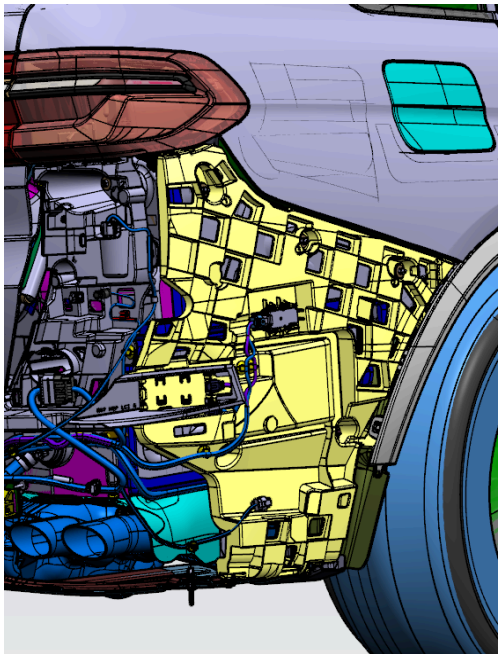
**Note:** The yellow highlighted component in the illustration is the right rear mounting bracket.

Replace the right rear mounting bracket.

Replace the right rear bumper bracket following the repair instructions listed in ISTA/AIR 51 12 160.
