SIB 52 19 23

## SECOND ROW 60/40 SEAT RAIL FLEX CABLE REPLACEMENT

| E-Series | Model Description | Affected Option Code |
|---|---|---|
| G07 | X7 Sports Activity Vehicle | 7-passenger vehicle equipped with second row 60% / 40% split seat |

# FLEX CABLE REPLACEMENT, SLV MOTOR, 60% SEAT

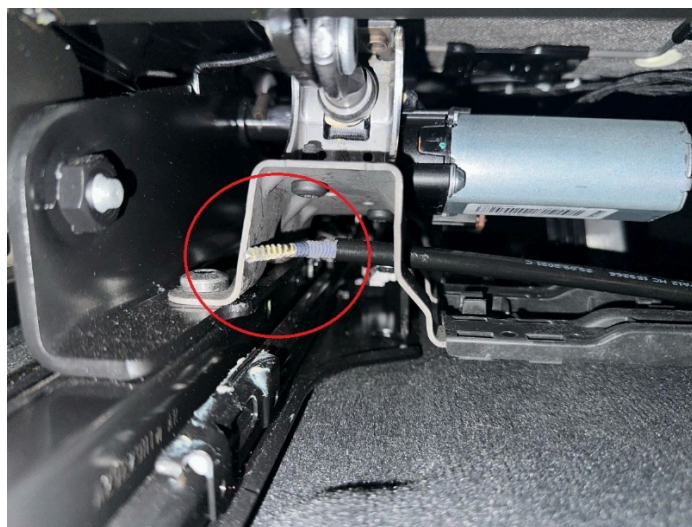
In vehicles equipped with the second row 60% / 40% split seat, the flex cable assembly can come out of the seat rail mechanism (circled). This stops the forwards and backwards travel of the seat.

Something has mechanically jammed the seat movement on one or both sides of the seat.

Locate and remove the foreign object, if still present.

Replace only the damaged flex cable assembly instead of entire seat rail assembly.

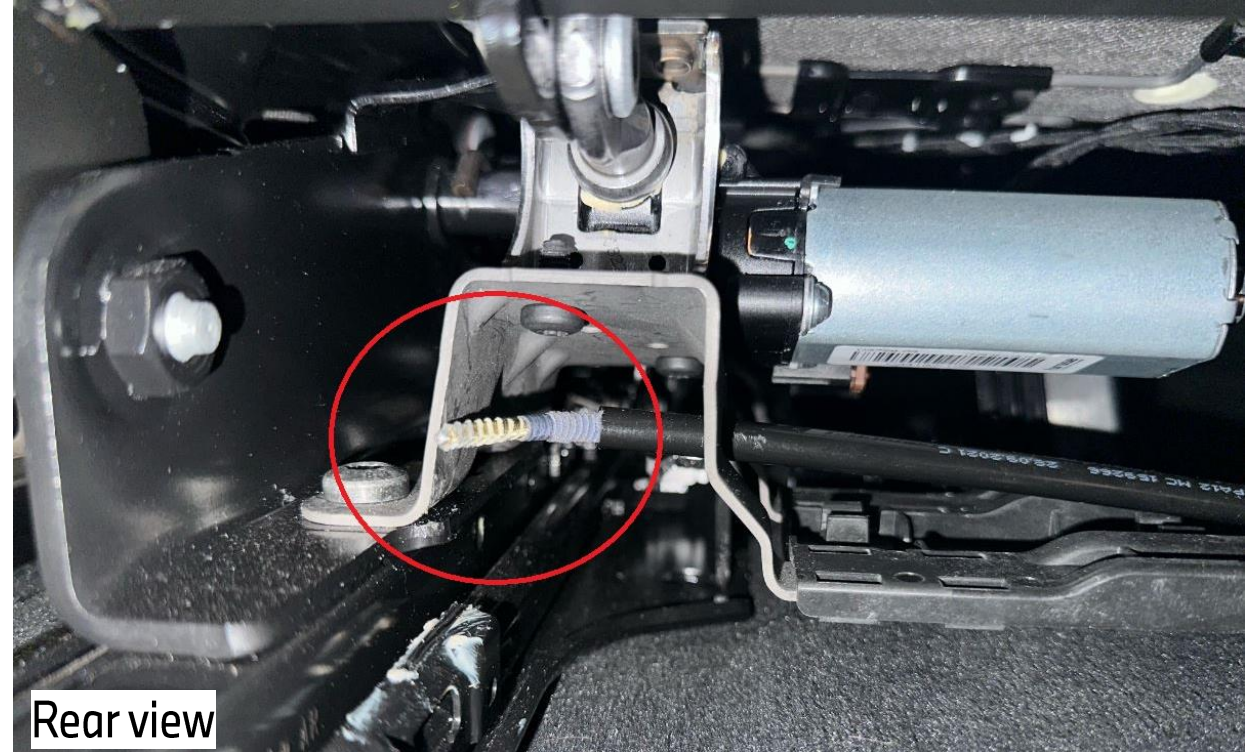
## 2. Locate problem area of flex cable drive(s)

In this example the 60% seat inboard flex cable has come out of the seat rail gearbox.

This will stop the seat from moving forwards and backwards on the rails.

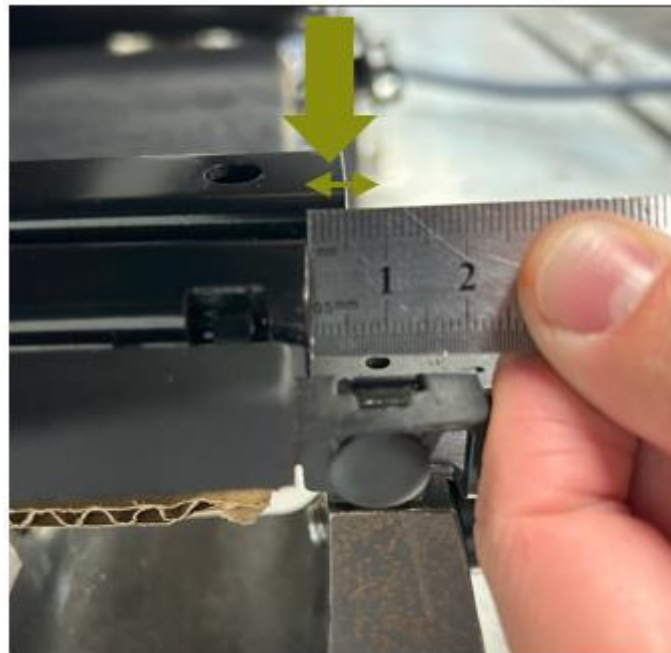
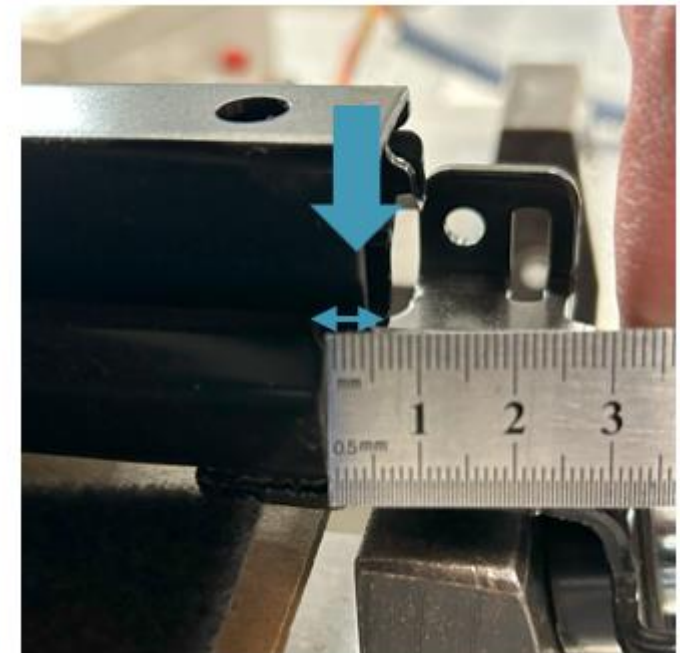
3. Measure the misalignment on both rails and compare how much the difference is. Note: Do the same process for the right side and the left side.

Left Rail: 8 mm outside Frame

Right rail: 6 mm Inside Frame

Considering that the right flex shaft is out of position, the left one must move the necessary distance so that it is aligned with the right one.

After aligning rails side to side remeasure before flex cable installation.

Now both rails are at 4 mm
