SIB 61 06 15

2024-12-18

## Washer Fluid Reservoir Rattles While Driving on Rough Roads

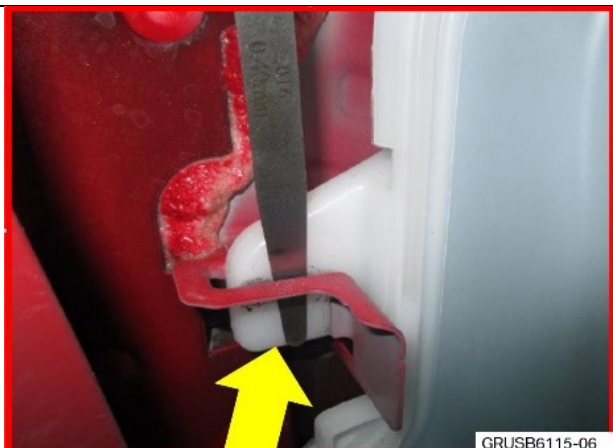
The windshield washer reservoir upper plastic locating guide tab has too much lateral play.

**Note: The close-up picture shows a gap (0.40 mm) that exists between the plastic reservoir guide and the metal securing bracket.**

6. With the reservoir removed, clean the upper guide tab with a clean cloth.

7. Prepare a piece of felt tape (80 x 60 x 1 mm) and apply it to the guide tab in the area shown.

8. The felt tape will eliminate the rattling noises coming from the metal bracket which can transmit into the glove compartment area. Reinstall the removed parts in the reverse order of their removal.
