SIB 65 36 24

2024-12-13

SERVICE ACTION: PERSONAL ESIM MALFUNCTION

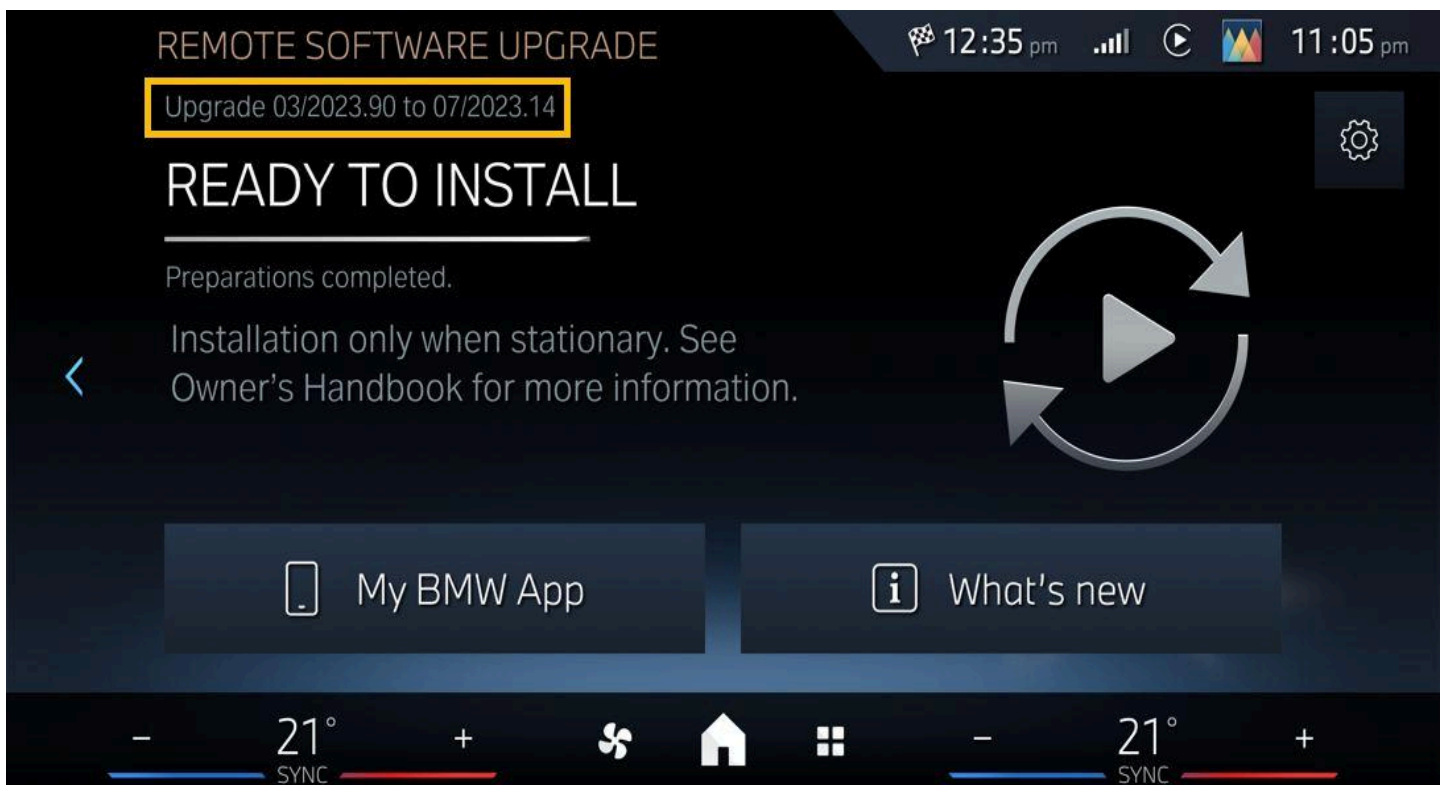
A. Check the available RSU version in the System Settings vehicle app

- i. Open the System Settings vehicle app and select Remote Software Upgrade.
- ii. The version of the software that is currently installed in the vehicle is shown in the upper area. The version of the software that **WILL BE** installed in the vehicle via Remote Software Upgrade is also displayed.
- iii. If the RSU **software version** to be installed is **11/2024.40** or higher, proceed with the RSU installation (**Step B**). If the RSU version is lower than 11/2024.40 or no RSU is available for installation in the vehicle, then skip to **Step 2**.
