SIB 65 37 24

2024-12-13

SERVICE ACTION: PERSONAL ESIM MALFUNCTION – I20

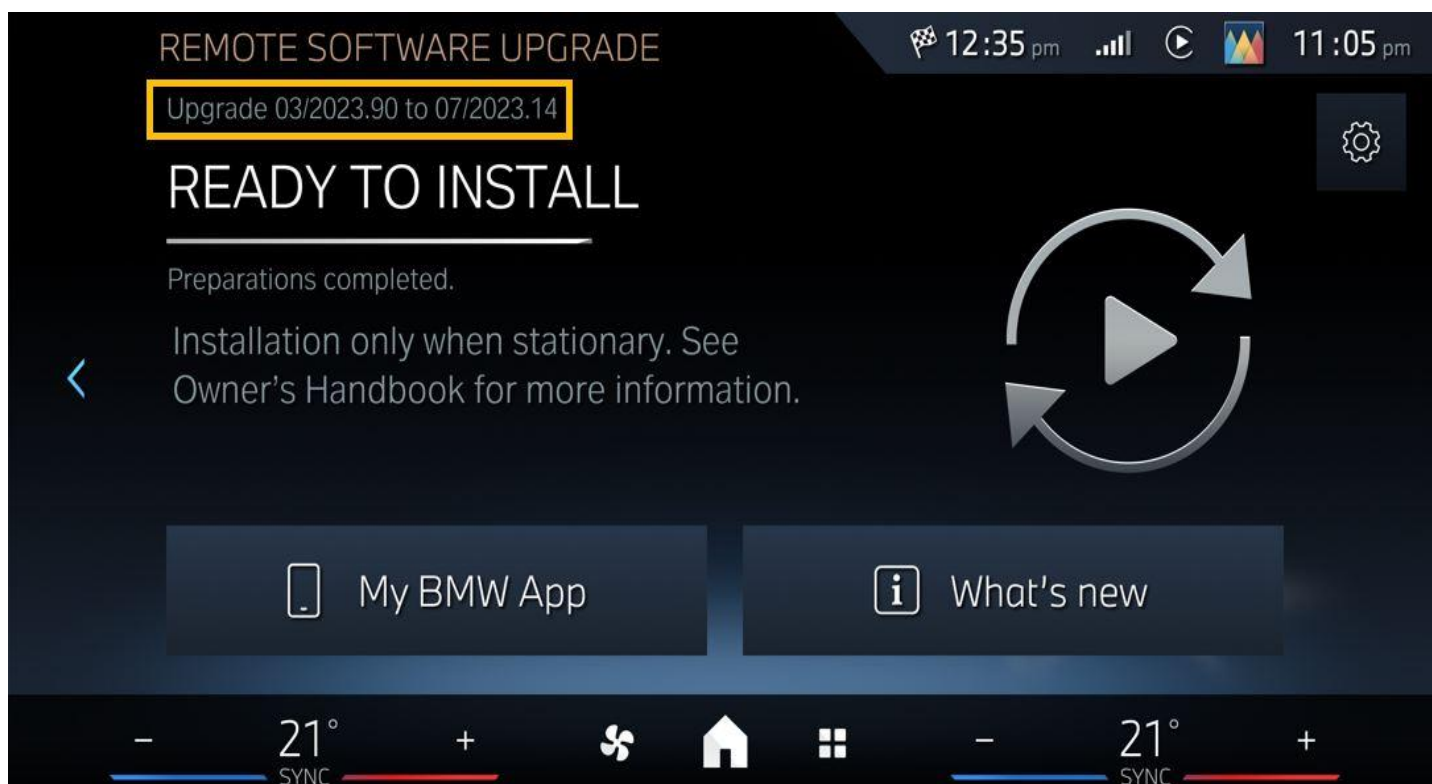
A. Check the available RSU version in the System Settings vehicle app

- i. Open the System Settings vehicle app and select Remote Software Upgrade.
- ii. The version of the software that is currently installed in the vehicle is shown in the upper area. The version of the software that **WILL BE** installed in the vehicle via Remote Software Upgrade is also displayed.
- iii. If the RSU **software version** to be installed is **11/2024.40** or higher, proceed with the RSU installation (**Step B**). If the RSU version is lower than 11/2024.40 or no RSU is available for installation in the vehicle, then skip to **Step 2**.
