SIB 65 38 24

2024-12-13

## SERVICE ACTION: PERSONAL ESIM MALFUNCTION (ADDITIONAL VEHICLES)

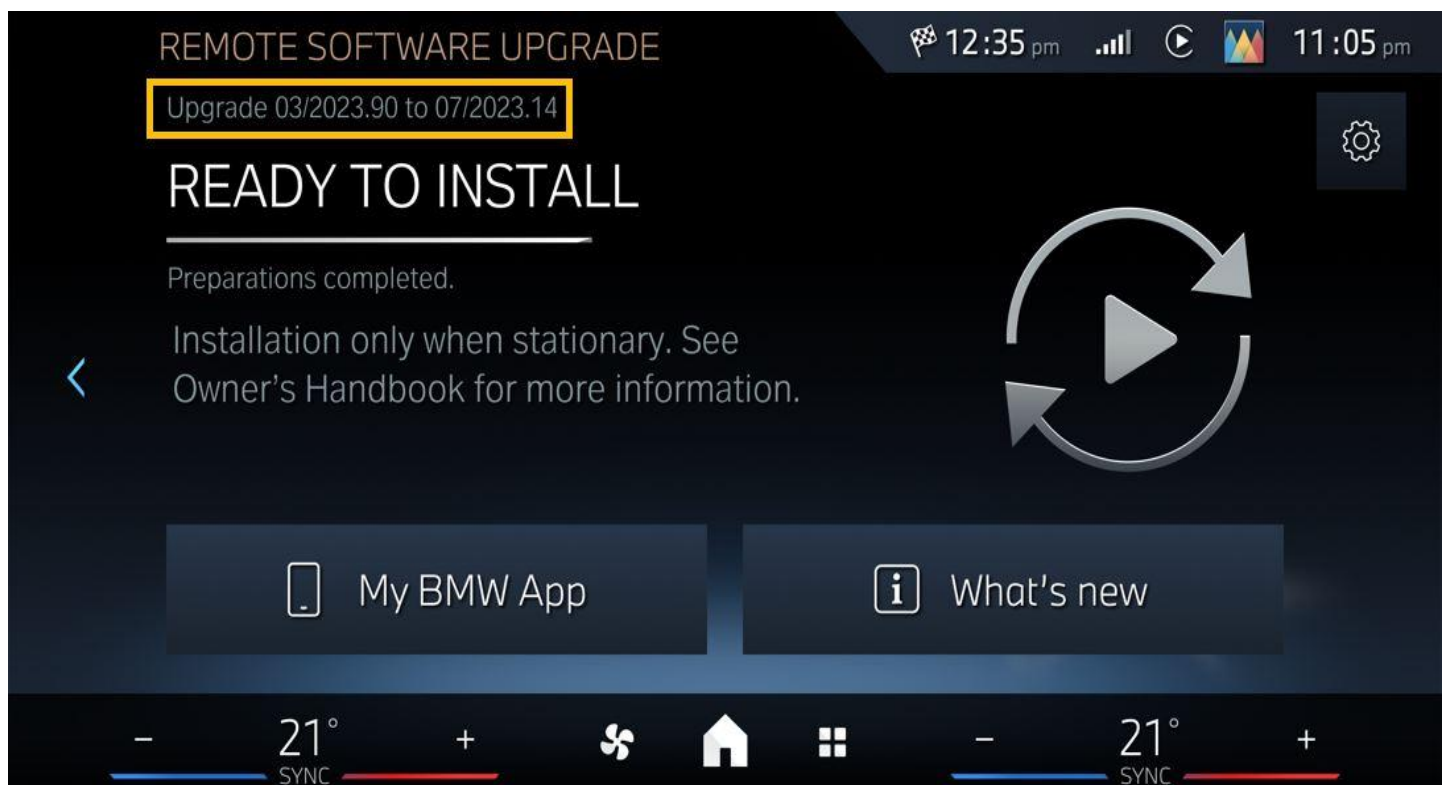
#### A. Check the available RSU version in the System Settings vehicle app

- i. Open the System Settings vehicle app and select Remote Software Upgrade.
- ii. The version of the software that is currently installed in the vehicle is shown in the upper area. The version of the software that **WILL BE** installed in the vehicle via Remote Software Upgrade is also displayed.
- iii. If the RSU **software version** to be installed is **11/2024.40** or higher, proceed with the RSU installation (**Step B**). If the RSU version is lower than 11/2024.40 or no RSU is available for installation in the vehicle, then skip to **Step 2**.
