SIB 65 39 24

2024-12-13

SERVICE ACTION: PERSONAL ESIM MALFUNCTION (ADDITIONAL VEHICLES) – I20

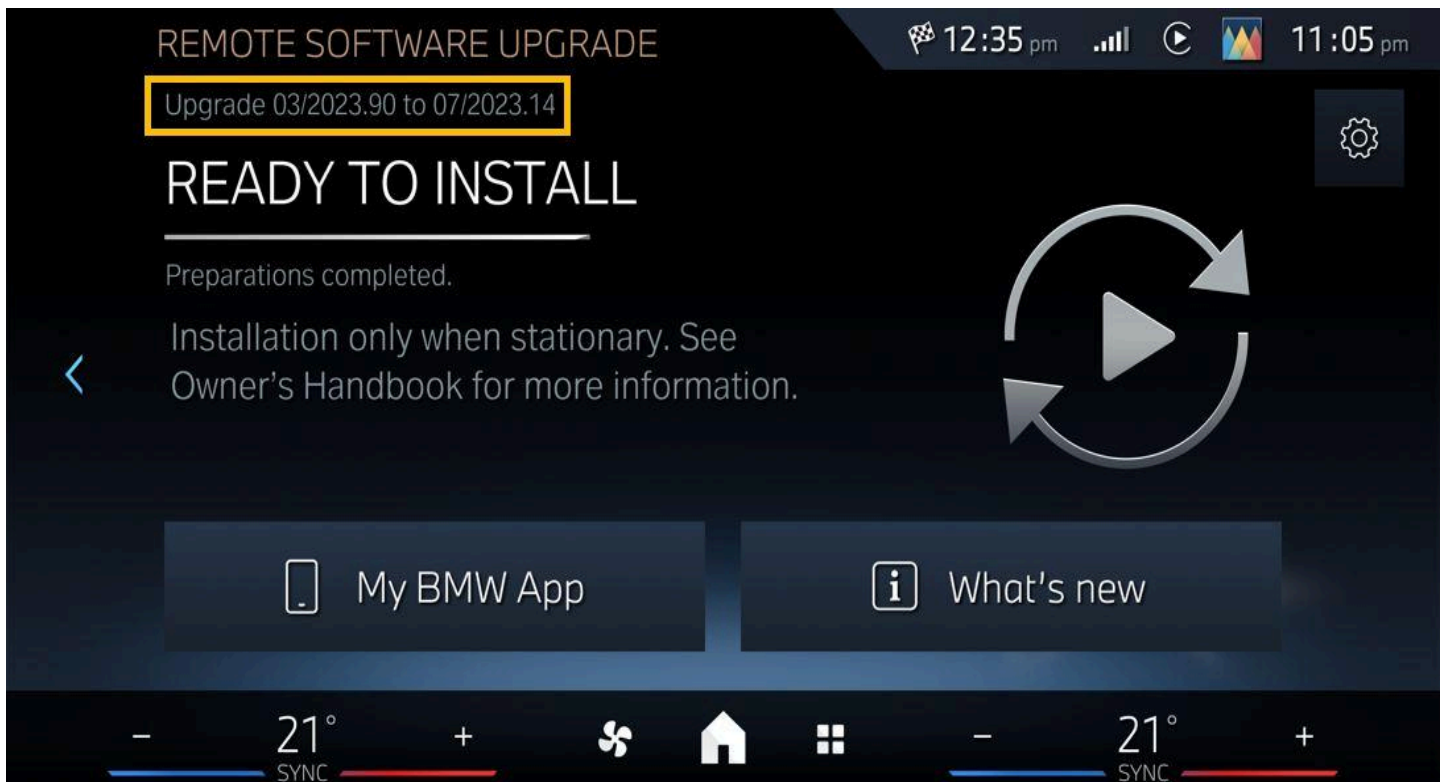
- i. Open the System Settings vehicle app and select Remote Software Upgrade.
- ii. The version of the software that is currently installed in the vehicle is shown in the upper area. The version of the software that **WILL BE** installed in the vehicle via Remote Software Upgrade is also displayed.
- iii. If the RSU **software version** to be installed is **11/2024.40** or higher, proceed with the RSU installation (**Step B**). If the RSU version is lower than 11/2024.40 or no RSU is available for installation in the vehicle, then skip to **Step 2**.

- i. If the RSU **software version** to be installed is **11/2024.40** or higher, start the RSU installation in the vehicle and follow the prompted instructions in the Central Information Display. If the software version to be installed is lower than **11/2024.40**, skip to **Step 2**.
- ii. After approx. 30 minutes, you must check in the vehicle whether the RSU installation has been carried out successfully and that **software version 11/2024.40** or higher has been installed.
- iii. If the programming has been carried out successfully, the vehicle can be returned to the customer.
