SIB 65 40 24

SERVICE ACTION: QUALITY MEASURE SOFTWARE – HU-H6

E-Series	Model Description	Affected Option Code
G45	X3 Sports Activity Vehicle	With HU-H6
U10	X2 Sports Activity Coupe	
U11	X1 Sports Activity Vehicle

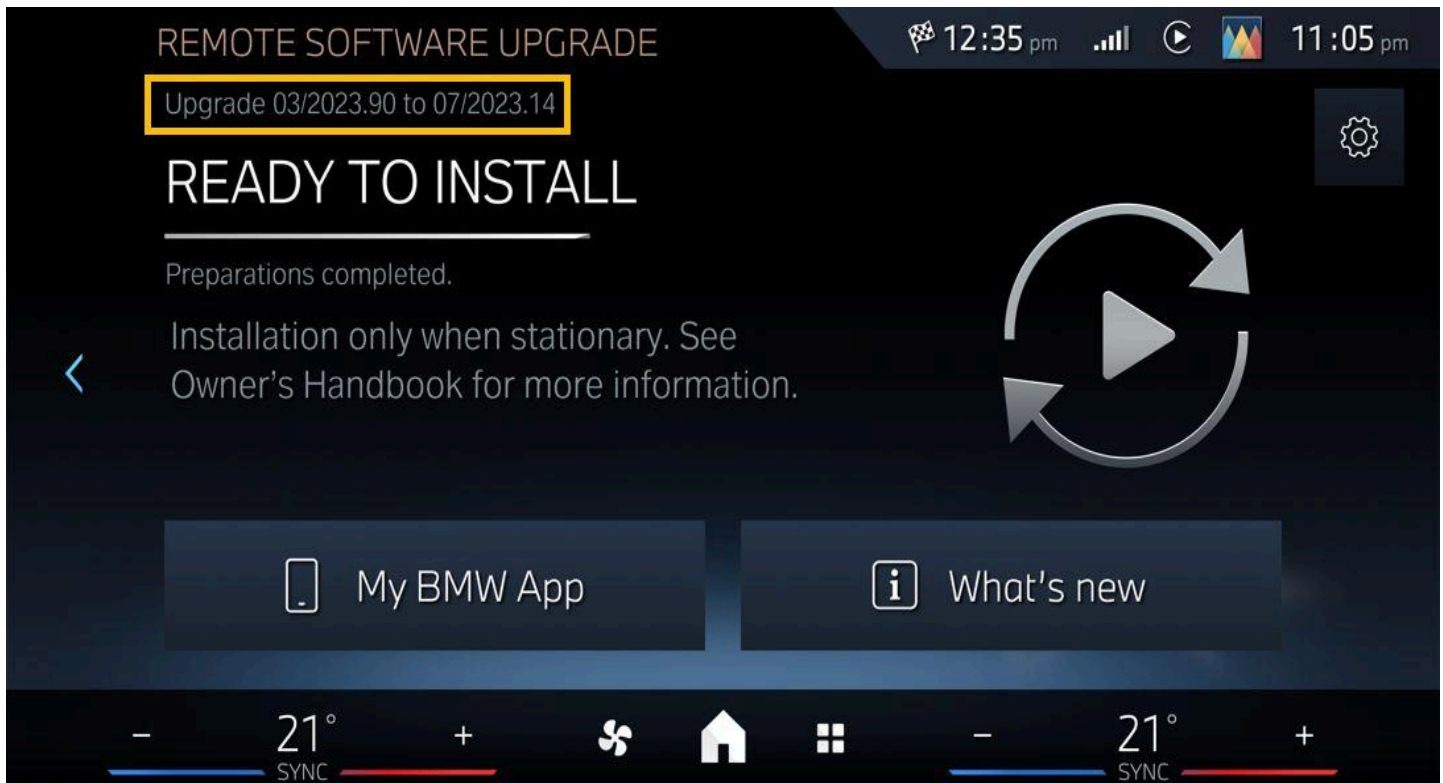
A. Check the available RSU version in the System Settings vehicle app

- i. Open the System Settings vehicle app and select Remote Software Upgrade.
- ii. The version of the software that is currently installed in the vehicle is shown in the upper area. The version of the software that **WILL BE** installed in the vehicle via Remote Software Upgrade is also displayed.
- iii. If the RSU **software version** to be installed is **11/2024.30** or higher, proceed with the RSU installation (**Step B**). If the RSU version is lower than 11/2024.30 or no RSU is available for installation in the vehicle, then skip to **Step 2**.
