SIM 51 04 24 TAILGATE DOES NOT LATCH WHEN CLOSED

2024-12-05

E-Series	Model Description
U25	MINI Countryman

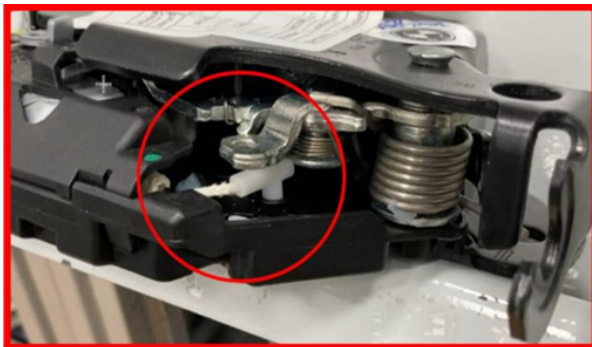
1. Inspect the white clip attached to the latch mechanism for proper installation.

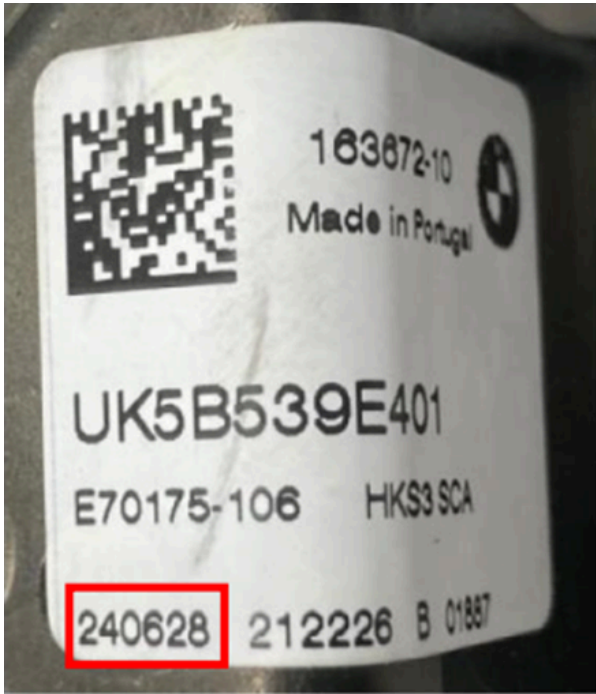
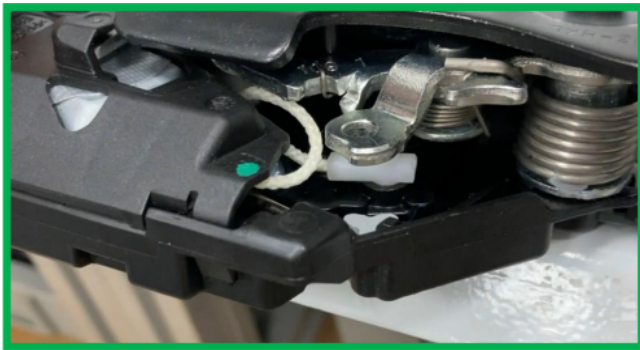
BAD

The white clip at the end of the ribbon cable can move out of its position and get jammed behind the latch mechanism.

- Latch will need to be replaced
- DO NOT** replace the SCA (Soft close actuator) if the vehicle is equipped with it
- When installing the new latch, make sure that the new latch has a production date after July 29, 2024 (yymmdd: 240730)
- The photo shows where to find the production date on the label
