SIM 65 12 24
Service Action: Quality Measure
Software – HU-H6

2024-12-27

E-Series	Model Description	Affected Option Code
F66	MINI Cooper S 2 Door	With HU-H6
U25	MINI Countryman ALL4, Countryman SE ALL4 (Battery Electric Vehicle), JCW Countryman ALL4

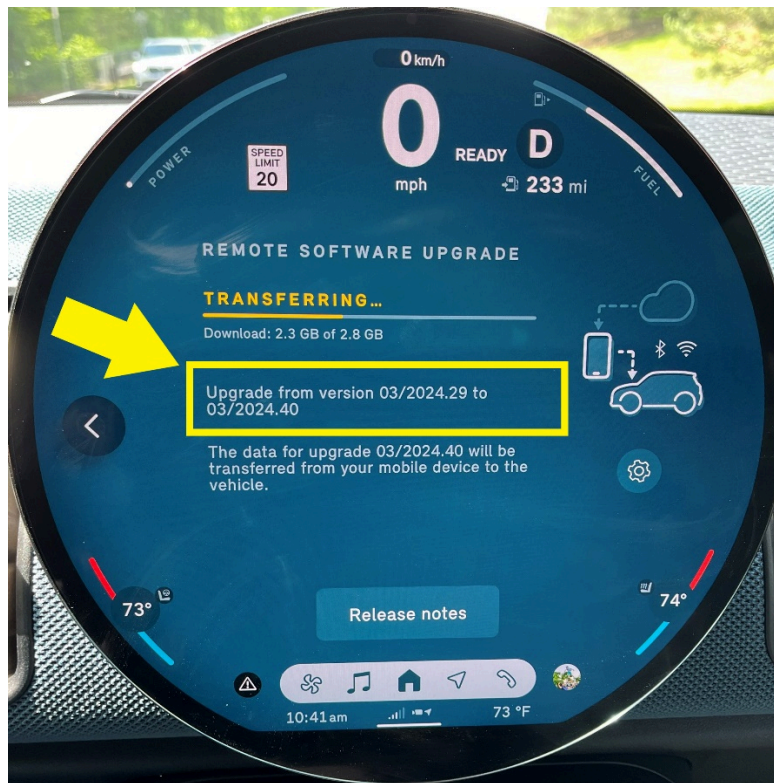
- i. Open the System Settings vehicle app and select Remote Software Upgrade.
- ii. The version of the software that is currently installed in the vehicle is shown in the upper area. The version of the software that **WILL BE** installed in the vehicle via Remote Software Upgrade is also displayed.
- iii. If the RSU **software version** to be installed is **11/2024.30** or higher, proceed with the RSU installation (**Step B**). If the RSU version is lower than 11/2024.30 or no RSU is available for installation in the vehicle, then skip to **Step 2**.
