STAR ONLINE PUBLICATION

Case Number: S2008000186 REV. B

Symptom/Vehicle Issue: Engine Control Module (ECM) Flash Failure, Diagnostic Trouble Code (DTC) U1601 – ECU Application Software Code 1 Missing Or Corrupted

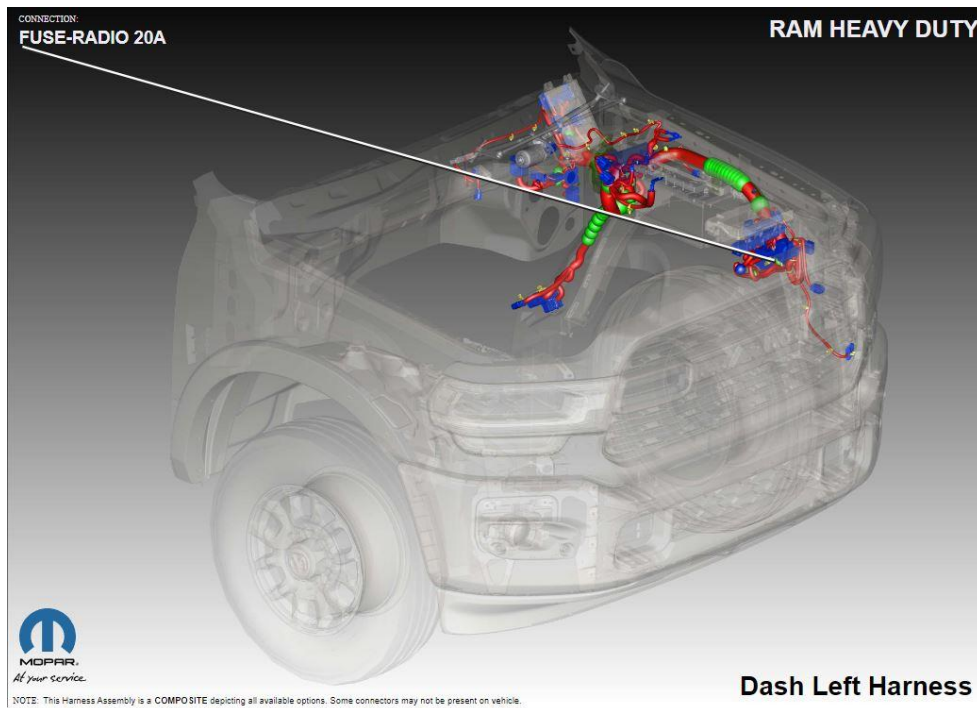
Figure 1.

Discussion: Several reports of ECM reprogramming failures have been received from the field. When the reprogramming process fails, it will often be accompanied by DTC U1601. Further investigation into these programming failures have found that most have been due to interference on the CAN C bus. This interference has been found to be caused by the following:

3. If no devices are found, or if everything is believed to be removed and the flash failure still occurs, disconnect the 20-amp Radio fuse located under the under-hood Power Distribution Center (PDC). Please see ([Figure 1](#)). This fuse supplies power to the radio and FTM/GTM if equipped.
