PERSONAL SERVICE LAB

Grecale Center Console Storage Lid Repair

DATE: DECEMBER 18, 2024

MODELS: M182 Grecale (All MY).

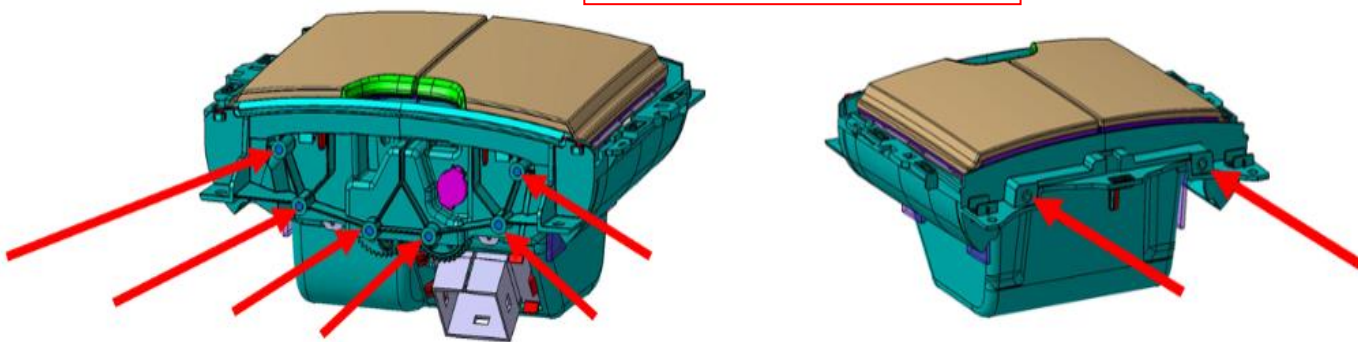
ROOT CAUSE: The storage box housing hole that holds the pin for the lid hinge is out of tolerance.

Apply glue in these 8 holes

Proceed to apply a small amount of adhesive at the 8 pins shown in the on the next page:

Adhesive to be used: Loctite 406

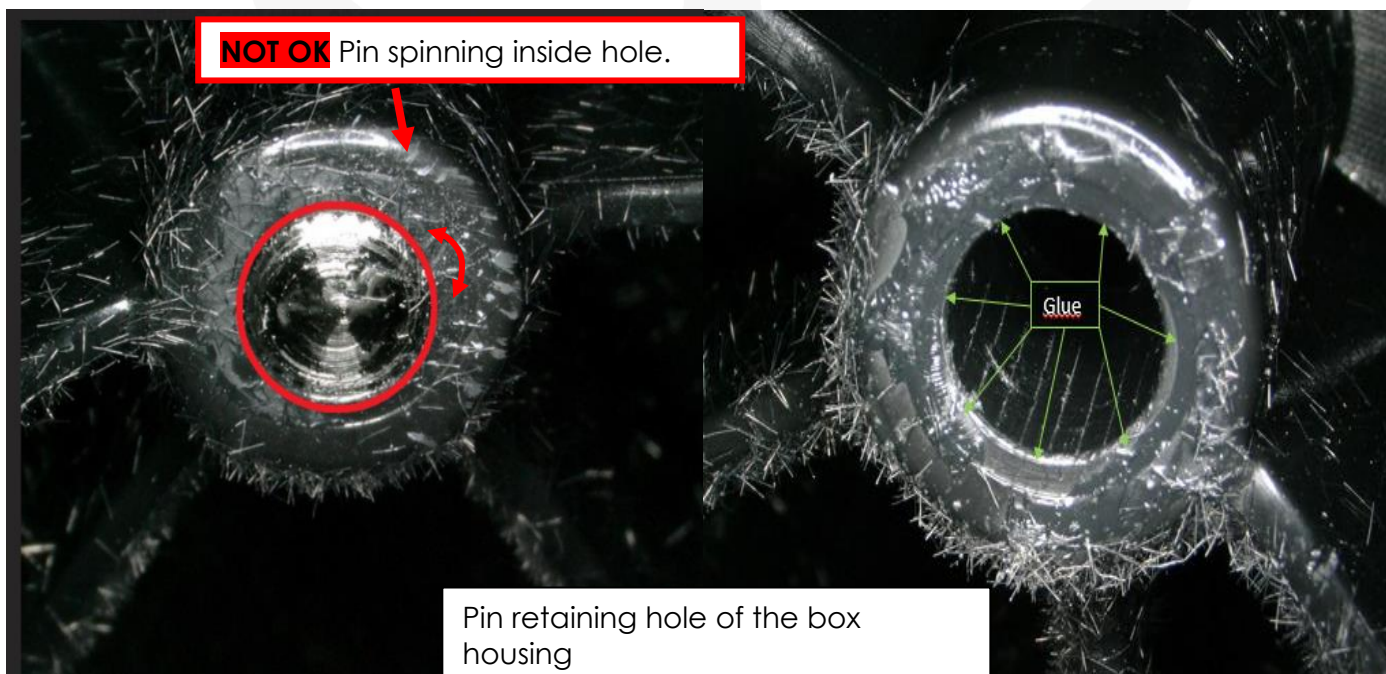
IMPORTANT: the adhesive must be applied in the interface area between the pin and its housing hole (red circle area indicated below)
