Service Campaign Bulletin

Campaign No. 2024110005, December 2024

SUBJECT: **Model S-Class (223 platform)**
Model Year 2021 – 2023

Check Lens Hood of Multifunction Camera

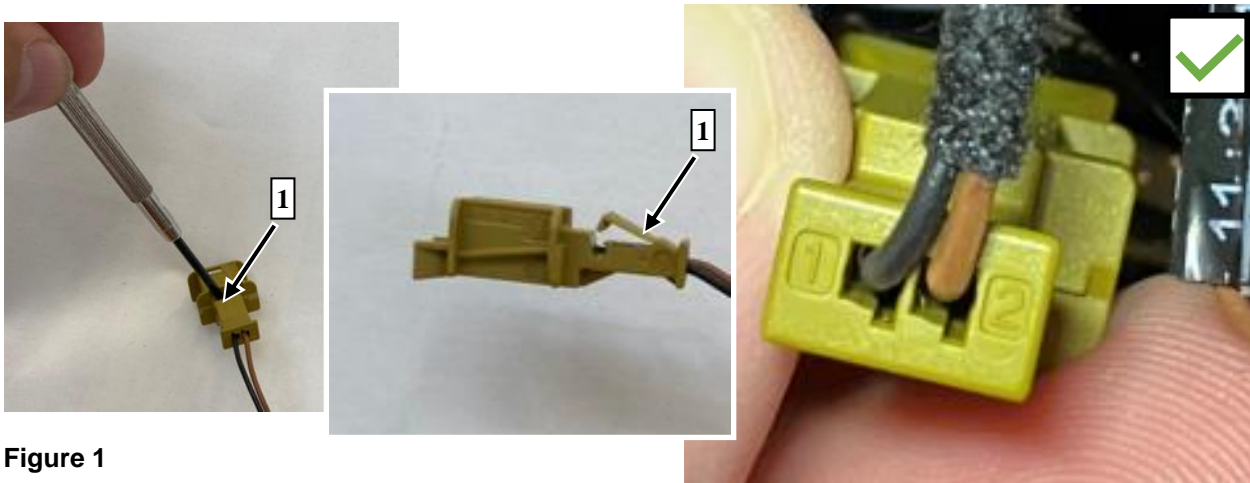
Figure 1

- i** Remove lens hoods from packaging, check the pin assignment in the connector housing, and correct it if necessary.
- i** Correct polarity: **Pin 1 = black (ground/negative); Pin 2 = brown (positive/+)** (Figure 1)

1. Carefully open the secondary lock of the connector (**Figure 1, 1**) and check/correct polarity.

i **Risk of damage:** Open the secondary lock so that the wiring harness pins can be backed out of the connector housing.

i Pull the pins out of the connector housing and insert them into the correct side of the connector if the polarity is incorrect. Ensure the pins are fully seated in the connector and close the secondary lock.

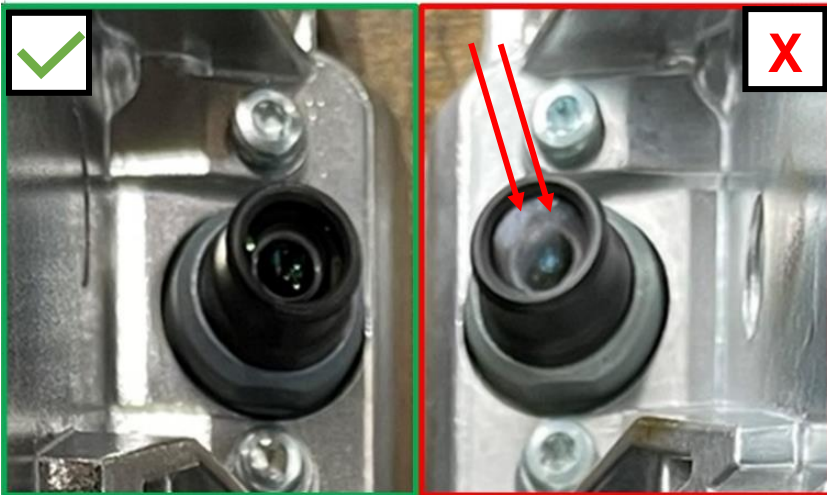
Figure 4

5. Check lenses of multifunction camera (**Figure 4**) for dirt build-up/soiling.

i If the lenses are dirty or soiled, the multifunction camera **must be replaced**.
