# TECHNICAL SERVICE BULLETIN

## Equipped With Minor Feature Code HUKAJ - 400 Watt DC/AC Inverter System Inoperative With B1330:9A In The BCM

24-2443

<b>Ford</b> 2021-2023 F-150	Equipped with minor feature code HUKAJ (400 watt DC/AC inverter system with a pickup bed AC power outlet socket)
--------------------------------	--

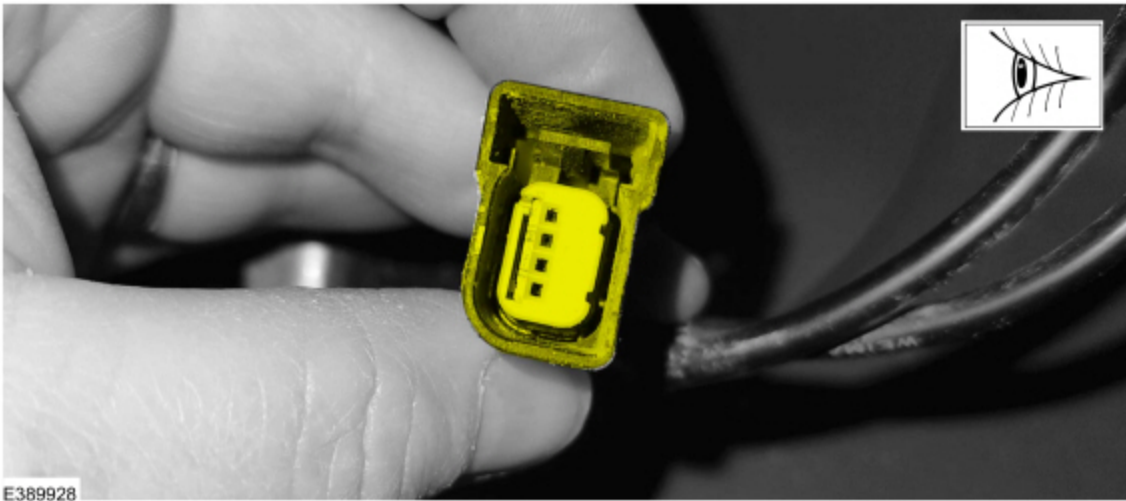
Figure 2

2. Using a suitable tool, carefully cut and remove the pickup bed AC power outlet socket harness retainer from the pickup bed AC power outlet socket harness. Discard the retainer.
3. Is the vehicle a Raptor?
  - (1). Yes - proceed to Step 4.
  - (2). No - proceed to Step 7.
4. For Raptor vehicles, inspect connector C4628 for the presence of corrosion, dirt and/or damage. Is corrosion, dirt and/or damage present in connector C4628? (Figure 2)

7. Inspect connector C4628 for the presence of corrosion, dirt and/or damage. Is corrosion, dirt and/or damage present in connector C4628? (Figure 2)

(1). Yes - replace the pickup bed AC power outlet socket assembly. Refer to WSM, Section 414-05. Replace the body side harness assembly (13A409) of connector C4628. Proceed to Step 8.

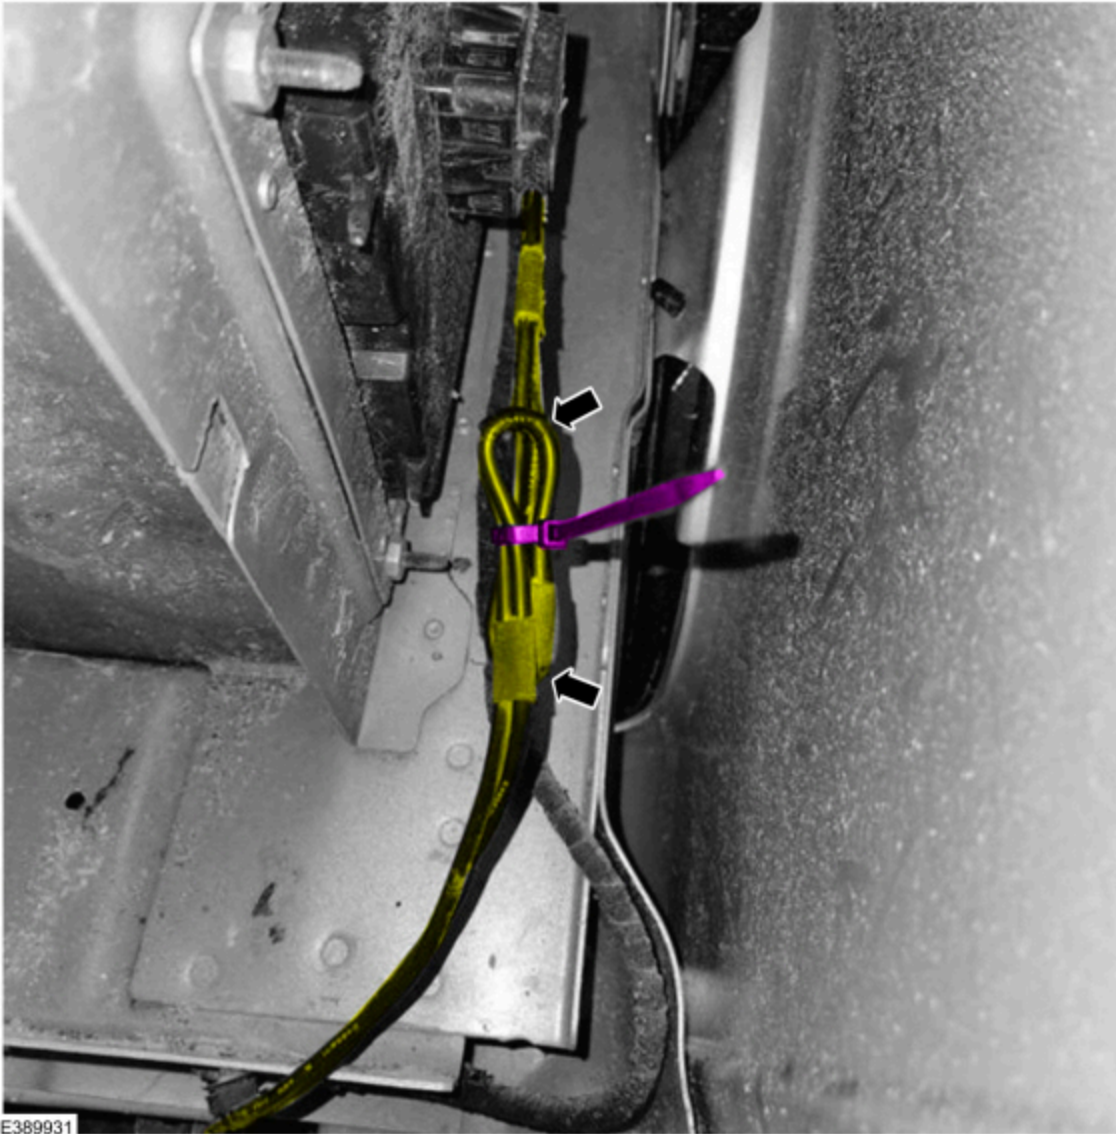
Figure 8

**⚠ CAUTION: The bend radius of the pickup bed AC power outlet socket harness should be no less than 4 mm. Hard kinks and tight bends of the pickup bed AC power outlet socket harness can lead to wire damage.**

**10.** Fold approximately 7 in. (185 mm) of the remaining/loose pickup bed AC power outlet socket harness in 2 bends just behind the pickup bed AC power outlet socket panel. Secure the folded wire with a wire tie. Inspect the routing of the harness to make sure it is not pulled too tight against the body sheet metal near the harness retainer and provides just enough length. (Figure 8)
