Auxiliary Battery Charging, Improvement

V-321-002

(December 2024)

Volvo truck models with USA17 and USA21 emissions levels, Aux. Power/Climate Systems and a LeeceNeville alternator.

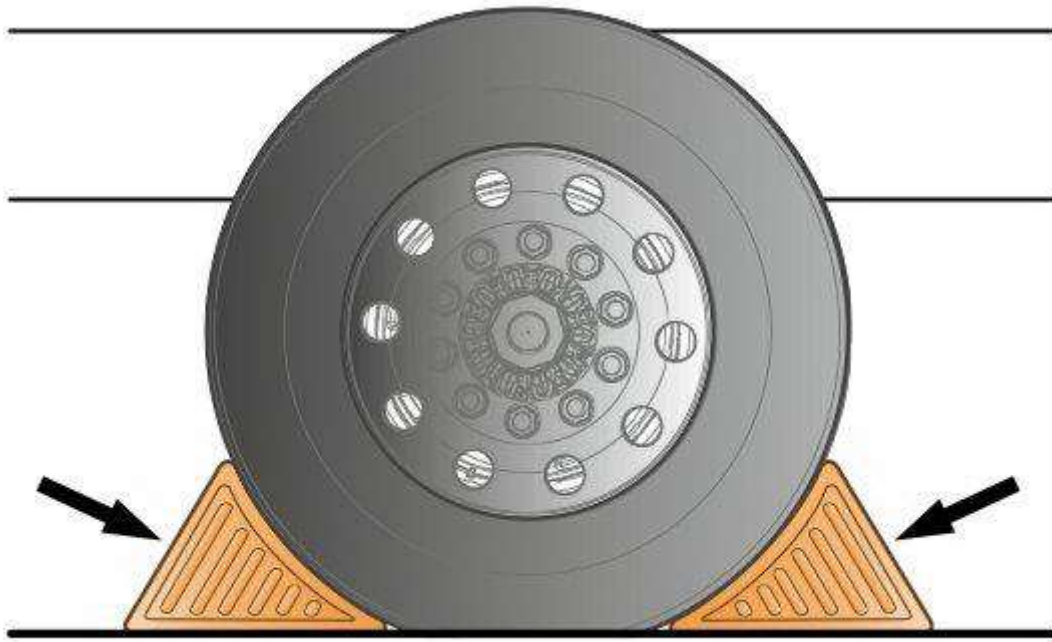
Volvo Trucks has identified that some VN model vehicles equipped with auxiliary power unit batteries may experience insufficient battery system charging. This could lead to early battery failure and improper functioning of the auxiliary power systems. Follow the instructions in the attached document to upgrade the charging system.

1. Park the vehicle on a level surface.
2. Apply the parking brake.
3. Place the gear lever in neutral.
4. Install the wheel chocks.
