# Service Bulletin

Bulletin No.: 22-NA-083

**Subject: Requirements for Replacement of Dual Mode Charge Cord Set Under Warranty**

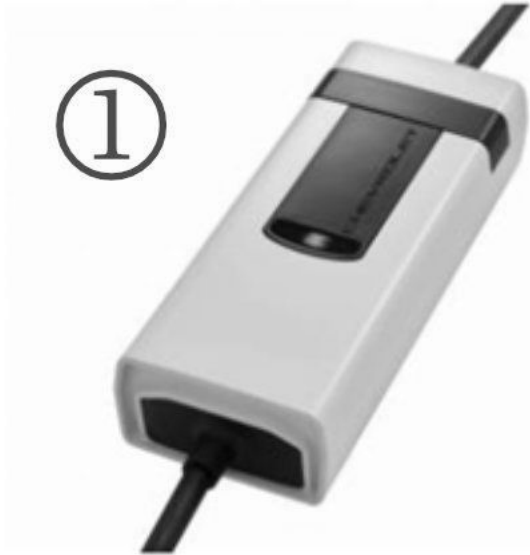
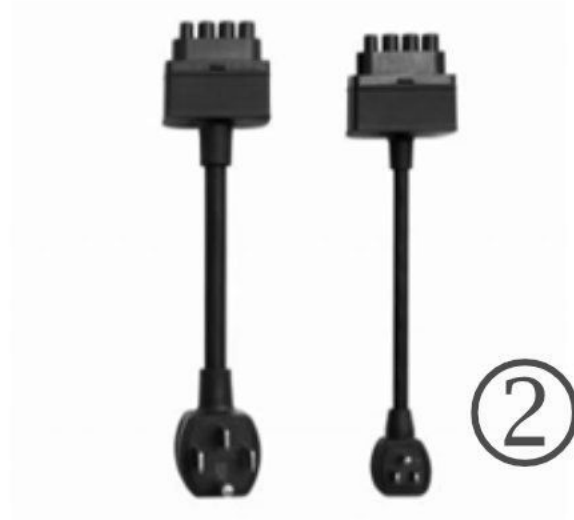
**(OLD) Webasto Cord Set**

Return **BOTH** the Charge Cord Body Module (1) and the Grid Plug that the customer was using when the fault occurs (2), as shown in the pictures above.
