**Technical Service Bulletin (TSB)**  
**B-Pillar Water Leak When Vehicle Is Parked On A Hill**

<b>REFERENCE:</b>	<b>TSB:</b> 23-060-24 <b>GROUP:</b> 23 - Body	<b>Date:</b>	December 18, 2024	<b>REVISION:</b>	23-040-21
<b>VEHICLES AFFECTED:</b>	<b>**2021 - 2025** (JL) Jeep Wrangler</b> <b>**2021 - 2025 (JT) Jeep Gladiator**</b> This bulletin applies to the following vehicles built on or after January 01, 2021 (MDH 0101XX) equipped with a Black 3-Piece Hard Top (Sales Code HT1) or a Body Color 3-Piece Hard Top (Sales Code HT3).			<b>MARKET APPLICABILITY:</b>	
				<input checked="" type="checkbox"/> NA	<input checked="" type="checkbox"/> MEA
				<input checked="" type="checkbox"/> SA	<input checked="" type="checkbox"/> IAP
				<input type="checkbox"/> EE	<input checked="" type="checkbox"/> CH
<b>CUSTOMER SYMPTOM:</b>	<b>Customers may experience one or more of the following:</b> <ul style="list-style-type: none"> <li>• The vehicle will leak water from the top of the B-pillar when the vehicle is parked on a downward incline.</li> <li>• Water on door trim or carpet.</li> <li>• Water drips down the inside door and panel <a href="#">Fig. 1</a>.</li> </ul>

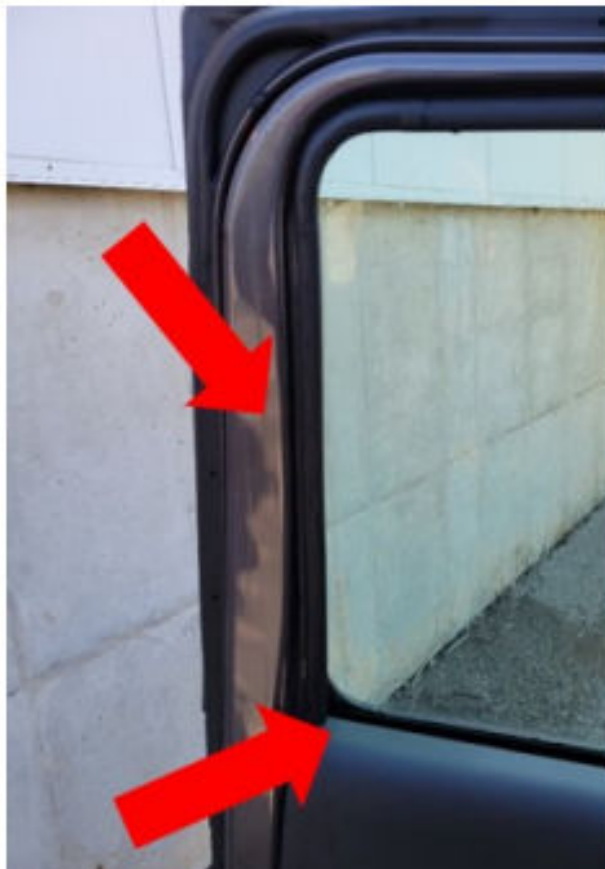
<b>CAUSE:</b>	Foam pads not applied

**Fig. 1**  
Water Drip Area Down The Inside Door And Panel

This bulletin includes performing a water test and possibly adding foam pads to both Freedom Panels.

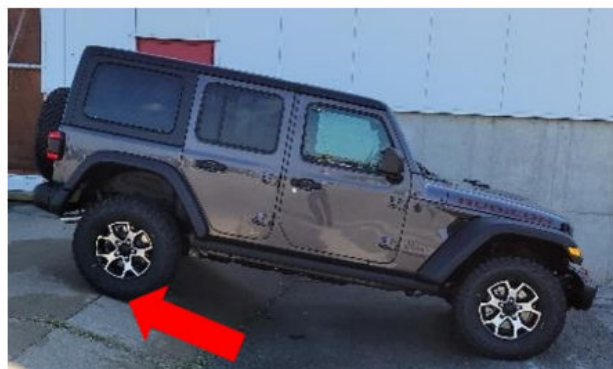
**Fig. 2**

Example Rear Wheels Lifted Approximately 30.4 cm (12 In.)

2. Perform a **\*\*B-pillar\*\*** water leak test. Raise the rear of the vehicle approximately **\*\*30.4 cm\*\*** (12 in.) [Fig. 2](#) off the ground.

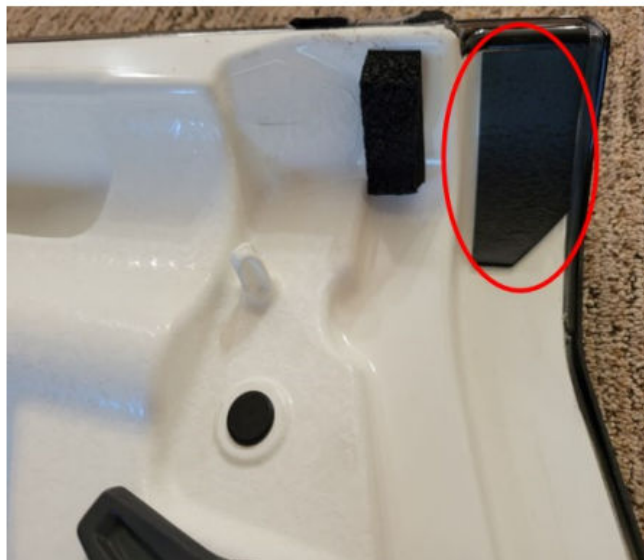
**Fig. 3**  
Foam Pad Installed

6. Remove both Freedom Panels and place on a padded working surface.
7. **\*\*Ensure freedom panels are dry and\*\*** install the foam pads at the rear outer corner of both left and right Freedom Panels [Fig. 3](#).

8. Firmly press the both foam pads down on both panels to promote full adhesion.
9. Install both Freedom Panels on the vehicle **\*\*and verify vehicles cabin is dry before returning to the customer.\*\***
