Service Bulletin

Bulletin No.: 24-NA-113
Date: December, 2024

Subject: Vehicle Wide Programming Instructions

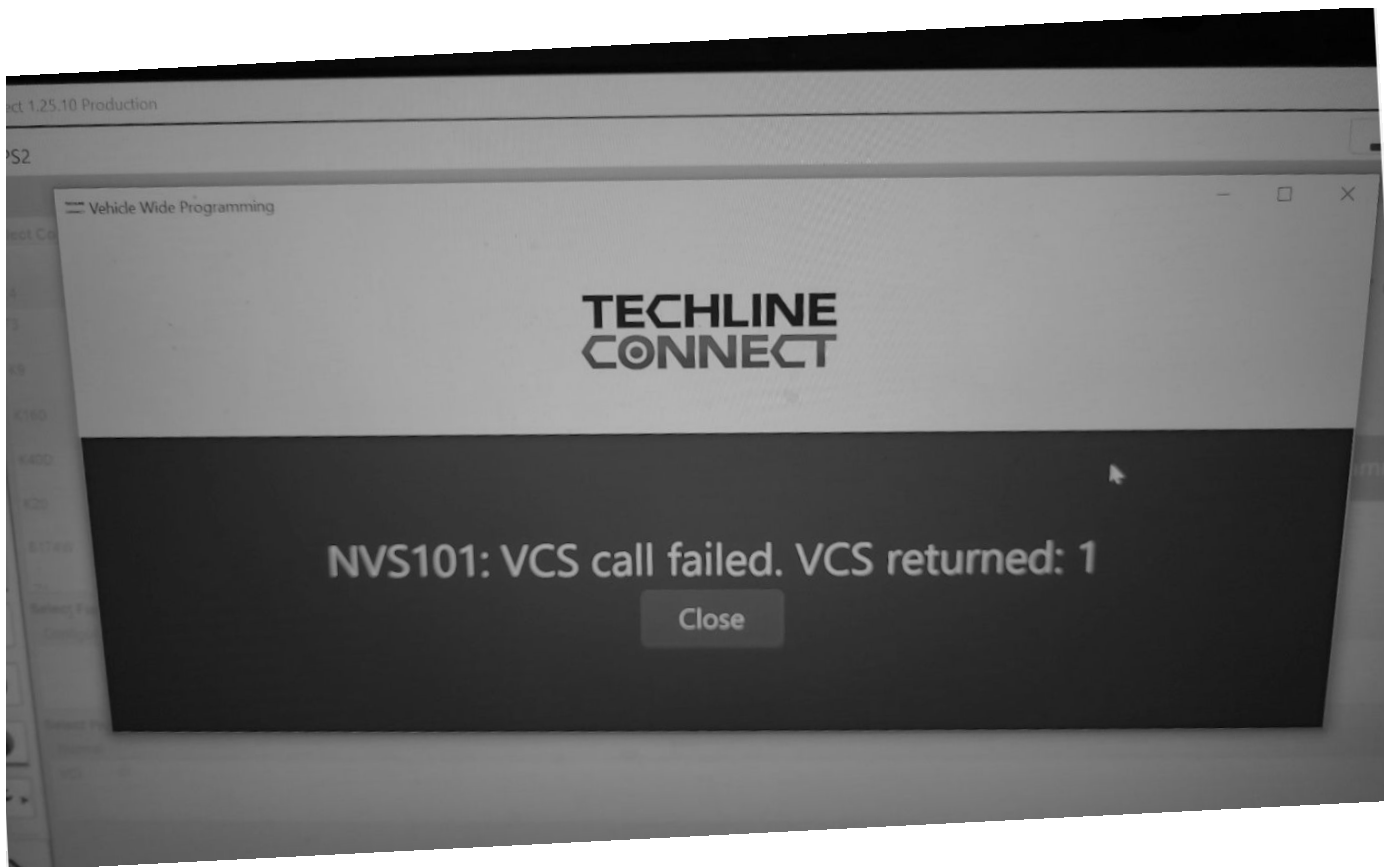
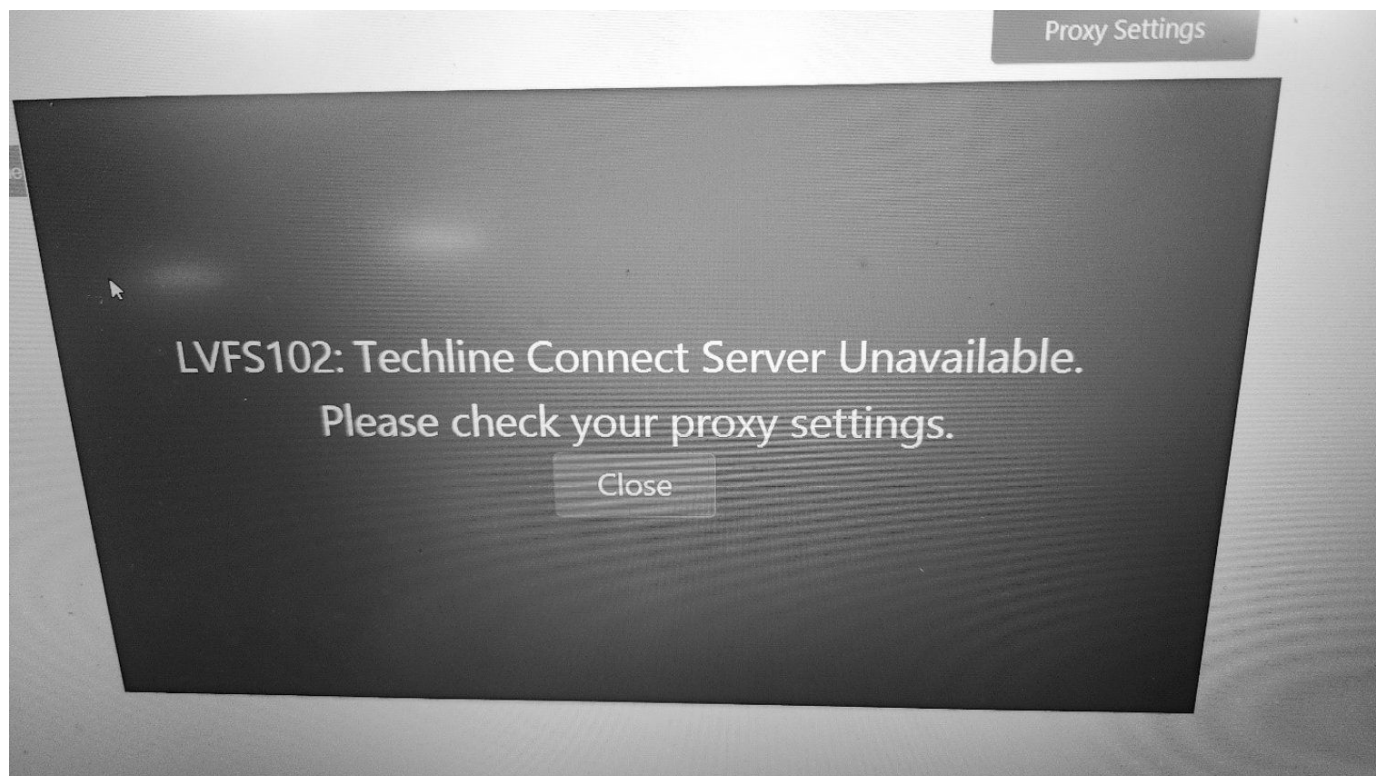
6689036

Note: If either of the following errors are received, this indicates a Techline connection concern. The recommended course of action is to exit from TLC completely and try again. If either failure persists, reboot the machine.
