## Technical product information

### New Continental GT / C and New Flying Spur

Bentley Rotational Display (BRD) clashing with the switch pack during rotation

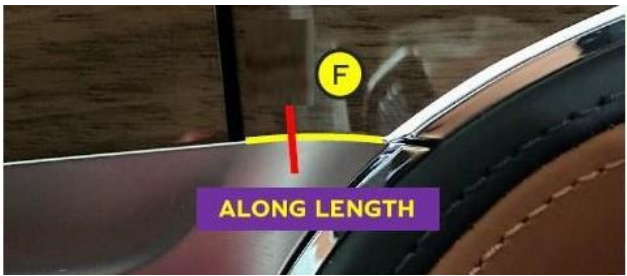
MMI switch to facias.  
Overflush at nominal

**F** Max 3.0mm OF  
Nom. 2.0mm OF  
Min 1.0mm OF

5) Referring to Figure 3 - Measure the profile of the switch pack to confirm the correct tolerance has been achieved

- Should the required tolerance be achieved - Rotate the BRD with care to confirm the issue is resolved - If resolved no further action is required
