<b>REFERENCE:</b>	<b>TSB:</b> 14-010-24 <b>GROUP:</b> 14 - Fuel System	<b>Date:</b>	December 20, 2024	<b>REVISION:</b>	14-006-23
<b>VEHICLES AFFECTED:</b>	<b>2023 (JT) Jeep Gladiator</b> This bulletin applies to vehicles built on or after December 01, 2022 (MDH 1201XX) and built on or before February 20, 2023 (MDH 0220XX) equipped with a 3.6L V6 24V VVT Engine Up Grade I W/ESS (Sales Code ERC).			<b>MARKET APPLICABILITY:</b>	
				<input checked="" type="checkbox"/> NA	<input checked="" type="checkbox"/> MEA
				<input checked="" type="checkbox"/> SA	<input checked="" type="checkbox"/> IAP
				<input checked="" type="checkbox"/> EE	<input checked="" type="checkbox"/> CH
<b>CUSTOMER SYMPTOM:</b>	<b>Customers may experience the following:</b> <ul style="list-style-type: none"> <li>Fuel gage reading incorrectly at 7/8 full after refueling.</li> </ul>				
<b>CAUSE:</b>	Fuel level sending unit float arm catching under vent line at top of the tank

This bulletin involves replacing the fuel tank and possibly the fuel delivery module.

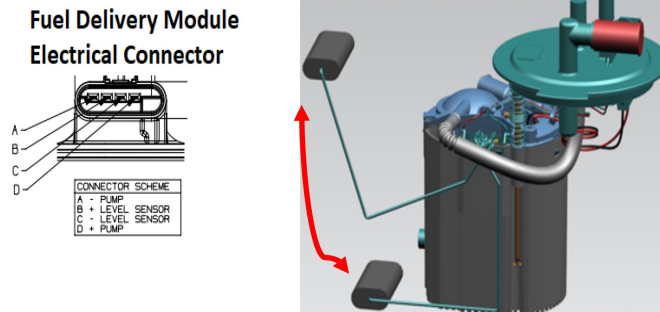
**Fig. 1**

1. Remove the existing fuel tank assembly. Refer to the detailed service procedures available in DealerCONNECT> Service Library under: 09 - Engine, 3.6L / Fuel System / Tank, Fuel / Removal.
2. Using a multimeter, perform an electrical resistance test of the fuel delivery module in 2 level sensor positions “empty stop” (51 Ohms) and “full stop” (992 Ohms) fuel delivery module electrical connector pins “B” and “C” Fig. 1.

3. Did the fuel delivery module pass the electrical resistance test?
  - YES >>> Reuse the existing fuel delivery module. Proceed to [Step 5](#).
  - NO >>> Install a new fuel delivery module. Proceed to [Step 4](#).
4. Replace the fuel pump delivery module with a new O-ring and module into the new fuel tank. Refer to the detailed service procedures available in DealerCONNECT> Service Library under: 09 - Engine, 3.6L / Fuel System / Modules / Removal and Installation.
5. Install the existing fuel delivery module with a new O-ring into the new fuel tank.
6. Install new the fuel tank assembly. Refer to the detailed service procedures available in DealerCONNECT> Service Library under: 09 - Engine, 3.6L / Fuel System / Tank, Fuel / Installation.
7. Fill the new fuel tank with the removed fuel from the old fuel tank.
8. Start the vehicle, verify no fuel leaks.
