Technical product information

Topic	Grease evident at the front lower ball joint bellows
Market area	Bentley: worldwide (2WBE), China 796 VW Import Comp. Ltd (Vico), Beijing (6796)
Brand	Bentley
Transaction No.	2074957/2
Level	EH
Status	Approval
Release date

New Continental GT / C and New Flying Spur

Grease evident at the front lower ball joint bellows

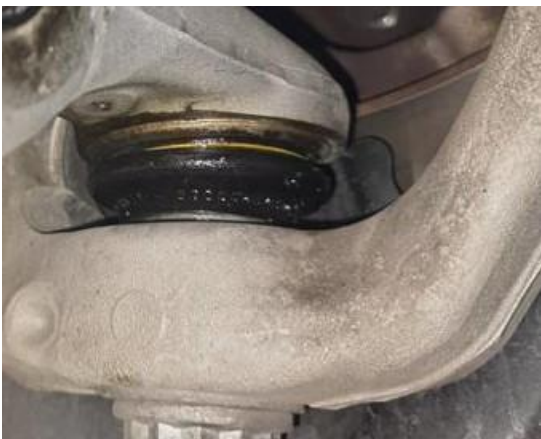
Figure 1

Grease may leak during the initial assembly of the front lower levers. This due to a maximum deflection of the conical spigot before the lower lever is assembled into the wheel carrier. Over the service life, additional foreign bodies can collect in the corresponding area and stick to the excess grease, which can then be distributed over a larger area

The level of grease on or around the lower ball joint boot/wheel bearing housing (Figures 1,2 and 3) is deemed as a normal characteristic

“Normal” Characteristic:

If there is no customer complaint about noises (rattling, pinching, creaking) from the area of the front axle and the lower levers have clearance, the operative must remove any excess grease and check the ball joint and bellows for damage

If the ball joint/bellows is not damaged, the lower lever does not need to be replaced

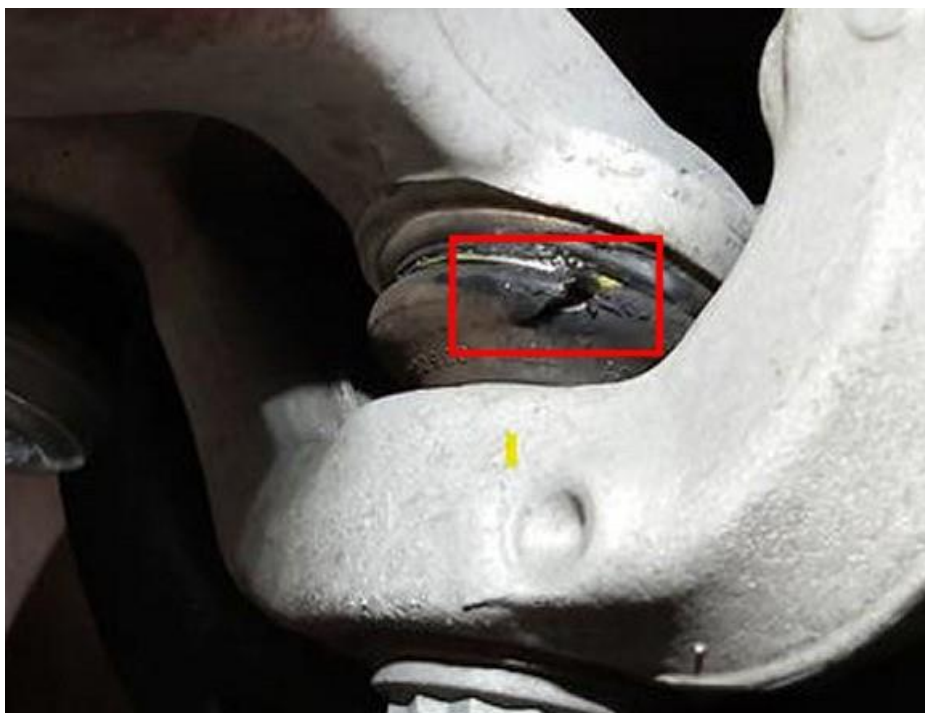
Figure 4

"Torn/split bellows" - Replacement necessary

If the ball joint is worn/damaged or the ball joint bellows is split/damaged (as shown in Figures 4 and 5) the lower front lever must be replaced – Refer to Rep.Gr 40

IMPORTANT: Prior to replacing the lower lever the operative **MUST** raise a Technical DISS query requesting permission to replace the front lower lever
