005 -24 MV
n°

Technical Bulletin

Subject: **MCU cod. SPMV8000D1269**

Product: **LXP 950 Orioli \ Enduro Veloce**

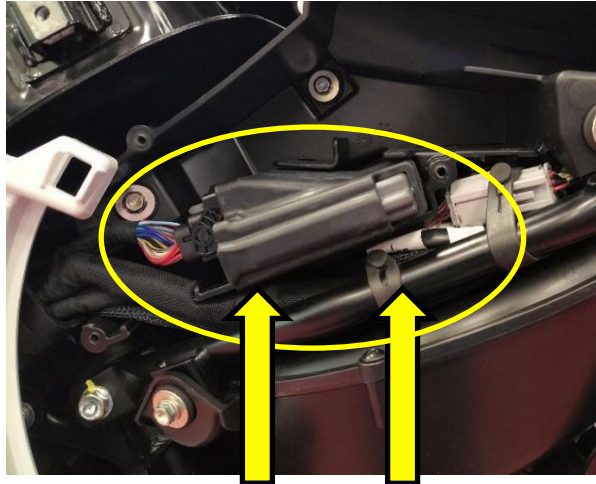
In the event that **“IMU LINK” and “GPS LINK” faults occur at the same time when the vehicle is turned on** (key ON) the issue can be directly related to the MCU driver that won't ensure the proper power supply to the two devices.

The errors previously indicated are attributable to the power supply by the MCU only when both appear and at the time of the initial vehicle check (key ON).

- Disconnect and remove the MCU module cod. SPMV8000D1269;

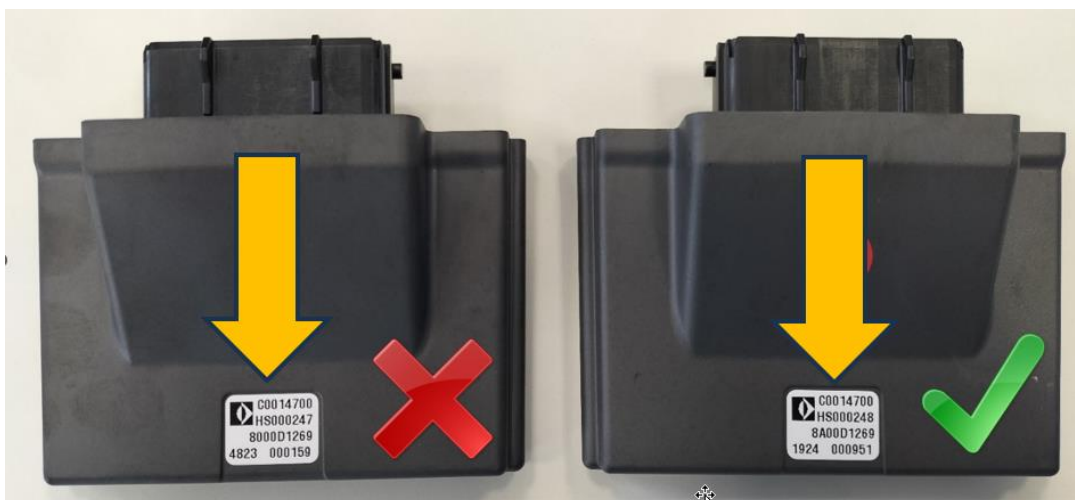
- Part's identification: the MCU can be identified by the code reported on the sticker on the MCU's body.
SPMV8000D1269 → old MCU
SPMV8A00D1269 → new MCU
