## SERVICE BULLETIN

**APPLICABILITY:** 2020-24MY Legacy 2.4L  
 2020-24MY Outback 2.4L  
 2019-24MY Ascent  
 2022-24MY WRX  
 2022-25MY Outback Wilderness

**NUMBER:** 16-150-24R

**SUBJECT:** Transmission Control Module (TCM) / Software Enhancement

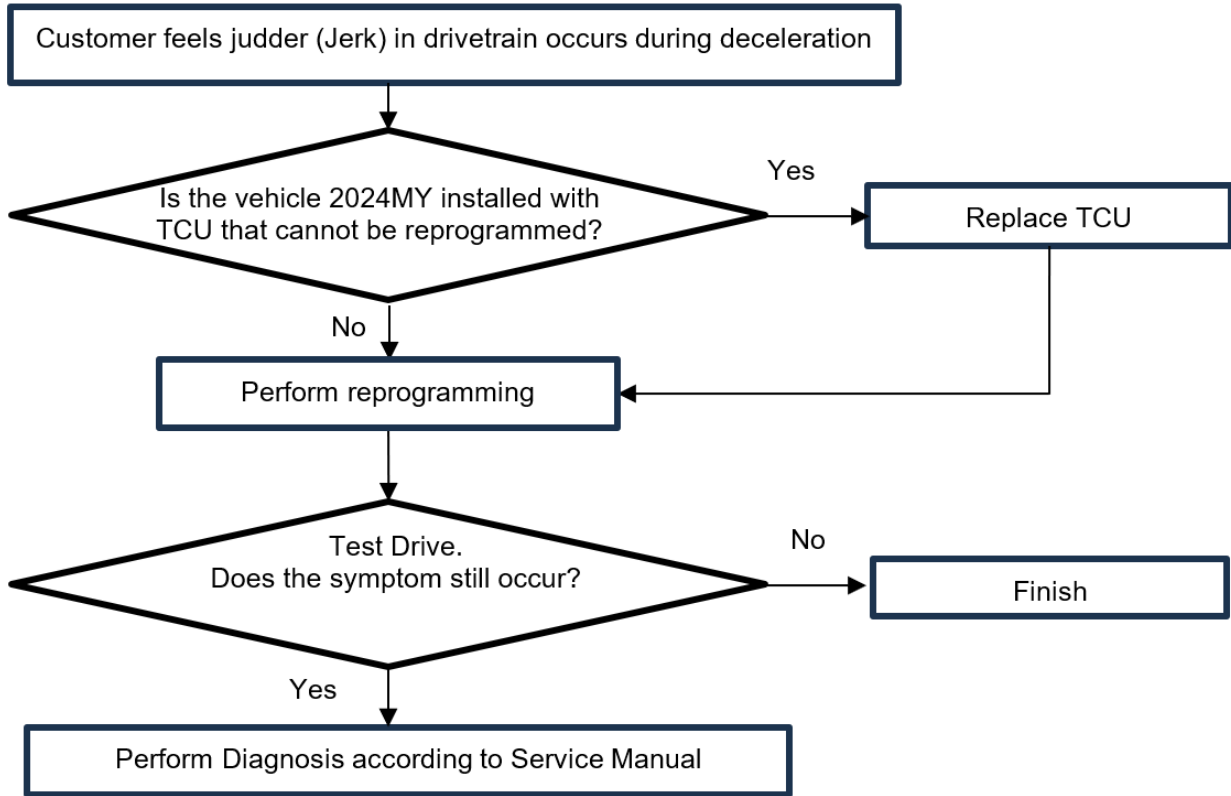
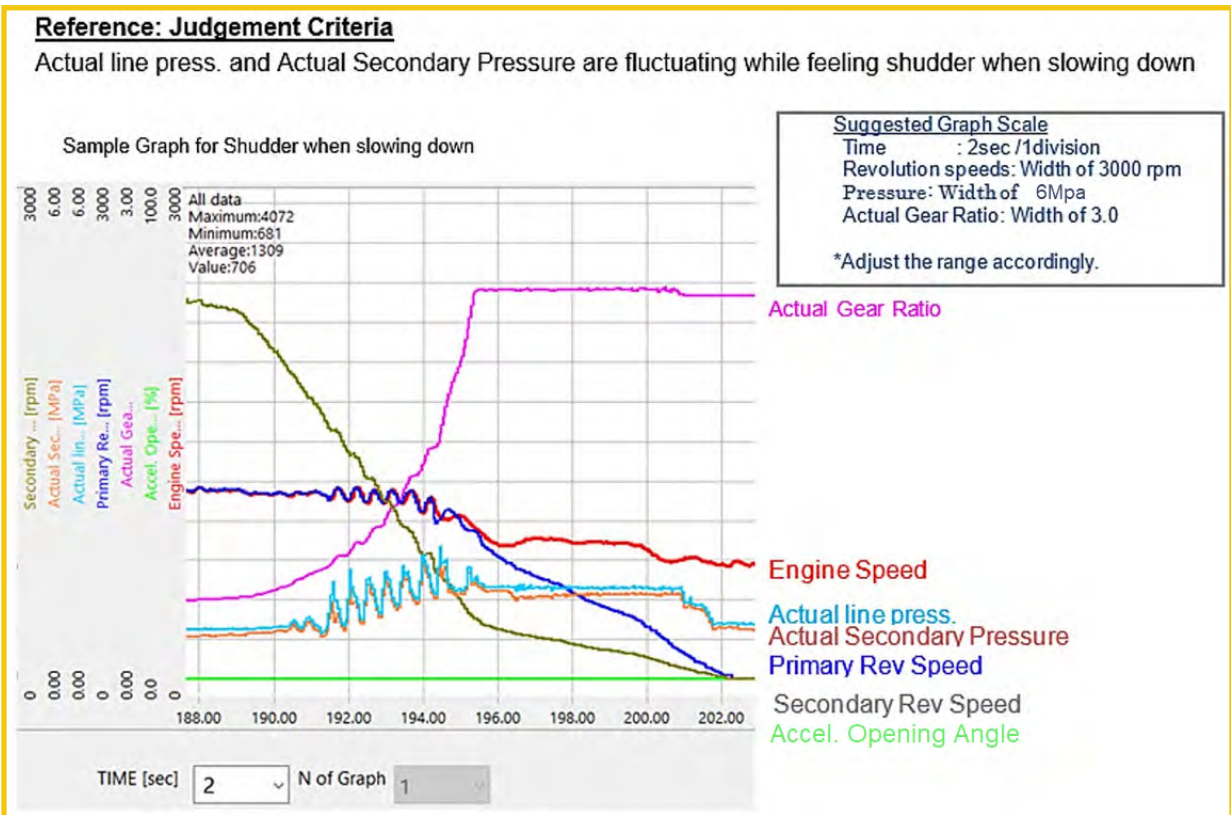
## SYMPTOM 1:

**SYMPTOM 1:** A jerk or judder sensation felt from the powertrain during braking with the air conditioning on.

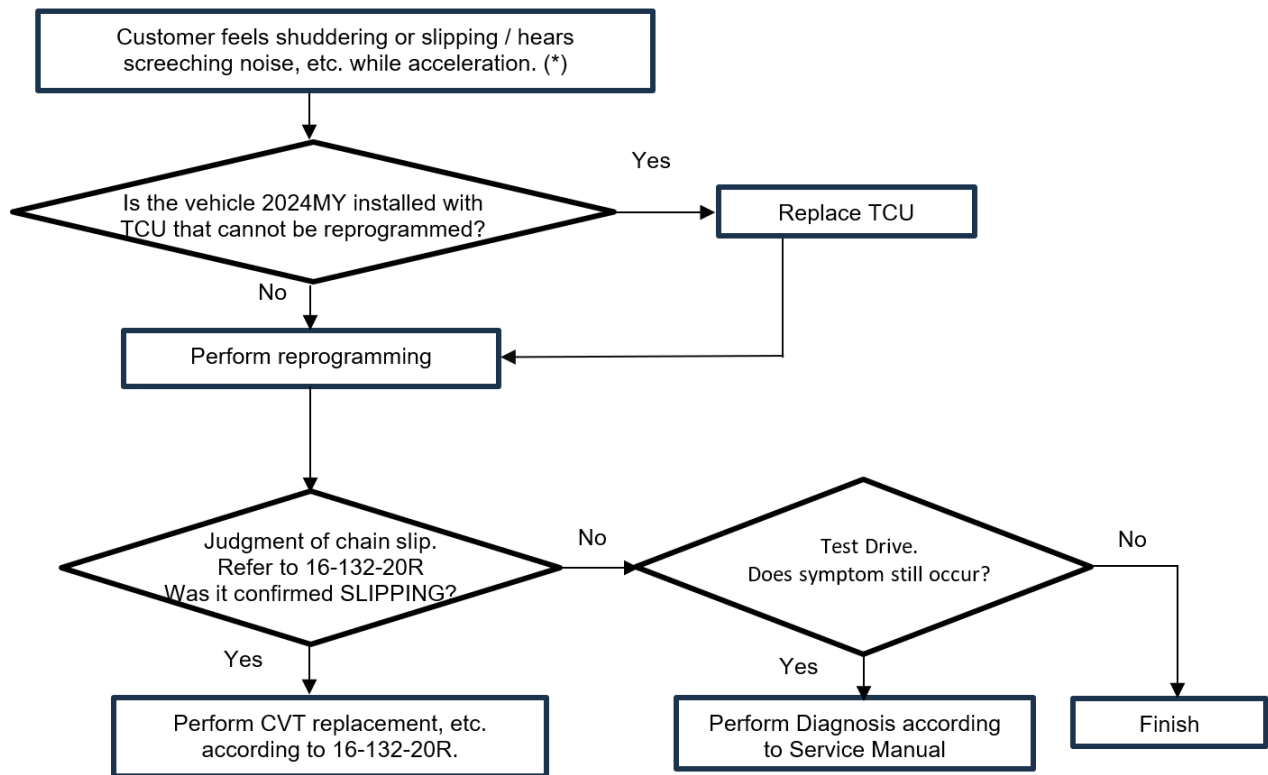
**SYMPTOM 2:**

**SYPMTOM 2:** A shudder is felt from the powertrain along with a screeching type of sound.

(\*) **NOTE:** In case of chain slip caused by input clutch slip, customers may experience symptoms under the following driving conditions.

- (1) Constant speed driving between 25 and 62 mph.
- (2) Gentle acceleration between 25 and 62 mph.

- All of the following are satisfied.
- Primary UP Duty > 80 %
  - Actual Pulley Ratio changes to Low
  - Above conditions last for 0.5sec or more
