SERVICE BULLETIN

APPLICABILITY: 2020-24MY Legacy & Outback
 2022-24MY WRX (A/T Only)
 2019-24MY Ascent

NUMBER: 16-151-24R

SUBJECT: TR690 Chain Slip, Judder, Shudder, & Hesitation Concerns

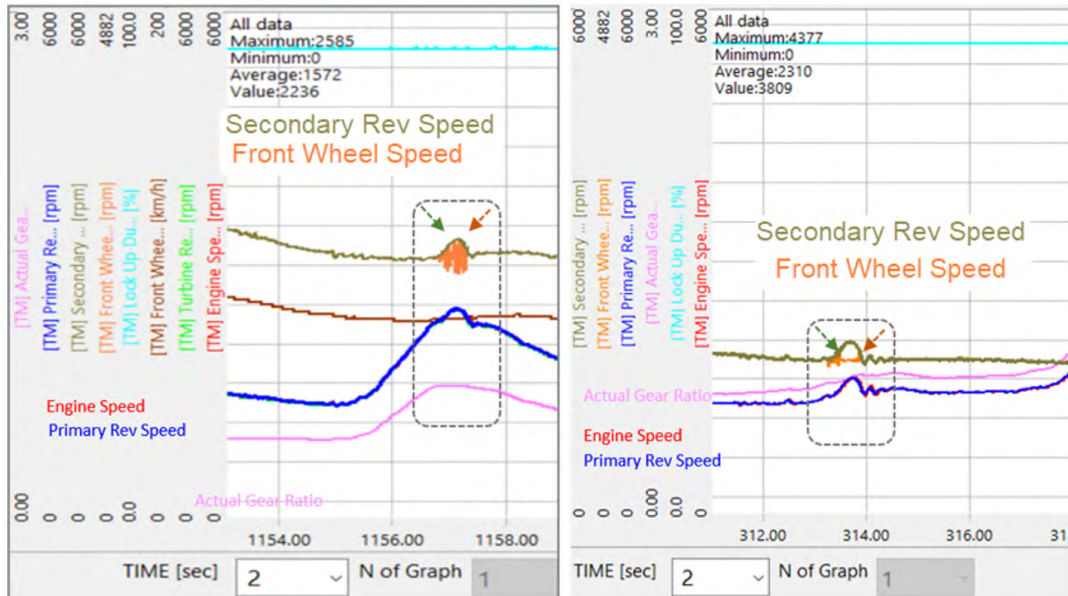
Examples Graph for Forward Clutch Judder:

Forward Clutch Judder Diagnosis Procedure:

The rotational speeds of the upstream and downstream sides of the forward clutch do not synchronize during driving.

Upstream side of the forward clutch: Secondary Rev Speed

Downstream side of the forward clutch: Front Wheel Speed

Forward Clutch Judder: CVT Fluid (p.n. 31333AA160) replacement and TCM software reprogramming (newest software available).

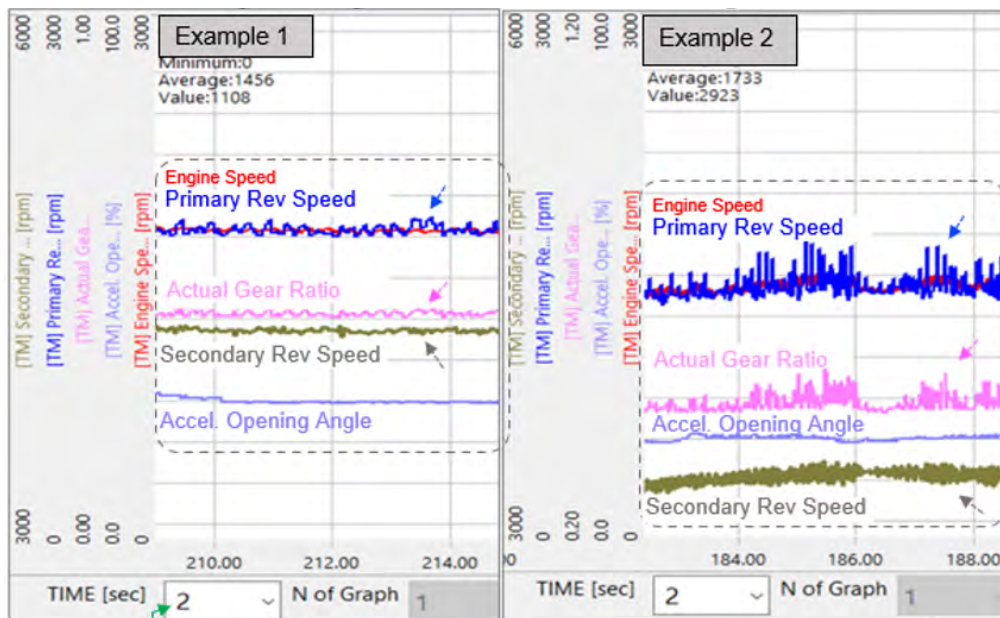
Examples of the data monitoring during Continuous Micro-Slip:

1. Continuous Micro-Slip

During a continuous micro-slip, while the Accelerator Opening Angle monitor displays a stable value for more than one second, there are fluctuations in the Actual Gear Ratio monitor:

Peak to Peak > 0.02

Frequency > 3 cycles per 1 second

There are fluctuations in the Primary Rev Speed and/or Secondary Rev Speed monitor:

Peak to Peak > 50 rpm

Using Subaru Select Monitor (SSM), check and record data monitors and compare to the three examples listed below. If the recorded data from the vehicle matches the examples below, the CVT will require replacement. The SSM data will be required for claim submission. A QMR containing the same information will also be required.

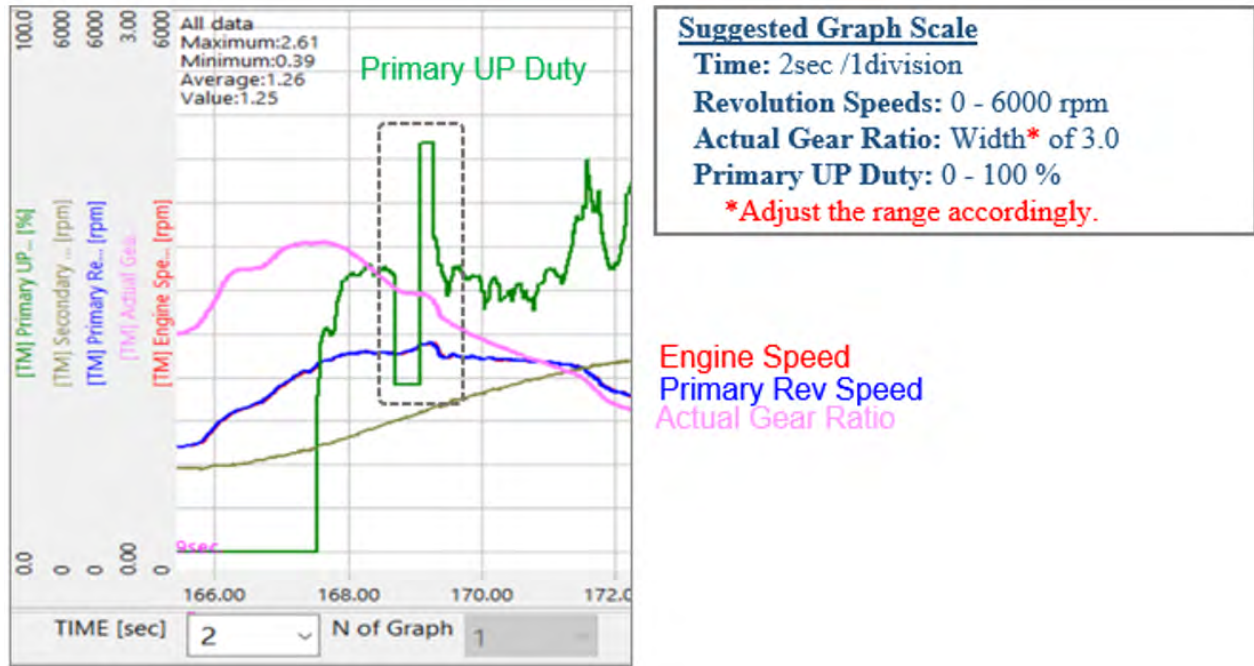
4. Primary Up Duty Square Control (Ascent Models up to 2021MY):

A harsh shift can be felt while driving. If this situation is reported, reprogram the TCM with new software if it is available. If there is no new software available or the reprogramming does not remedy the issue, report the situation to Techline.
