CAMPAIGN BULLETIN

Rear Window Glass Inspection

Reference: PMA43
Date: December 23, 2024

PMA43 – 2025 SENTRA REAR WINDOW GLASS INSPECTION

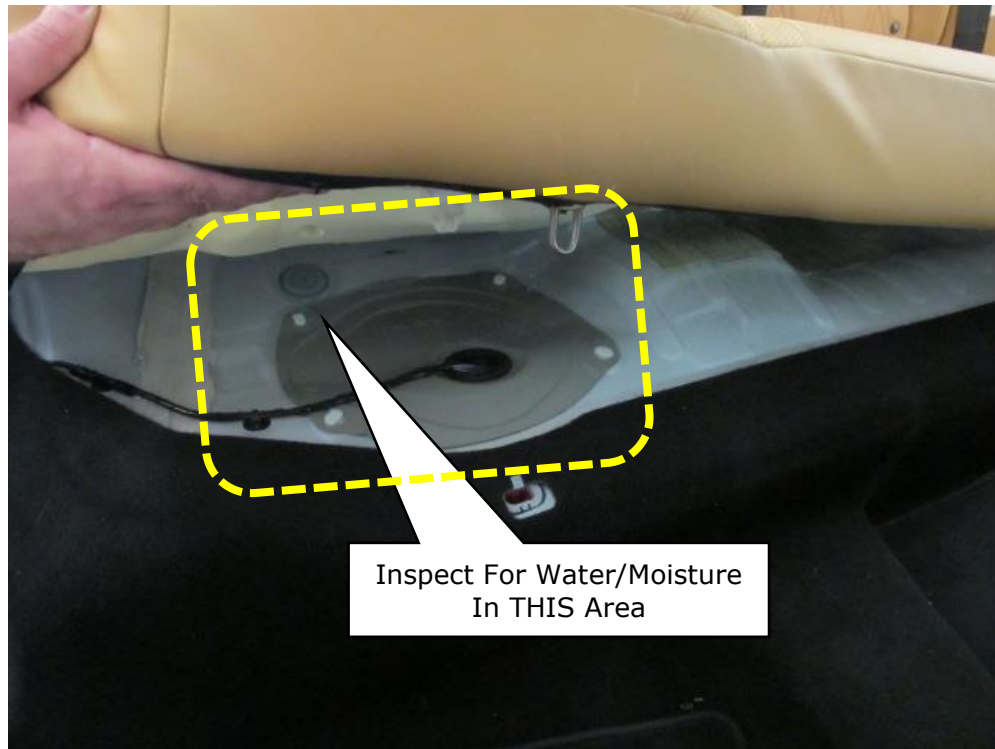
Figure 5

5. Inspect the right (passenger) rear floor under the rear seat cushion for water intrusion (puddled water) or moisture (Refer to Figure 5).

- Is there water intrusion under the rear seat cushion?
 - **NO** => Proceed to Step 6 for 2ND Inspection Procedure.
 - **YES** => Dry the area and replace the Rear Window Glass. Refer to the ESM; **BODY EXTERIOR, DOORS, ROOF & VEHICLE SECURITY - GLASS & WINDOW SYSTEM - REMOVAL AND INSTALLATION – REAR WINDOW GLASS - Removal and Installation**
 - Follow all Warnings and Cautions in the ESM related to rear window glass replacement.

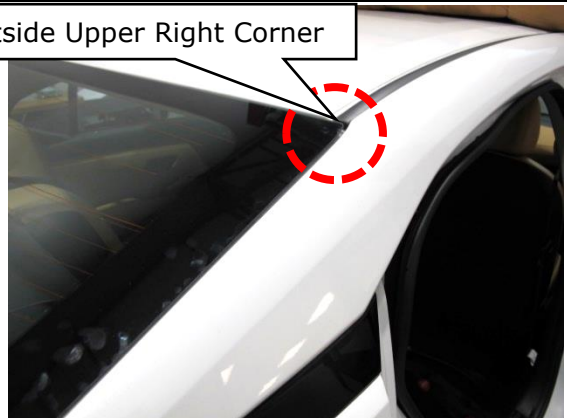
Figure 16

13. Locate the outside upper right corner of the rear window glass.

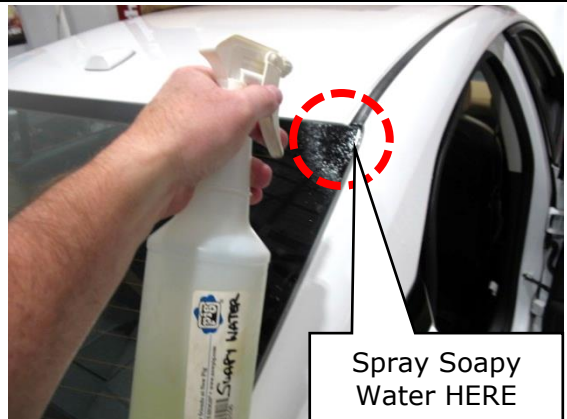
Figure 17

14. Spray a soapy water mix at the upper right corner of the rear window glass.

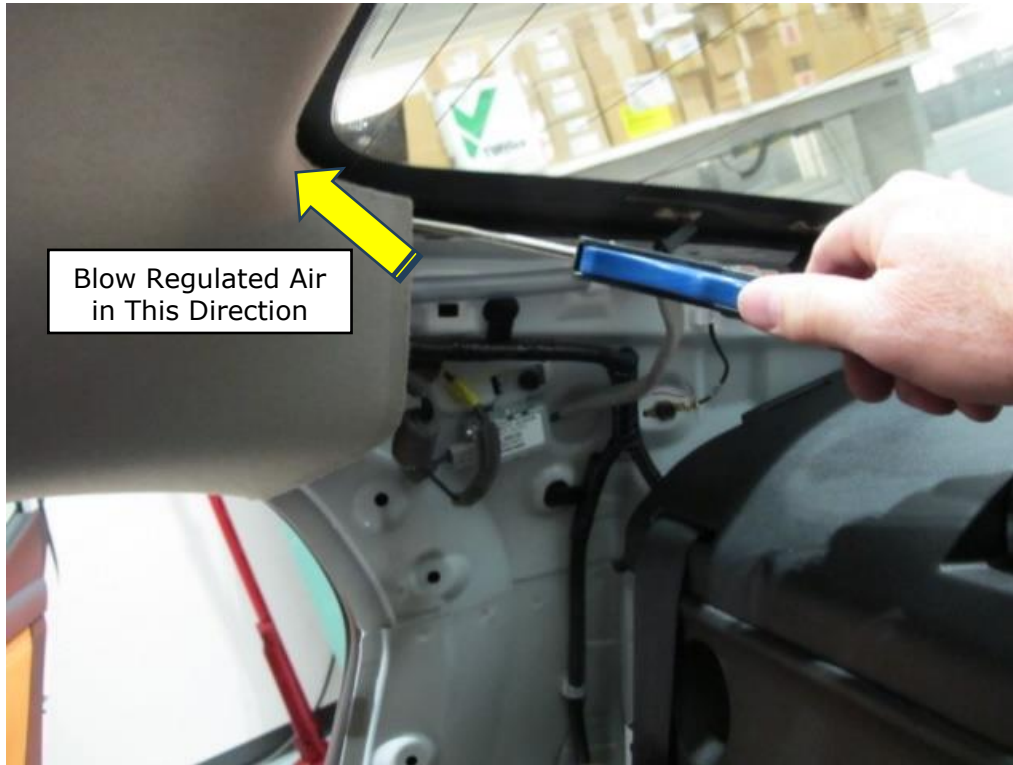
Figure 18

15. From inside the vehicle, using a blow gun, blow compressed air under the headliner toward the upper right corner of the rear window glass.

**IMPORTANT: Regulate air pressure to 80-87 PSI
(Do NOT use shop air pressure)**

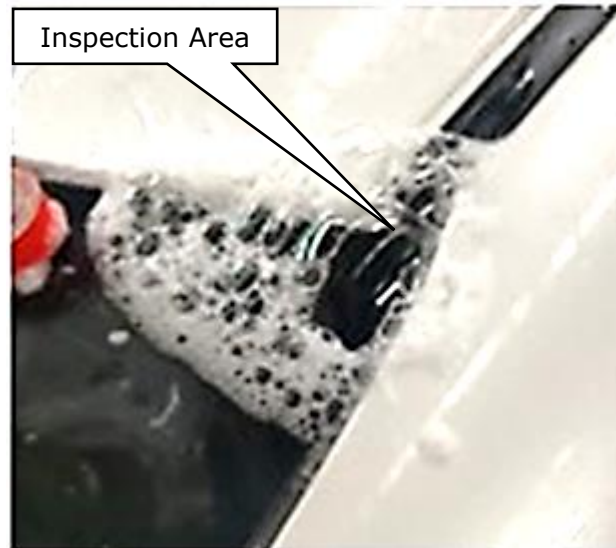
16. Inspect the outside upper right corner of the rear window glass for bubbles.

- Do air bubbles appear at the upper right corner of the rear window glass due to a compressed air leak path? (refer to Figure 19 below)

- **NO=>** The inspection is complete, proceed to **Claims Information** section.
- **YES=>** Replace the rear window glass. Refer to the ESM; **BODY EXTERIOR, DOORS, ROOF & VEHICLE SECURITY - GLASS & WINDOW SYSTEM - REMOVAL AND INSTALLATION – REAR WINDOW GLASS - Removal and Installation**
 - Follow all Warnings and Cautions in the ESM related to rear window glass replacement.
