To: Mercedes-Benz Dealers, General Managers, Sales Managers, Service Managers, Parts Managers	From: Anthony Washington, Senior Manager, Regulations and Certifications
Re: Service Campaign Notification Model: Sprinter Model Years: 2024 Inspect Coolant Hose Routing	Date: December, 2024

IMPORTANT SERVICE CAMPAIGN INFORMATION

Campaign No.:	Campaign Desc.:	NHTSA ID:	Inspect Coolant Hose Routing
2024120009	V3EKUMILL	N/A	
This is to notify you of a Service Campaign to Inspect Coolant Hose Routing on approximately 66 MY 2024 Mercedes-Benz Sprinter Vans. All affected VINs will be flagged as " OPEN " in VMI.			
Background			
Issue	The coolant bleed line was routed improperly and can cause chaffing.		
What We're Doing	MBUSA is conducting a service campaign. An authorized Mercedes-Benz Sprinter dealer will inspect the routing of the coolant bleed line and modify if necessary.		
Parts	Parts are not required for repair.		
Vehicles Affected			
Vehicle Model Year(s)	2024		
Vehicle Model	Sprinter		
Vehicle Populations			
Total Vehicles	66		
Dealer Inventory	17		
Next Steps/Notes			
AOMS/SOMS	Please ensure your dealers have read and understand this notice		
While we regret any inconvenience this m

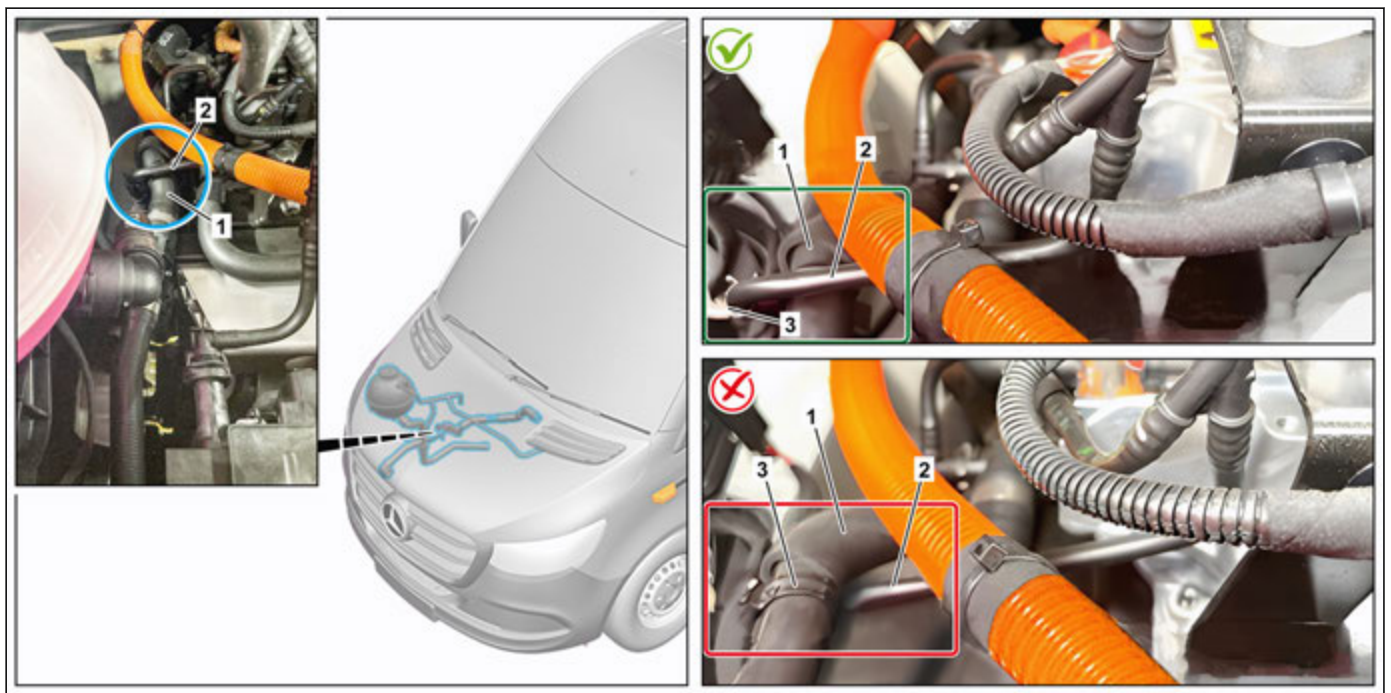
D20.20-A053-79

1 Vent line

2 Line

3 Bracket

Check		
1	Check if vehicle is affected by measure.		
2	Check routing of bleed line (1) of coolant expansion reservoir.

The bleed line (1) must run below the line (2) and be fastened to the holder (3) as shown. If the bleed line (1) is correctly routed, ↓ end the measure. If the bleed line (1) is not routed correctly, ↓ Continue with operation step 3.	
	Modify routing		
3
