Document Title:	Truma Aventa Air Conditioner Leak		
Document Type:	Technical Document	Make and Model:	Ember Overland Ember Touring
Document #:	TD-24-08	Model Year:	2023 and 2024
Revision Date:	11.06.2024	Flat Rate:	50000653

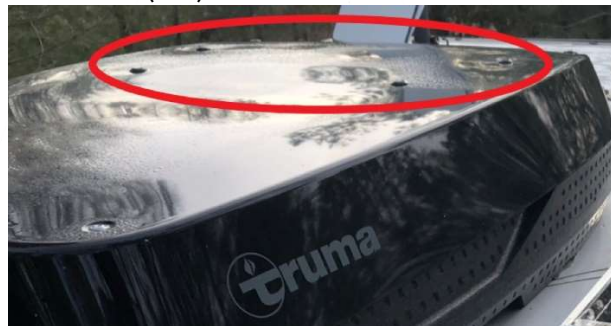
IMPORTANT! The screws identified below will allow water into the Recreational Vehicle (RV) if not sealed.

1. Ember applies sealant to all the screw heads on the shroud. This is in alignment with the [Truma Aventa Installation Manual Addendum](#).
 - a. Verify all screws on shroud have sealant on them. If not seal with black butyl rubber sealant.

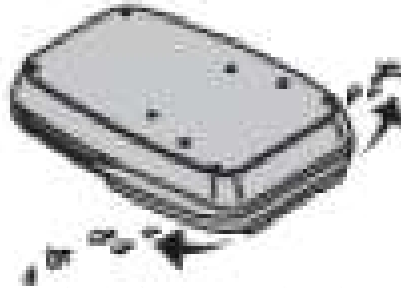
2. Next be sure condensation drains are not blocked. The air conditioner's condensation drains on the roof must be kept free of obstructions, e.g. dirt or foliage. If the condensation outlets are dirty, water can enter the interior of the RV. **NOTE: This is not a warrantable step.**
