VOLUNTARY SERVICE CAMPAIGN

| Classification: HA24-001 | Reference: NTB24-048 | Date: October 29, 2024 |

VOLUNTARY SERVICE CAMPAIGN 2018-2025 LEAF; HVAC REPROGRAM

CAMPAIGN ID #: P4A17
APPLIED VEHICLES: 2018-2025 LEAF (ZE1)

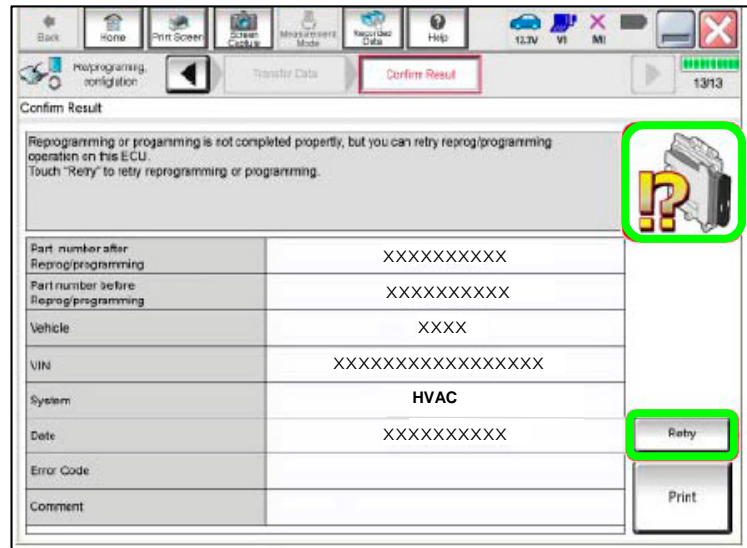
Figure 22

If reprogramming does not complete and the “!?” icon displays, as shown in Figure 22:

- Check battery voltage (12.0 V – 13.5 V).
- EV system is ON (Not Ready).
- External Bluetooth® devices are OFF.
- All electrical loads are OFF.
- Select **Retry** and follow the on screen instructions.
- Retry may not go through on first attempt and can be selected more than once.

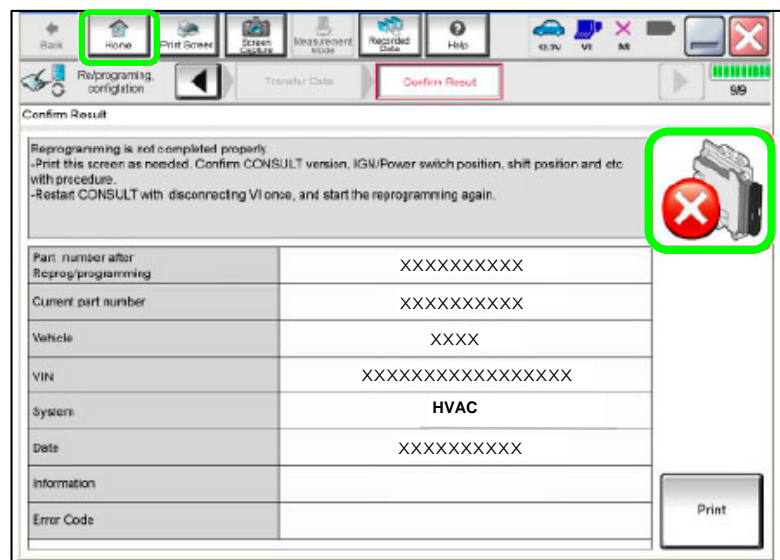
Figure 23

If reprogramming does not complete and the “X” icon displays, as shown in Figure 23:

- Check battery voltage (12.0 V – 13.5 V).
- CONSULT A/C adapter is plugged in.
- EV system is ON (Not Ready).
- Transmission is in Park.
- All C-III plus / VI cables are securely connected.
- All C-III plus updates are installed.
- Select **Home**, and restart the reprogram procedure from the beginning.
