SS 771 WST 47X/49X Front Suspension Aluminum Shackle Bars

WST 47X/49X vehicles specified with 12000 lb and 13300 lb rated front suspensions.

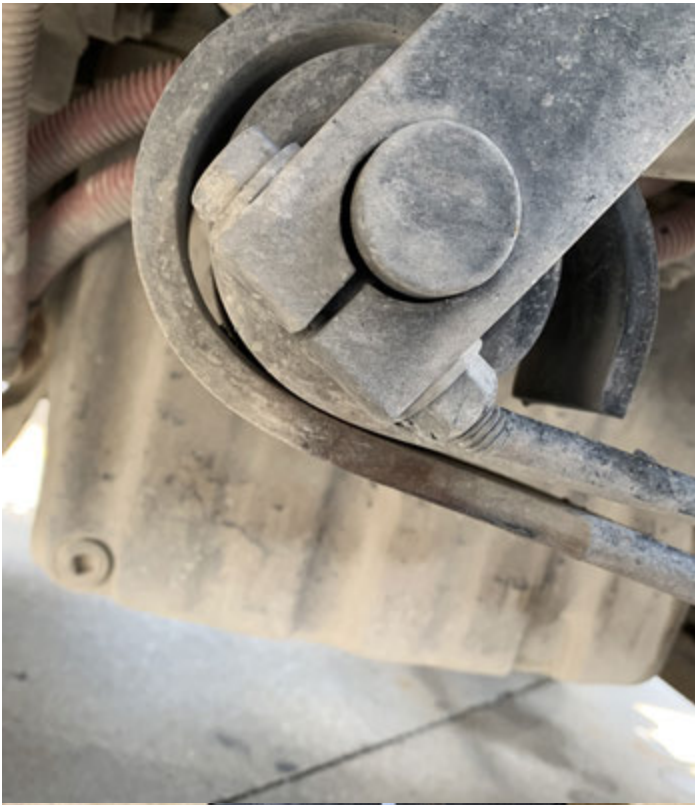
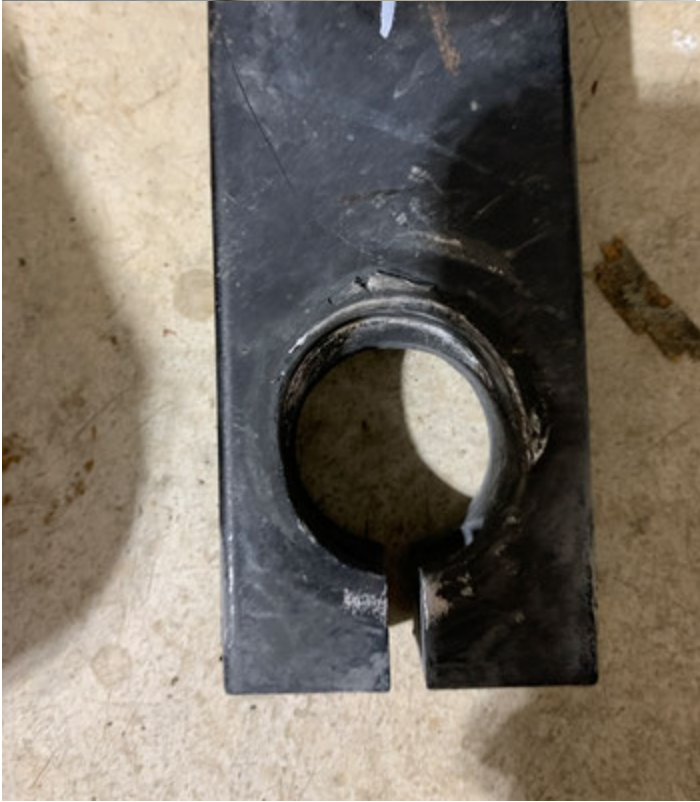
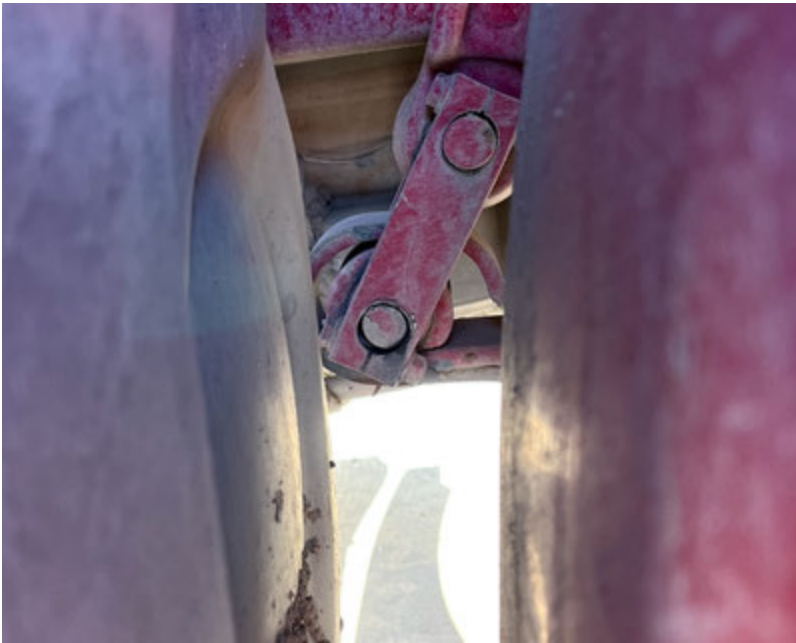
- Loud popping/grinding/banging noise from vehicle front end while driving or turning.
- Pre-mature wear on the front suspension spring shackle bars or spring bushing pins
- Shackle bar clamping bolts breaking or severely worn.
- Inside/outside shackle wear from spring contact

The images below show the condition of the Aluminum shackle bars when the spring pin wears the bore of the shackle bar to an out of round condition.

Certain 47X/49X vehicle applications for the 12k and 13.3k rated front suspensions can cause specific load transfer into the spring pin/shackle bar interface. This load transfer can result in premature wear of the Aluminum shackle bars.

- Replace the Aluminum shackle bars with the Steel shackle bar part number 16-11890-001.
- If applicable, inspect the rubber bushing spring pin. Any sign of abnormal wear/deformation, replace the rubber bushing
- If applicable, inspect the threaded bushing spring pin/sleeve. Any sign of abnormal wear/deformation, replace the threaded bushing
- Replace the 1/2" clamping bolts and nuts . Torque to 63 lbf.ft (85 Nm)
