13–007 Air Compressor Discharge Line Blocked by Ice in Cold Weather

TSB-13-007-FTL

Engine or Vehicle Affected:

- ▶ eM2
 - ▶ eCascadia
-

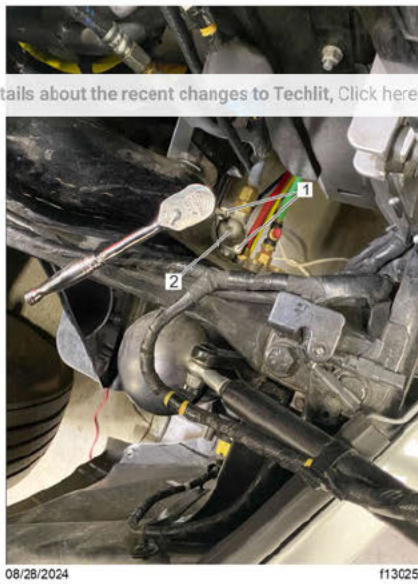
Fig. 1, Removing Bolts of the Overflow Valve

On eCascadia and eM2 vehicles, specific environmental conditions near freezing (both slightly above and below), where significant moisture and humidity are present, can lead to an ice blockage in the compressor discharge line overflow valve. As a result, the compressor will no longer build air and may blow air and mist oil out of a pressure relief valve on the compressor housing. This issue typically occurs upon startup of the vehicle but could also happen during operation under certain rare conditions. Follow the detailed procedure below to fix in the event this occurs, or if a vehicle is operating in conditions where this may occur.

3. Remove the two bolts from the top of the overflow valve. See Fig. 1.

4. Replace the overflow valve.

5. Install the bolts. Tighten the bolts 62–80 lbf-in (700-904 N-cm).

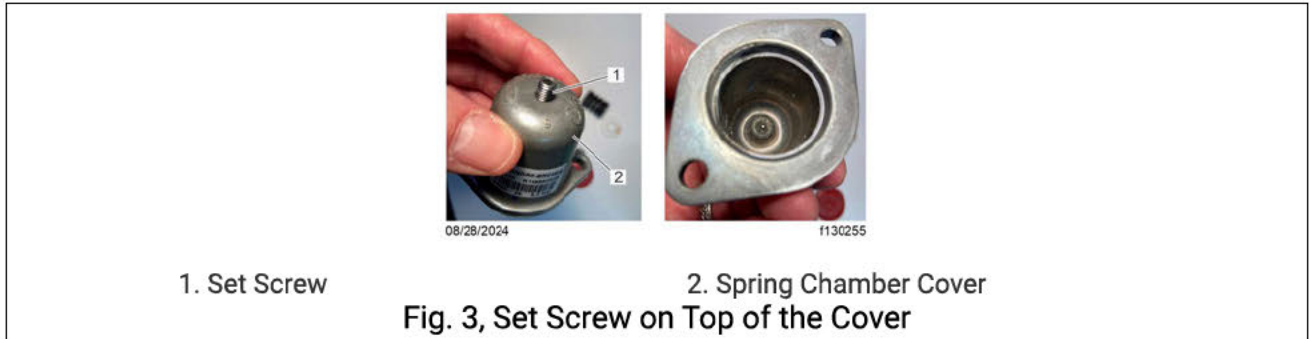
● Important: DO NOT adjust the set screw on the top of the overflow valve spring chamber. This screw setting is precisely calibrated when the valve is manufactured, and changing the screw position will render the valve non-functional. See Fig. 3.

10. Defrost, clean, and dry the valve.
