35–039 Detroit New Final Drive Standard Performance Forward Carrier Change to Top Performance Passive Lube Management

TSB-35-039-FTL

Creation Date:2023-01-26

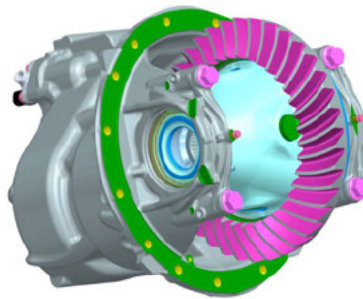
Fig. 1, Original Standard Performance Carrier without a Lube Management System

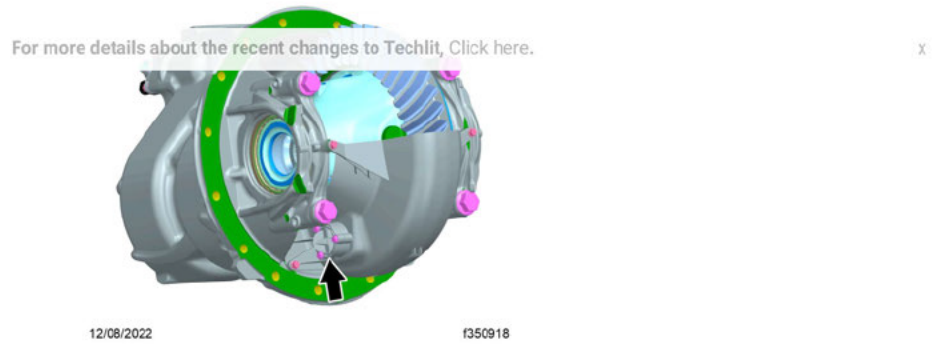
Fig. 2, New Standard Performance Forward Passive Lube Management Carrier with Fixed Valve

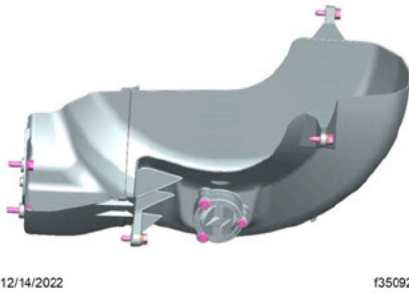
Fig. 3, New Passive Lube Management Valve and Windage Tray

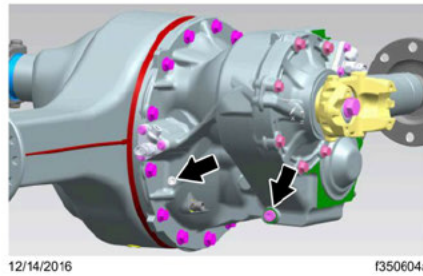
Oil fill locations will change to match the New Final Drive Top Performance locations. See Fig. 4. The type of approved oil is DFS93K219.01 only. The rear fill plug on the axle housing will change to MBA 6809900117, and it will be installed from the inside, similar to the Top Performance carrier. See Fig. 5.

Fig. 4, New Fill Locations for New Final Drive with Passive Lube Management System

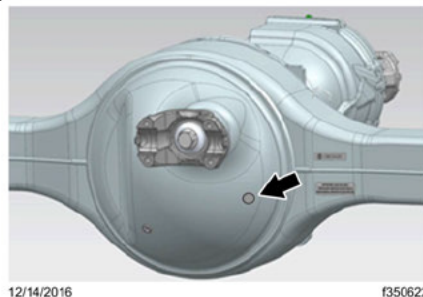
Fig. 5, Old Fill Plug Blocked with New Plug Inserted from Inside of the Carrier Housing
