Technical product information

Topic	Outer dashboard speaker grille lifted / Incorrect flushness
Market area	Bentley: worldwide (2WBE), China 796 VW Import Comp. Ltd (Vico), Beijing (6796)
Brand	Bentley
Transaction No.	2075601/2
Level	EH
Status	Approval
Release date

New Continental GT / C and New Flying Spur

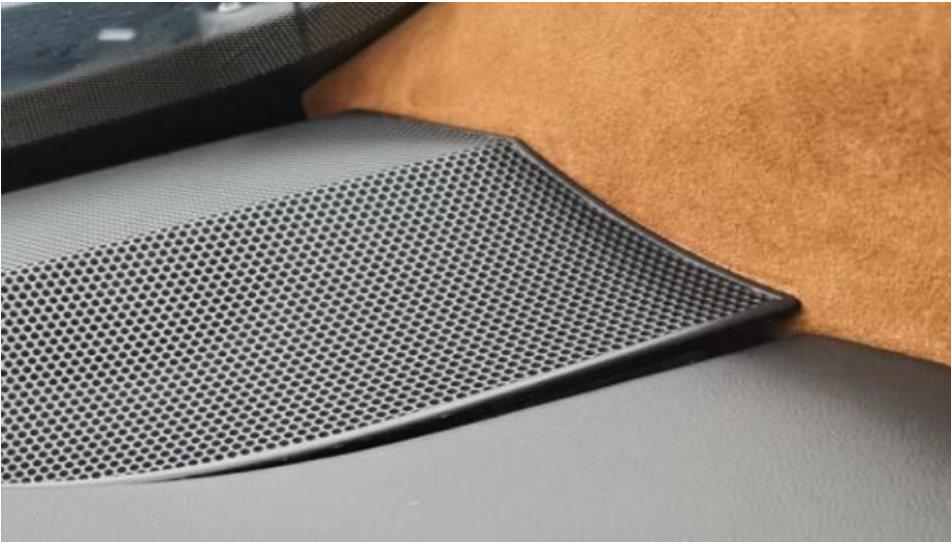
Figure 1

Outer demister panel (speaker grille) lifted / Incorrect flushness (Figure 1)

- 4) With care remove and discard the original clip
- 5) Fit a new clip (See parts information section)
- 6) Refit the demister panel back into position Note: When refitted correctly the demister panel clip should click / lock into position
