Technical Service Bulletin

| Subject: CLICKING NOISE FROM LIFTGATE LATCH AND LOCK ACTUATOR WHEN DRIVING ON BUMPY ROADS | Bulletin No.: 09-012/24 |
| | Last Issued : 12/05/2024 |

2024 CX-90 with VINS lower than JM3KK*****152546 (produced before Decemeber 6, 2023)

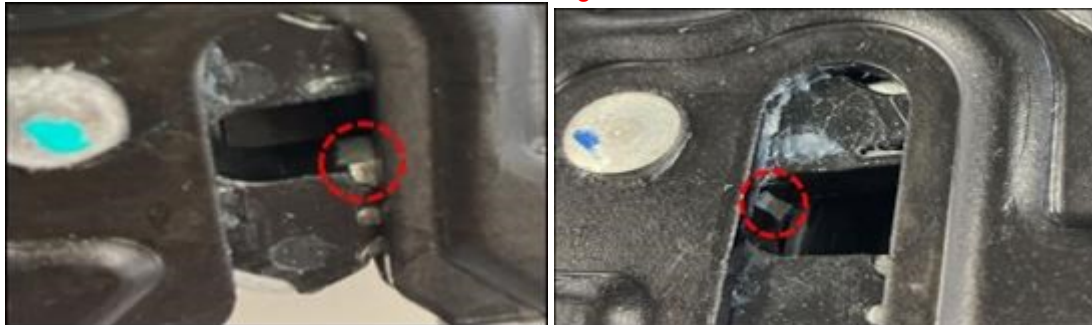
Some customers may complain about clicking noise coming from the liftgate latch-and-lock actuator (lock actuator) when driving on bumpy roads. This is caused by stick-slip friction between the lock actuator and the lock striker due to wear debris originating from the friction between them. To eliminate this concern, the lock striker coating has been changed to prevent coating wear.

NOTE: The areas indicated below without coating do not cause noise.
