Technical Service Bulletin

Mazda North American Operations
Irvine, CA 92618-2922

Subject: WIRELESS CHARGER (Qi) CONCERNS	Bulletin No.: 09-048/24
	Last Issued : 12/10/2024

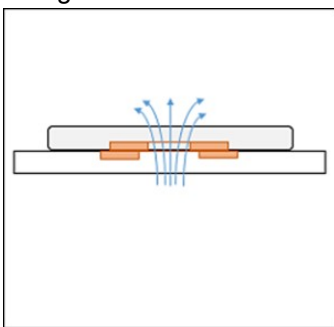
Well aligned coils for best performance

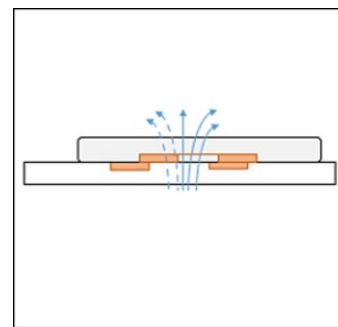
Poor alignment causes reduced power reception

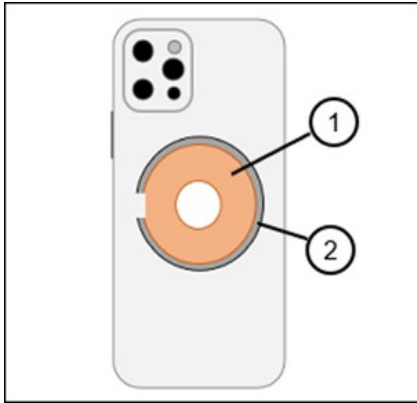
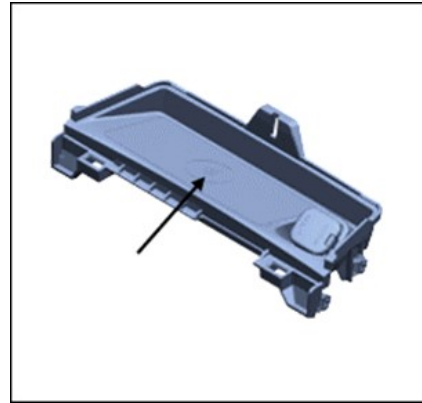
The coil (1) and magnets (2) are located at the center of iPhone. The coil is located at the center of the Qi symbol of the charger.

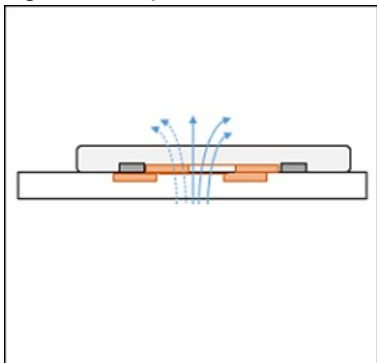
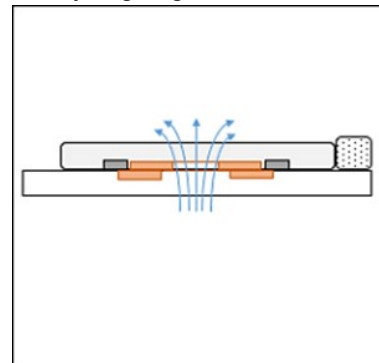
Interference by the coil and magnets spoils the charging performance. Assist alignment with a rubber block for better power transfer.

Even for the MagSafe compatible mobile device, place it on the charger manually aligning the center of the coils.
