GROUP	NUMBER
CAMPAIGN	25-01-001H
DATE	MODEL(S)
JANUARY 2025	SONATA (DN8/DN8A)

ECU UPDATE & CHECK VALVE/FUEL TANK INSPECTION AND REPLACEMENT (SERVICE CAMPAIGN 9B1)

This TSB supersedes 24-01-020H to update the Part Number for the Check Valve and include information regarding DTC P14EE00.

Description: Certain 2021-2023MY Sonata (DN8) and 2020-2022MY Sonata (DN8A) vehicles may have DTC P0451 stored in the ECU. Follow this bulletin to inspect the check valve, fuel pump cover and fuel tank, and update the ECU. If necessary, replace the check valve and/or fuel tank based on inspection results. The ECU Upgrade contains a revised DTC P14EE00 which supersedes P0451.

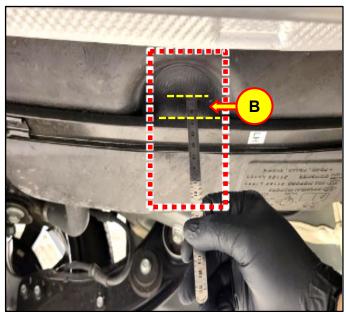
2. Use a suitable measuring tool gauged for millimeters to measure the gap (B) between the fuel tank and fuel tank band from the **center** of the groove as shown in the figure.

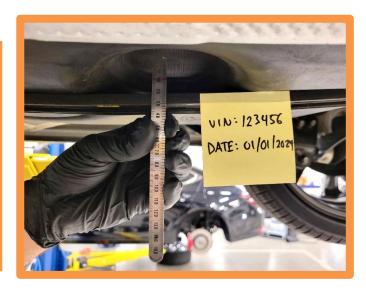
Using STUI, take a photo of gap showing the ruler and measurement, with the last 6 digits of the VIN and the date of repair on a piece of paper.

NOTE: Photo at right shown as measurement example only, and may not represent a gap of >25mm.

- If the gap is 25 mm or less:
 - Replace the check valve (C) with a new part.
 - Proceed to the ECU Update Procedure on page 17.

If the gap is more than 25mm continue to Fuel Pump Service Cover Inspection and Fuel Tank Replacement below.

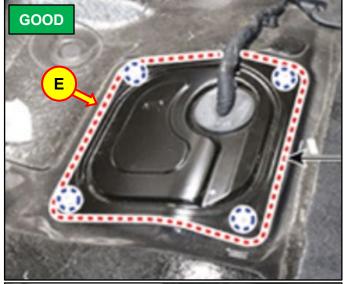
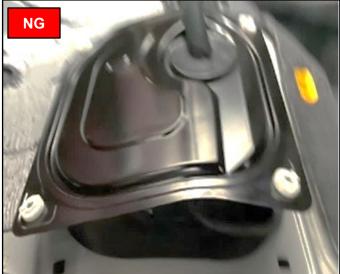
- 5. Inspect the fuel pump service cover (E).
 - If a gap is <u>NOT</u> present (GOOD):
 - o Replace the check valve.
 - o Proceed to step 8.
 - If a gap <u>is</u> present (NG)
 - o Open RA Techline Case.
 - o Continue to step 6.

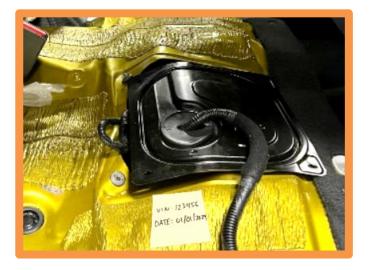
Using STUI, take a photo of the gap in the fuel pump service cover, with the last 6 digits of the VIN and the date of repair on a piece of paper.

7. Proceed as directed by Techline. Service procedure is complete.
