WINDSHIELD MOULDINGS DAMAGED DURING REMOVAL AND / OR INSTALLATION

Defender

- 20 - 25MY Defender

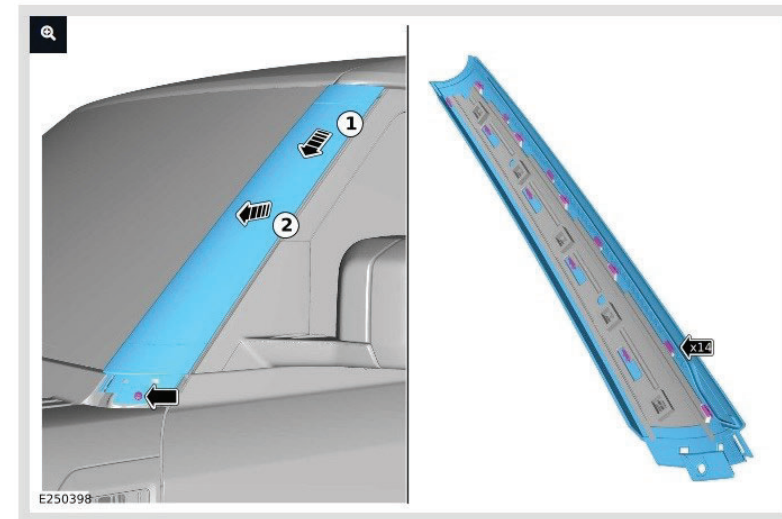
- The windshield trim is not sitting correctly or rattles.

- During removal or installation of the exterior A-pillar trim, the correct procedures are not being followed resulting in damage to the trim.

- SSM76227 has been published to request reminding technicians of the Workshop Manual procedure and to inspect the trim for damage due to incorrect removal or installation process.
